Model GS7000 GainMaker Node Optical Interface Board DC Voltage Short Technical Bulletin

A small number of optical interface boards (OIB) in the Model GS7000 GainMaker® Scalable 4-Port Nodes have experienced an electrical short. The 5 V DC and 24 V DC power planes have shorted to each other and sometimes to ground. These two voltages and the ground plane are on different layers of the six-layer OIB printed wiring board (PWB). The short could affect performance of the forward or reverse path, or both. It could even result in a node outage.

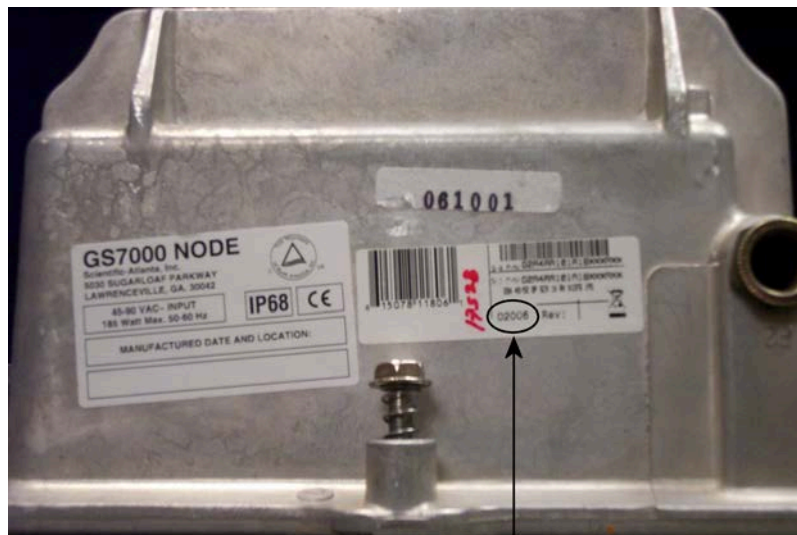
Manufactured Date Code

Model GS7000 Nodes with manufactured date codes before June 2007 could be affected by this issue.

The manufactured date code appears on one of the product labels affixed to the side of the node housing. The following illustration shows the location of the date code. The date code in this example is D2006.

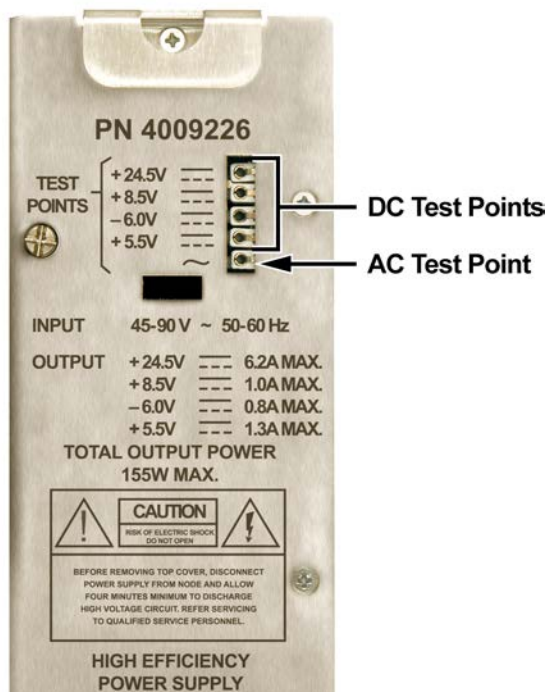
- 1 Measure voltages at the power supply test points and verify proper DC output.

Note: Improper voltage readings from the power supply do not necessarily indicate a failed power supply. It could indicate an issue in another node component.

- a If the power supply voltages are correct, continue with step 2.
- b If the power supply voltages are NOT correct, troubleshoot and/or replace the power supply before continuing with the rest of this test procedure.

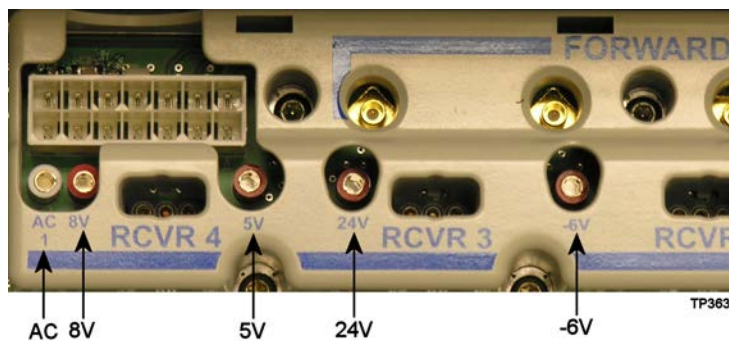
- 2 Measure voltages at the OIB test points.

Note: OIBs with the shorting condition will indicate improper voltages at the test points. Typically, only the 5 V DC is affected by the shorting condition.

- 3 If the OIB is bad, it should be replaced. Refer to *OIB Replacement Procedure* (on page 6).
