GS7000, GainMaker, and 694X Node Transmitter RF Shutdown Technical Bulletin

The optical transmitters of the GS7000, GainMaker, and 694X Nodes with specific date codes may have a defective capacitor which results in RF shutdown.

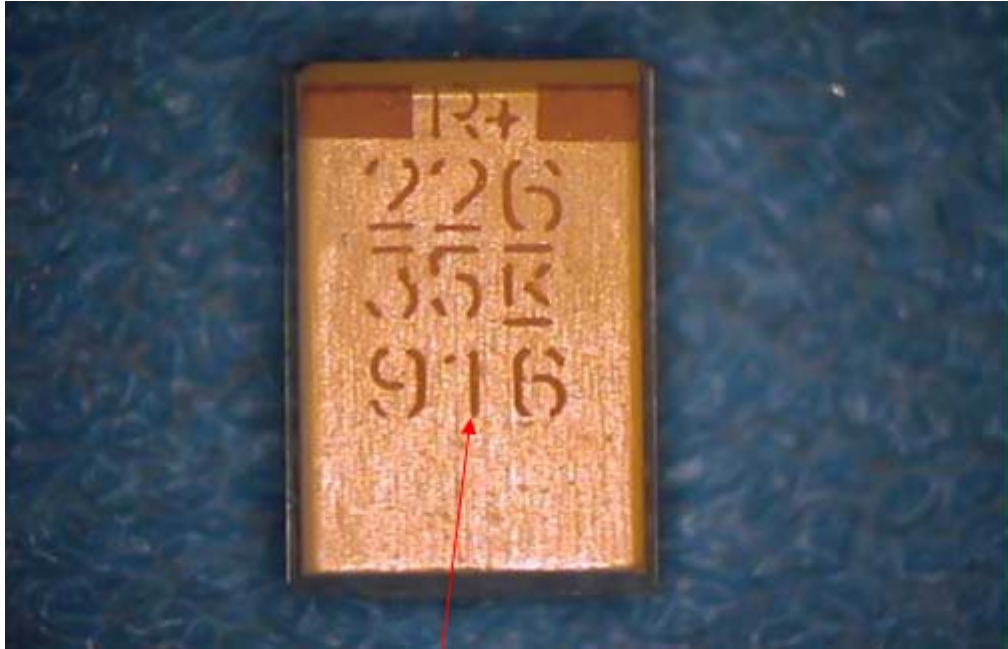
If you have a transmitter that displays this symptom and contains a capacitor with a date code of 916, 917, or 919 (As shown in illustration #4), the transmitter(s) should be returned to our repair facility for replacement.

Illustration # 4-The component date code is the bottom number (916)

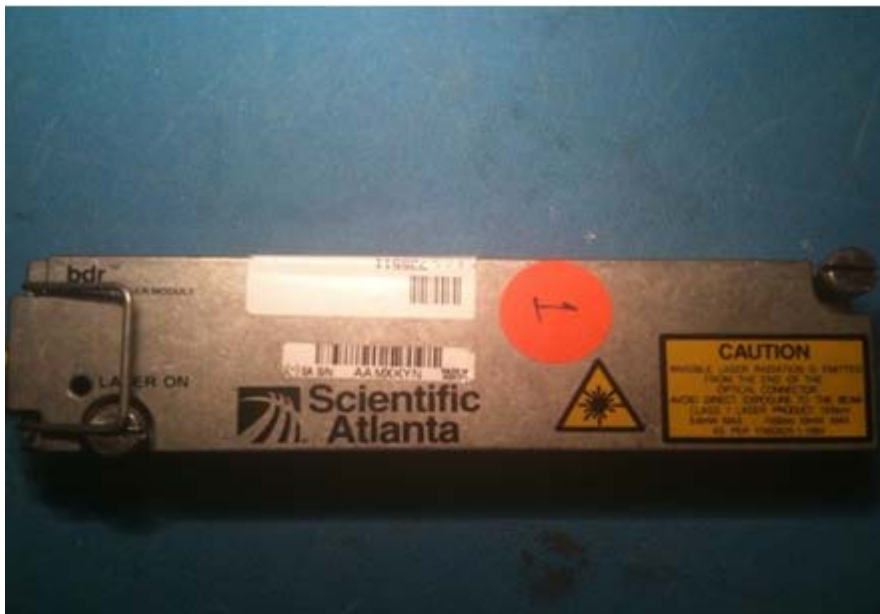
Illustration #5-2:1 BDR Transmitter

The following illustration shows BDR 2:1 transmitters ONLY. There is no access to view the capacitor with the cover installed. If the transmitters have date code D2009 - K2009 and they are listed under the affected part number series, return the module for service. Refer to *Support Telephone Numbers* (on page 10).

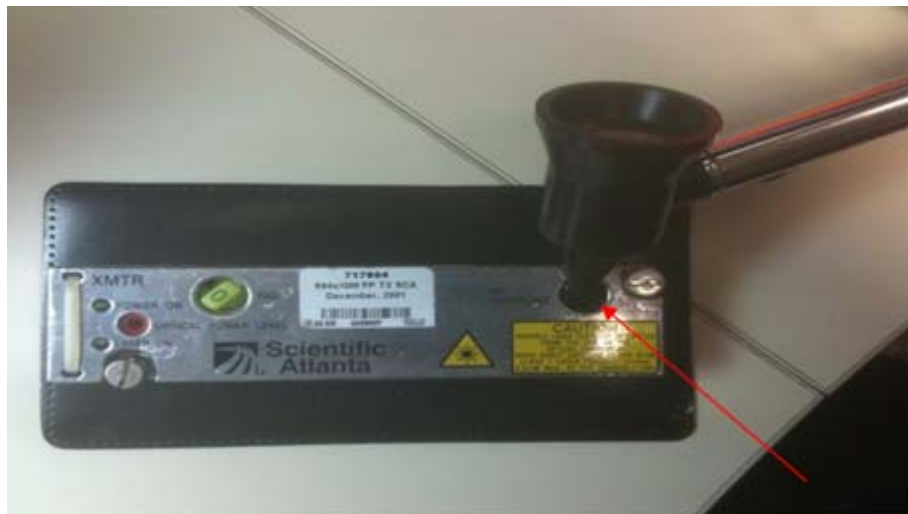
Illustration #7-6940 Tx

The following illustration shows the 6940 transmitter and the ostoscope used to inspect the capacitor. Capacitor location reference designator is C32.
