Troubleshoot HX Nodes PCI Address Reorder

This document describes the Network Interface Card (NIC) reorder issue on various 3rd Gen C-series Virtual Interface Card (VIC) adapters. A behaviour change is noticed with reference to Virtual Network Interface Card (vNIC)/ Virtual Host Bus Adapter (vHBA) placement, device order, Peripheral Component Interconnect (PCI) enumeration, and contribute to PCI re-order issues are seen from various Operating Systems (OS).

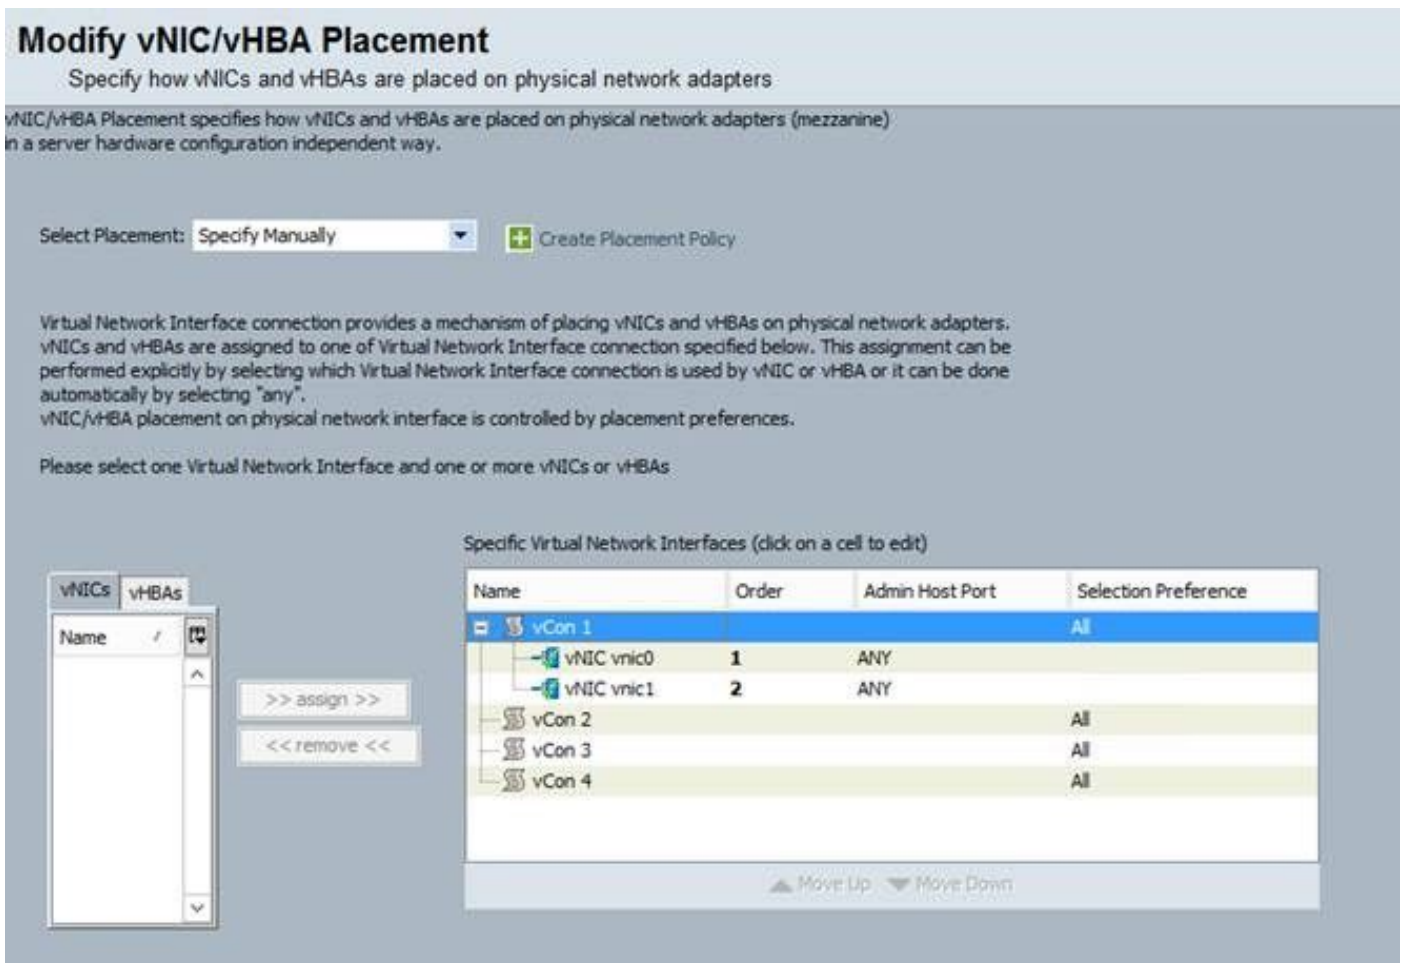
1. During the initial install: navigate to **Modify vNIC/vHBA Placement** policy as shown in the image.

2. Right now you see **Admin Host Port** as **ANY**. This would be a round-robin assignment, that puts **vnic0** on Host Port 1, and **vnic1** on Host Port 2. If you want to add two additional vNICs to the service-profile, first match the assigned host-port of the vNICs that already exist:

3. Then, add any new vNICs only to host-port 2. This will keep the PCI address of the pre-existing vNICs, and won't cause any re-assignment:

Note: You now have 1 vNIC on host port 1, and 3 vNICs on host port 2. The point of the load balancing is so that the load and bandwidth is evenly distributed. If you have a higher load on one host-port, it might cause a performance/bandwidth impact. If more than 2 additional vNICs must be created, it is recommended you plan a re-install of the OS in order to keep the host ports evenly distributed.
