CSCvb66655: Cannot Add Packet Transfer Mode (PTM) Entry for xDSL WAN on RV134W

Summary

When attempting to add a DSL WAN connection on the RV134W router, an option does not exist to add Packet Transfer Mode (PTM).

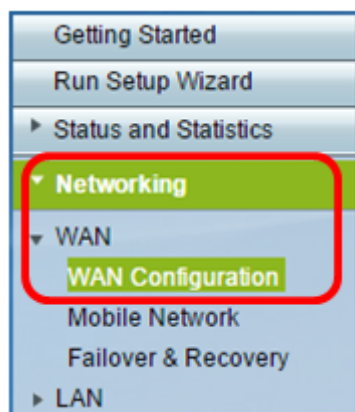
Step 1. Log in to the web-based utility and choose **Networking > WAN > WAN Configuration**.

Step 3. Under the DSL Settings area, the Transfer Mode is set to ATM. There is no way to configure PTM.

This issue will be fixed in the next firmware release of the RV134W.
