LACP Between Nexus 9000 and UCS Server

Document ID: 118851

Contributed by Viral Bhutta and Manuel Velasco, Cisco TAC Engineers.

Mar 18, 2015

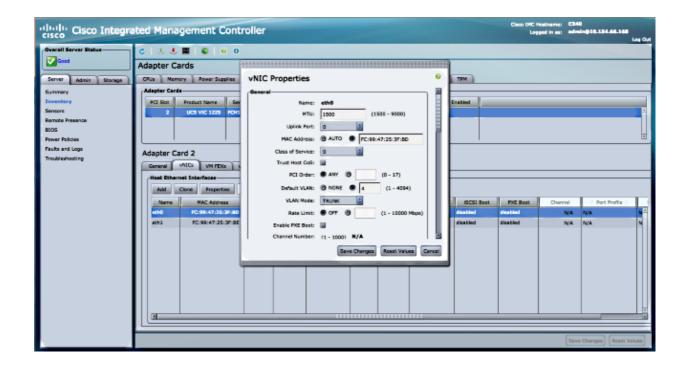
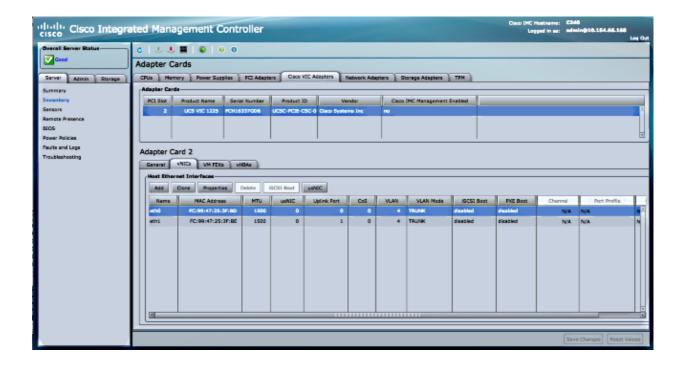
However, the VLAN ID is set to 0. Now, when you look at the configuration for Virtual Network Interface Card (vNIC), you see that by default the VLAN is set to *None* and the VLAN Mode is set to *access*. Now even in this mode, it sends LACPDU with the dot1q header. However, the Nexus 9000 does not identify VLAN 0 and hence this packet is dropped. This behavior is documented in UCS C–Series Rack Servers VIC Connectivity Options.

In order to make this work, you must configure the VLAN Mode as *Trunk* and also configure the default VLAN as a VLAN that is allowed on that port. In order to change this, you log into your server's CIMC IP address.

- 1. Click the *Sever tab* in the left pane and then click *Inventory*.
- 2. Click Cisco VIC adapters in the right pane and then click vNICs.
- 3. Choose the interface and then click *Properties*. You should be able to make the changes here:

4. Once the changes are made, *Save* changes. You must reset the server for the changes to take effect. After the reset, the port–channel should form correctly.
