Troubleshoot BGP Flaps Between Ultra Packet Core and Nexus Switch Due to Incorrect Configuration

This document describes the solution to the Border Gateway Protocol (BGP) flaps between Cisco Ultra Packet Core (UPC) and Nexus 9000 switch configured with redundant BGP connection.

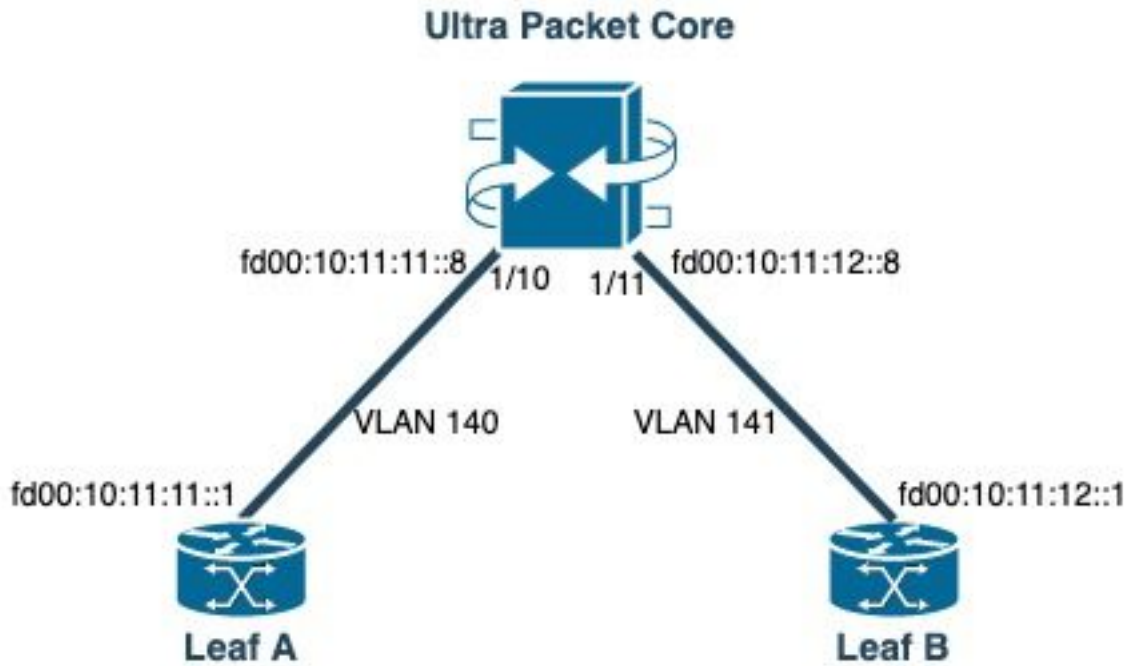
Figure 1: Network

The Ultra Packet Core (UPC) node is connected to Nexus Leaf A and Leaf B on separate ports. The BGP IPv6 peers are established and the default routes are installed on the UPC node. Figure 1 shows the high-level network diagram with redundant path to Leaf switches.
