UCS M5刀片DIMM填充标签与文档不匹配

本文档介绍旧UCS M5刀片DIMM填充贴纸不反映当前在线文档的问题。

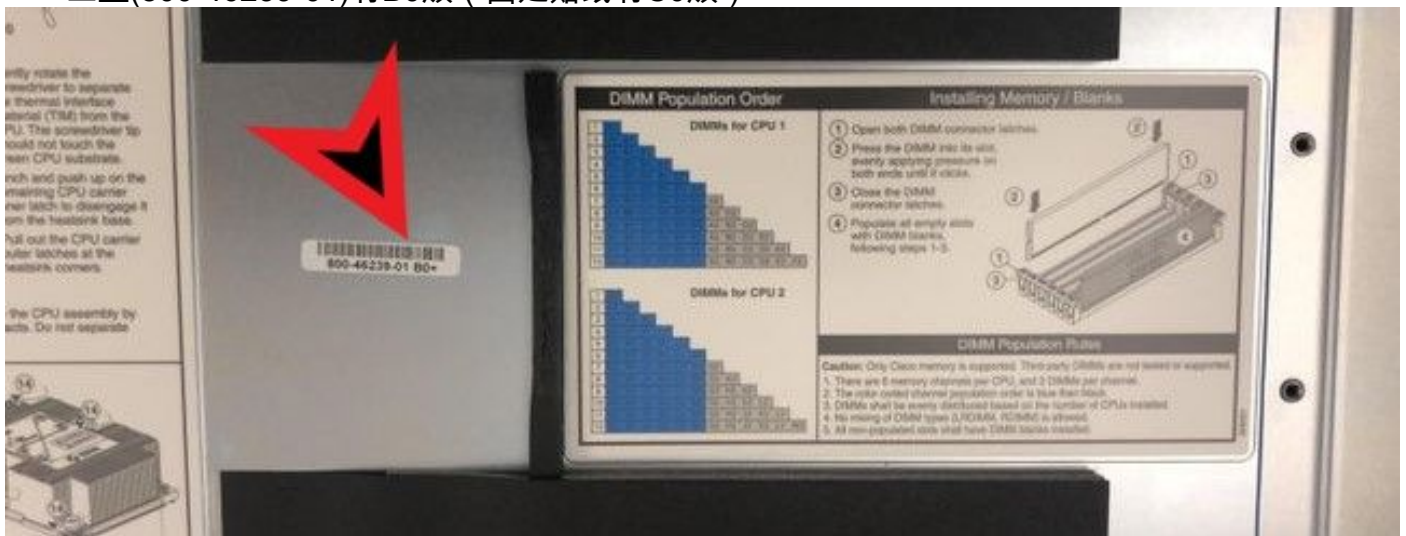
- UCS B200 M5
- UCS B480 M5
- 上盖(800-46239-01)有B0版（固定贴纸有C0版）

原始DIMM填充标签并不不正确，但应将客户引导至在线文档，以获取最新且最佳配置。

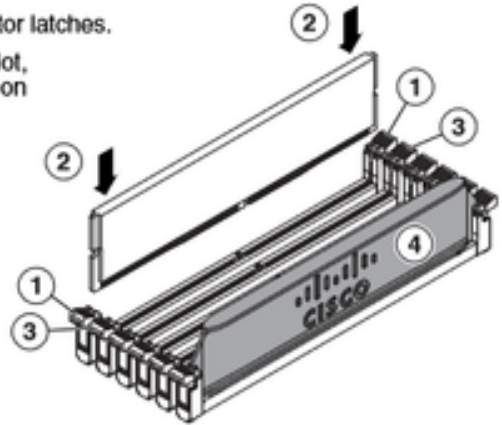
以下是B200-M5的旧贴纸供参考：

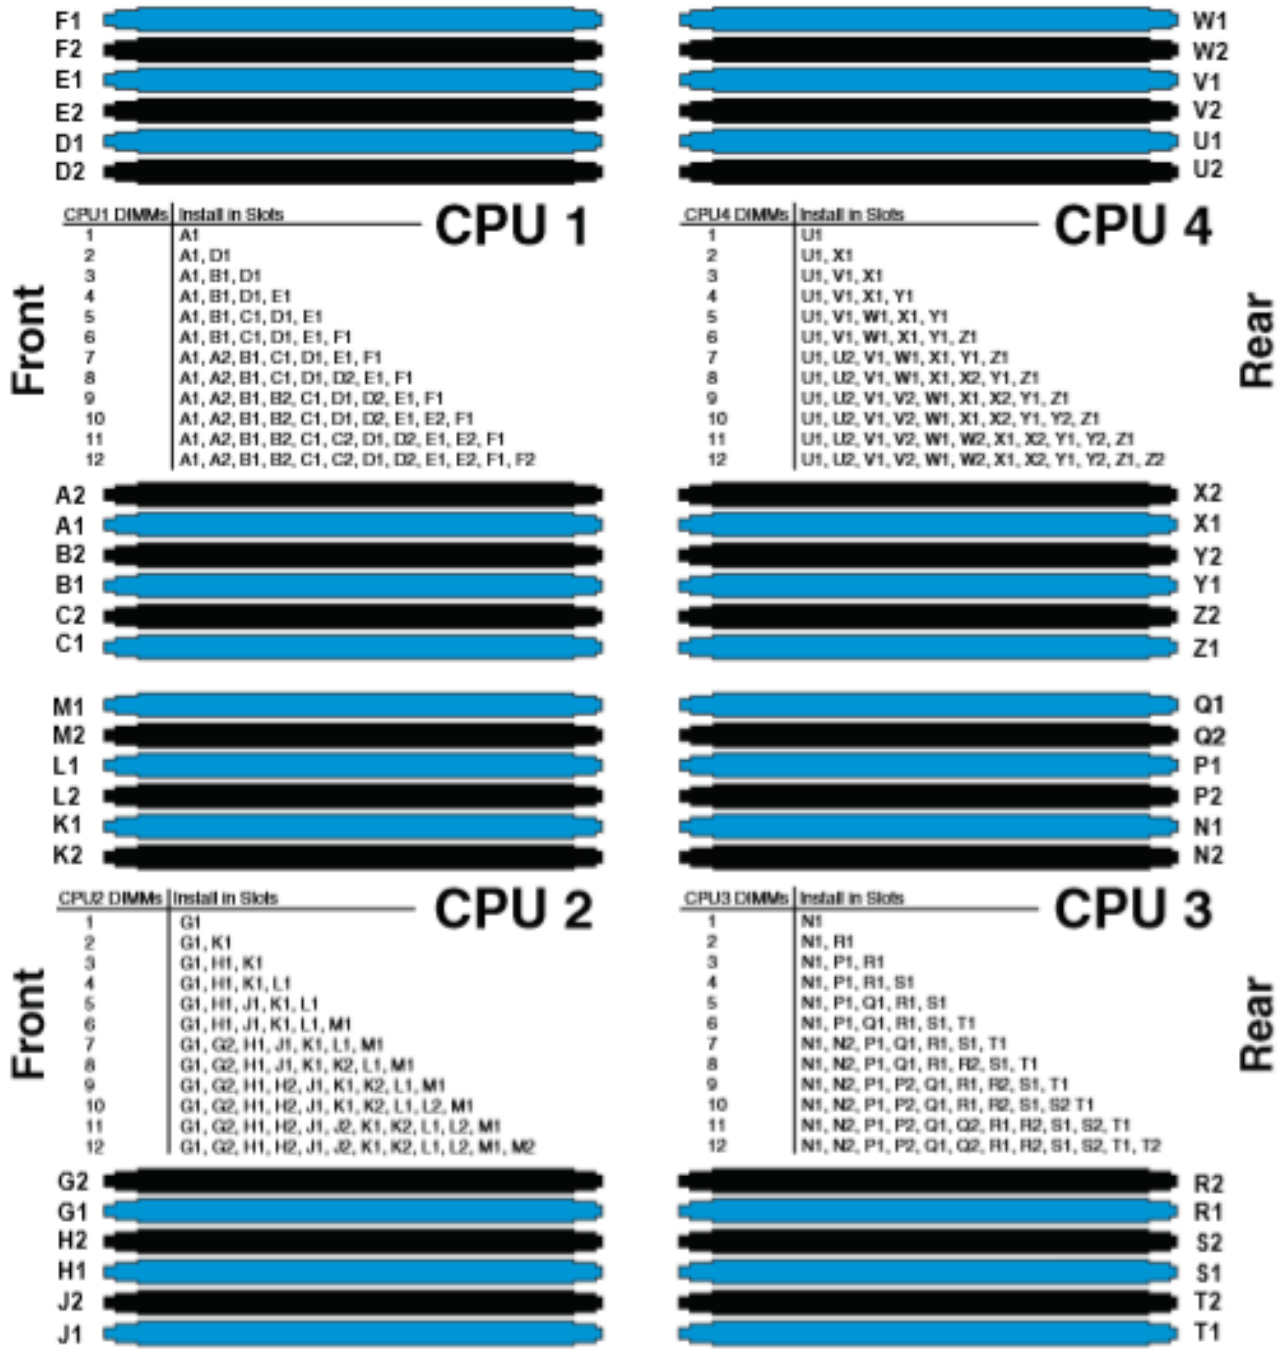
Cisco UCS B480 M5 Memory Slot Locations

以下是B480-M5的旧贴纸供参考：
