Introduction

This document describes general troubleshooting steps for Enterprise License Manager (ELM) and Prime License Manager (PLM). Perform the given checklist before opening a TAC case.

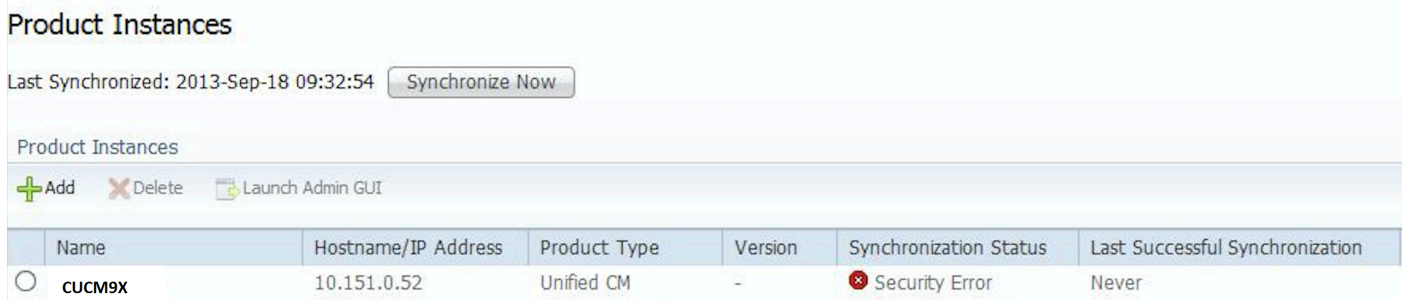
Problem 1. " when you add Product Instance in ELM/PLM.

Name	Hostname/IP Address	Product Type	Version	Synchronization Status	Last Successful Synchronization
<input type="radio"/>	cucm9x	10.151.0.52	Unified CM	-	Security Error	Never

Security error triggers because of Network Time Protocol (NTP) synchronization issue in CUCM. In this case, log in to CLI and check the NTP sync status by running **utils NTP status** command.

Ensure that NTP is synchronized correctly to NTP reference and NTP stratum is less than five.
