Understanding and Configuring DLSw and 802.1Q

Document ID: 26470

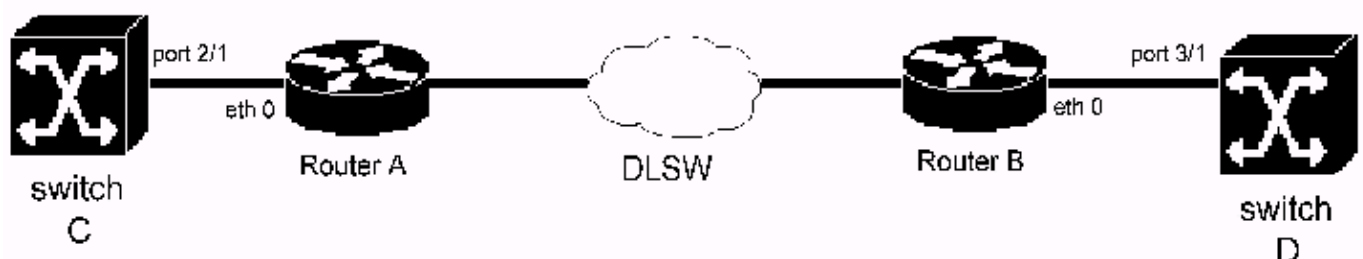
In the above topology, ethernet 0 of Router A connects to port 2/1 on Switch C. Ethernet 0 of Router B connects to port 3/1 on Switch D. Interface ethernet 0 of both Router A and B is configured as a non-trunk port. DLSw is enabled on interface ethernet 0 of both Router A and B (transparent bridging is enabled on ethernet interface 0 of both Router A and B.) Router A and B form a DLSw peer connection.

If port 2/1 of Switch C is misconfigured as a trunk port, Switch C regularly sends out PVST+ BPDU frames to Router A. As Router A does not understand PVST+, Router A treats PVST+ BPDU frames as ordinary multicast frames. Thus, Router A sends the BPDU frames to Router B by DLSw. Similarly, Router B does not understand PVST+. When it receives PVST+ BPDU frames from Router A, it forwards the PVST+ BPDU frames to Switch D. When Switch D receives the PVST+ BPDU frames, it detects a problem (that is, Switch D receives PVST+ BPDU frames on a non-trunk port.) As a result, Switch D shuts down the port and logs %SPAN TREE-2-RX_1QNONTRUNK: Rcvd 1Q-BPDU error messages on non-trunk port VLANs.
