MTU Mismatch Problem in IS-IS

Document ID: 47201

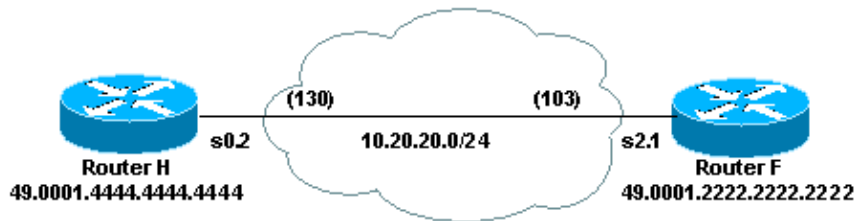
The network diagram and configurations used to describe this problem are shown here:

Router H does not receive the hellos from Router F because IIHs are padded to the full MTU of the link, whereas ES hellos are not padded to full MTU size. This happens because Router F thinks the MTU is 2000, and it sends a 2000-byte hello, which is ignored by Router H.

The solution is to make sure that both sides of a link have the same MTU. One way to do this is to use the **mtu** command as shown here:
