Troubleshoot License Alarm for NCS2K and ONS15454

This document describes general license-related alarms raised for Network Convergence System 2000 (NCS2k) and the procedure to troubleshoot and install the license.

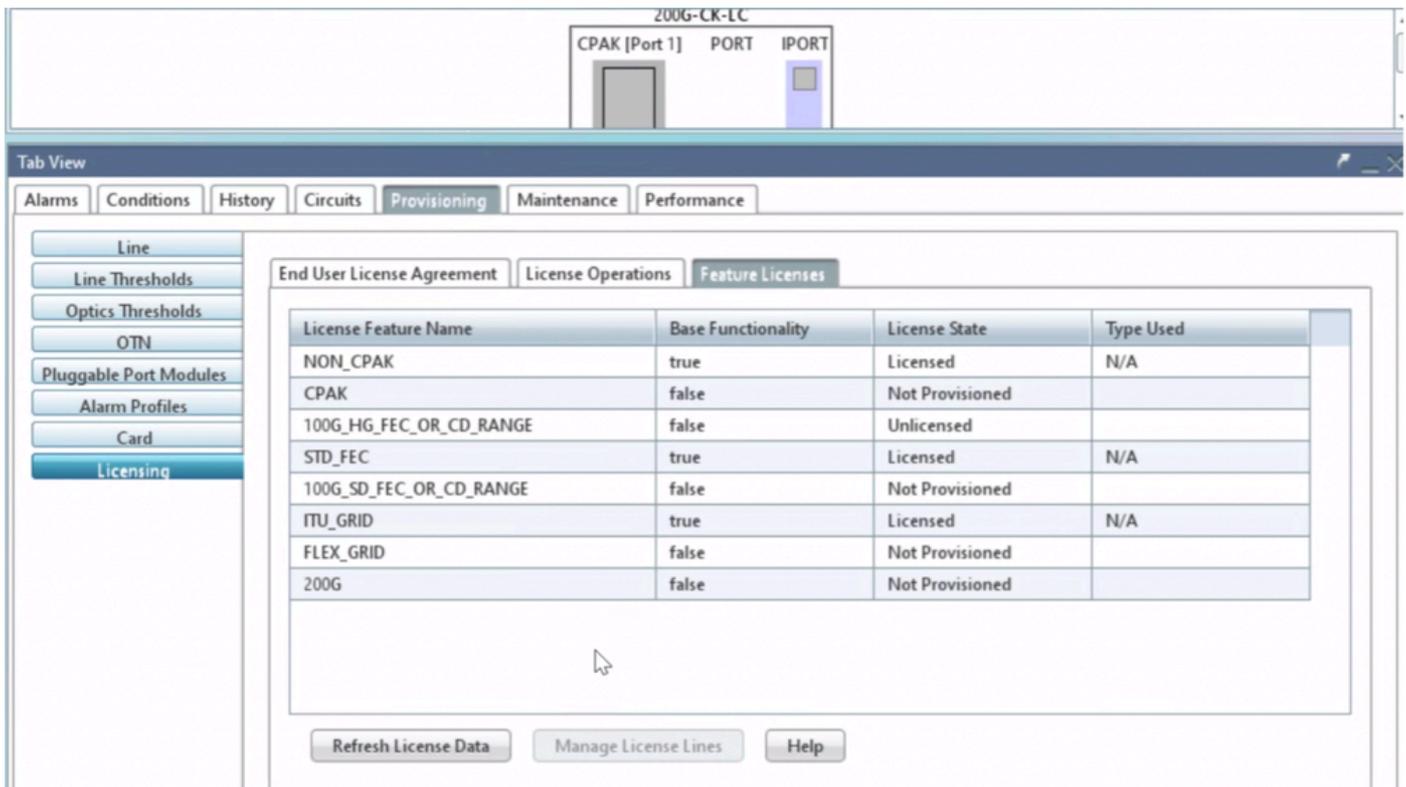
Feature Licenses table

1. Navigate to `Card view > Provisioning > Licensing > Feature Licenses` as shown in this image.

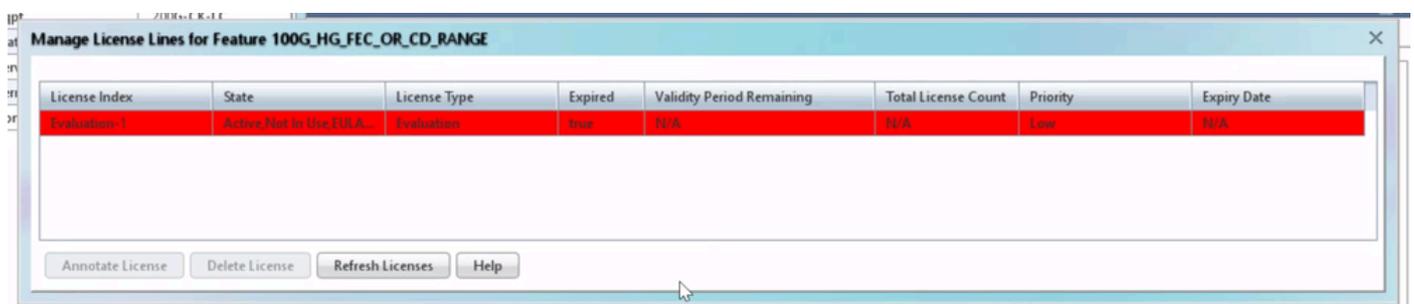
License Detail

3. If a value is Unlicensed, select the row from the Feature Licenses table and click on **Manage License Lines** as shown in the image.

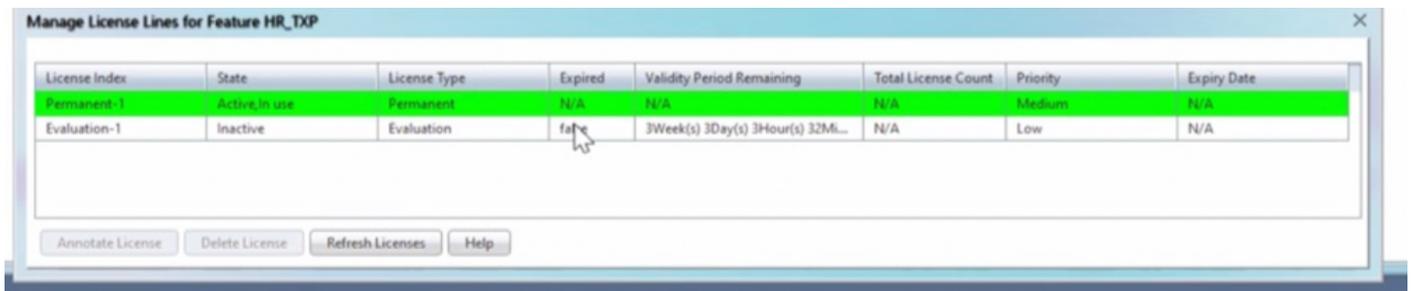
Selected License Detail

4. New pop-up shows all licenses against that feature (evaluation, temp, and permanent).

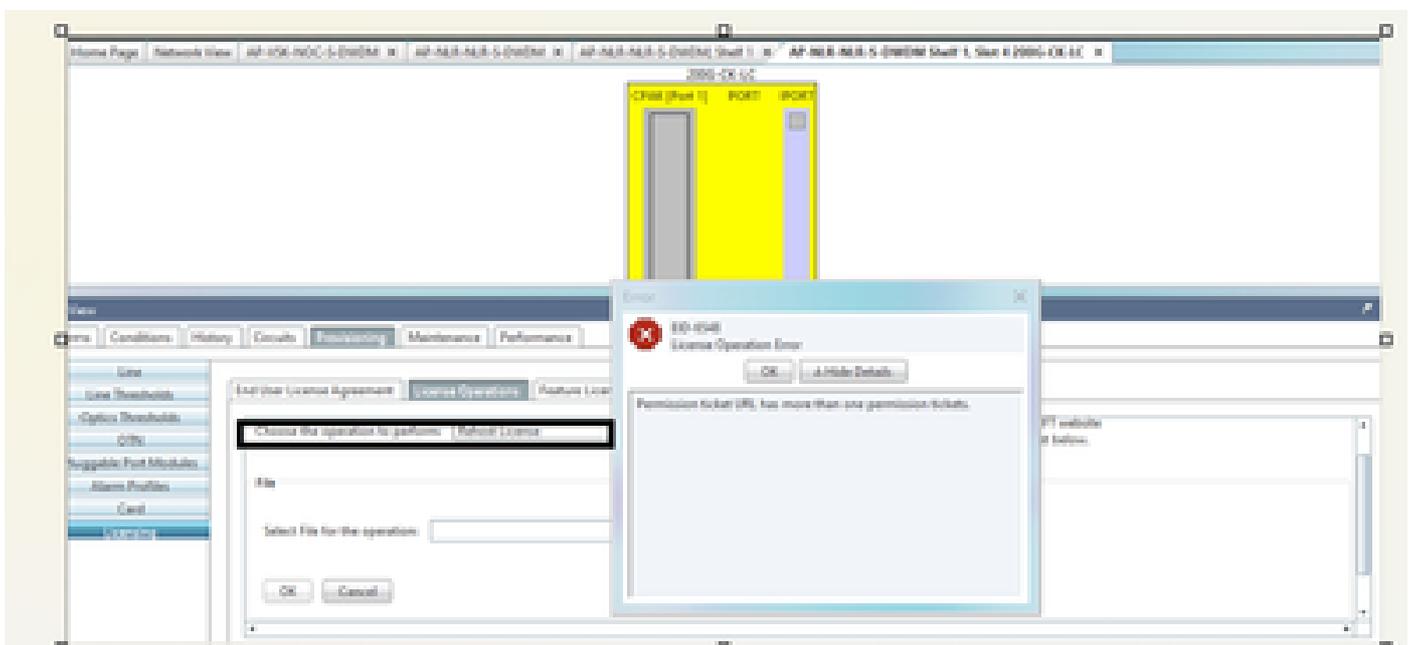
- After replacing the 200G card, we started observing an "Evaluation in Use" alarm on the card.
- We initiated the process of rehosting the license files from the old SN to the new SN.
- Encountered an error: 'Permission ticket URL has more than one permission' while rehosting the license.
- Advised to select the 'Install' option instead of the 'Rehost License' option and retry.
- This helped to clear the alarm.
