DCX–No ACK in 100 PDUs Error Message

Document ID: 116249

Contributed by Prashanth Krishnappa and Shelley Bhalla, Cisco TAC Engineers. Jul 10, 2013

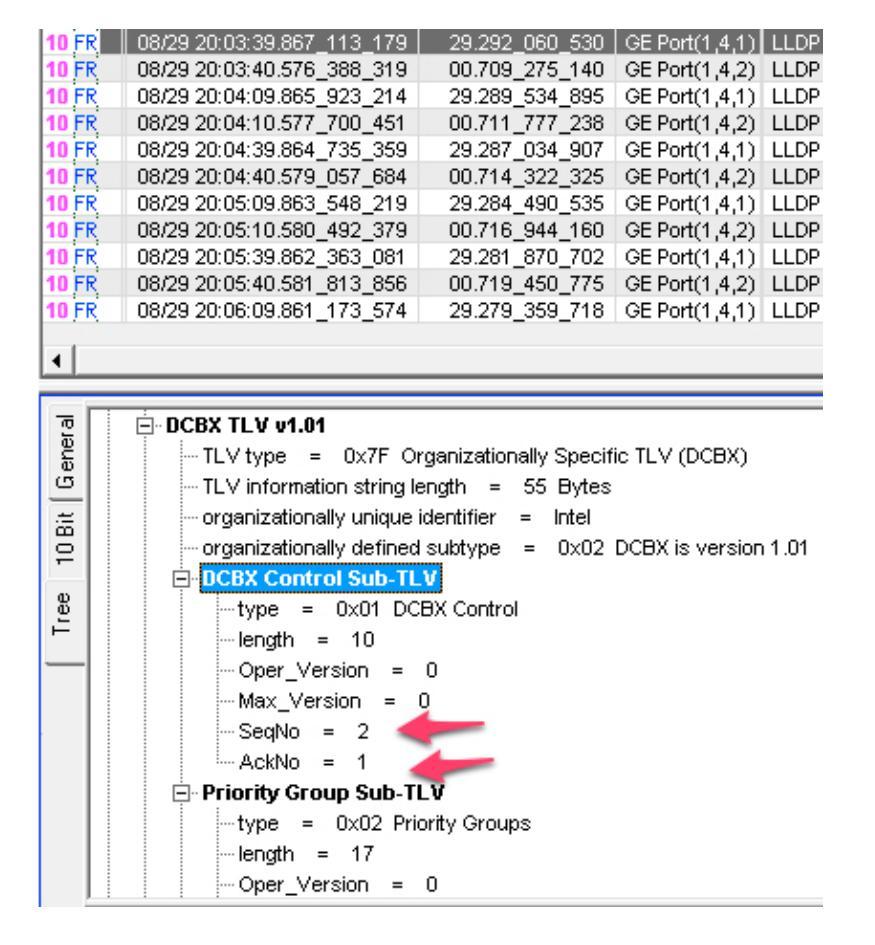
Inline Packet Capture of CNA Sending LLDP Frame DCBX Control Sub–TLV of SeqNo 2 and AckNo 1

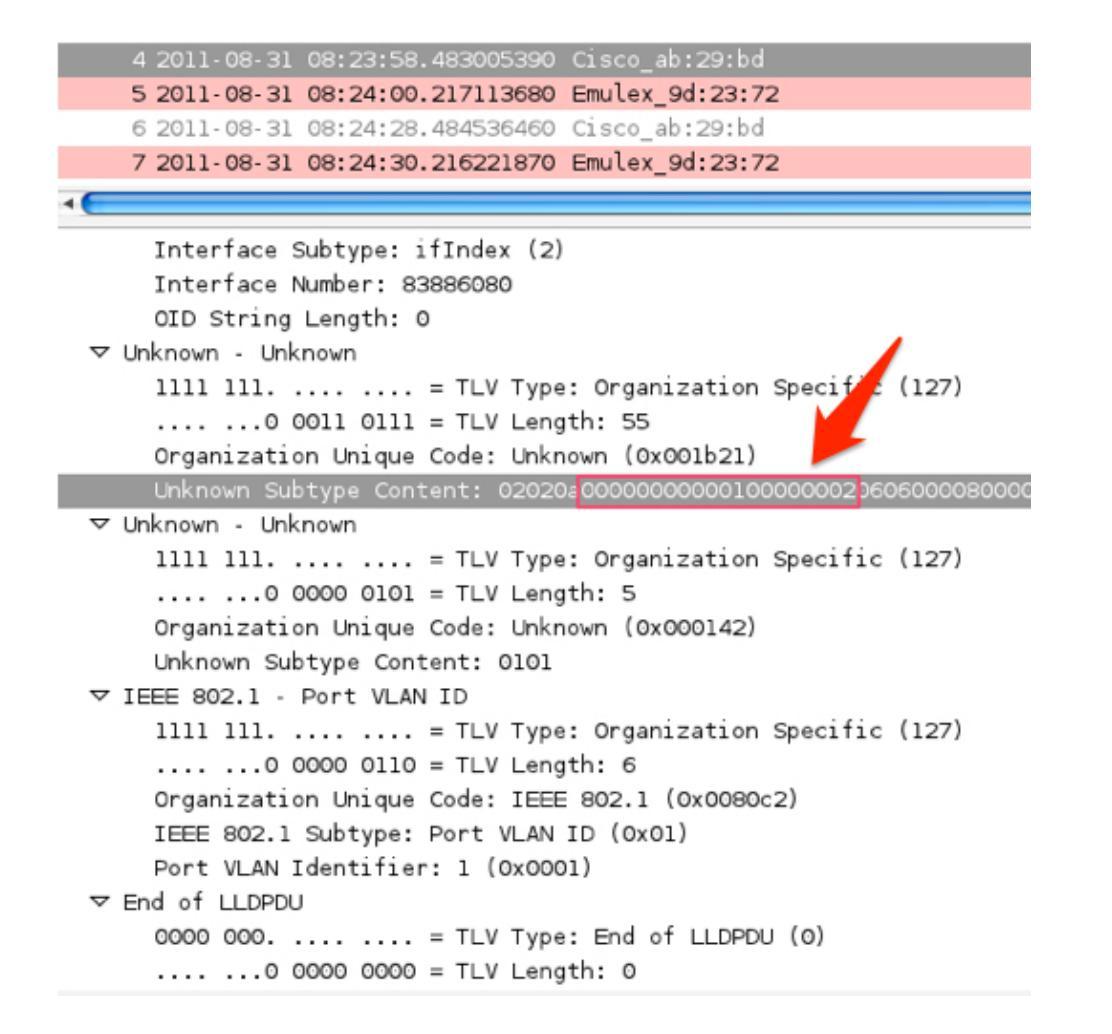
Wireshark Capture of Nexus 5000 Sending LLDP Frame DCBX Control Sub–TLV of SeqNo 1 and AckNo 2

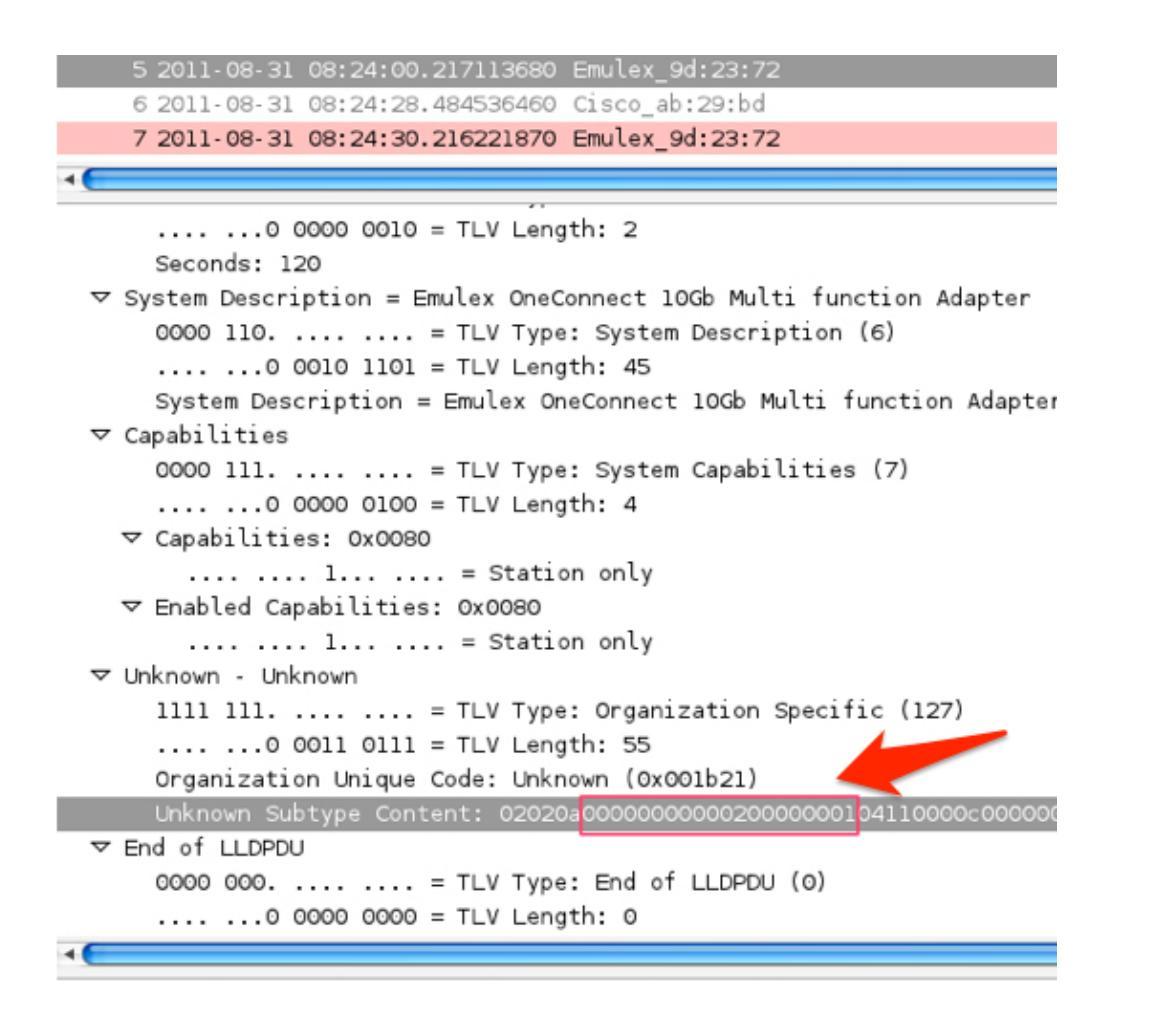
Wireshark Capture of CNA Sending LLDP Frame DCBX Control Sub-TLV of SeqNo 2 and AckNo 1
