ピア スイッチ設定で Nexus 7000 STP プライオリティを変更することによるインパクト アセスメントおよび設定例

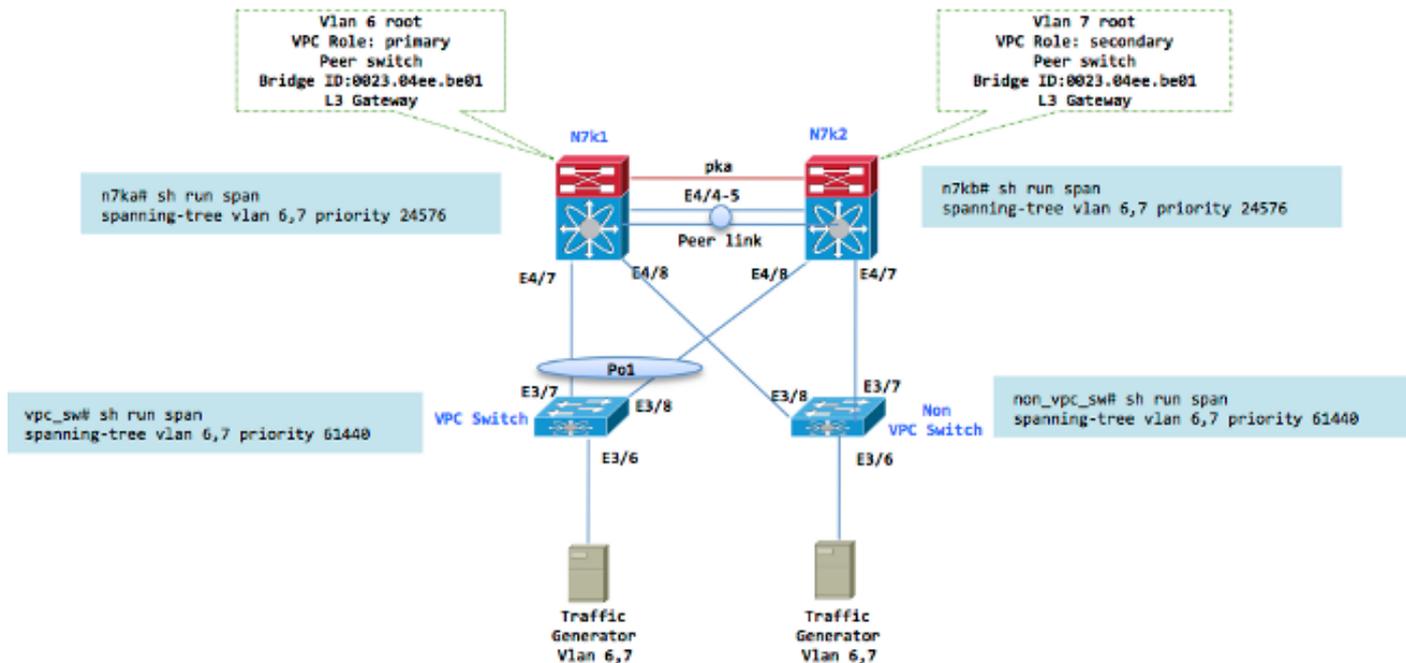
次に示すトポロジでは、Nexus 7000 上の VLAN 6 と 7 の STP プライオリティが変更されています。ピア スイッチ セットアップでは、両方の Nexus 7000 が独立してブリッジ プロトコル データ ユニット (BPDU) を生成するため、このような変更が原因で、いずれかの Nexus 7000 がもう一方のピアと同じ属性で BPDU をアドバタイズします。

非 vPC スイッチが、異なるパスから優れた BPDU を受信する可能性があり、これが原因で特定のリンクのフォワーディング ステートが変更される可能性があります。次の出力例にこのステートの変更を示します。この出力では、ピア スイッチの変更後に e3/7 がフォワーディング ステートになっています。RSTP が使用中であるため、このステート変更は 1 秒未満で実行されます。ただし、これが原因でトポロジ変更通知 (TCN) が生成されます。
