如何在TC/CE終端升級後排除TMS上的「無HTTPS響應」錯誤

本文描述如何對Telepresence Management Suite(TMS)上的「no HTTPS response」(無HTTPS響應)消息進行故障排除。

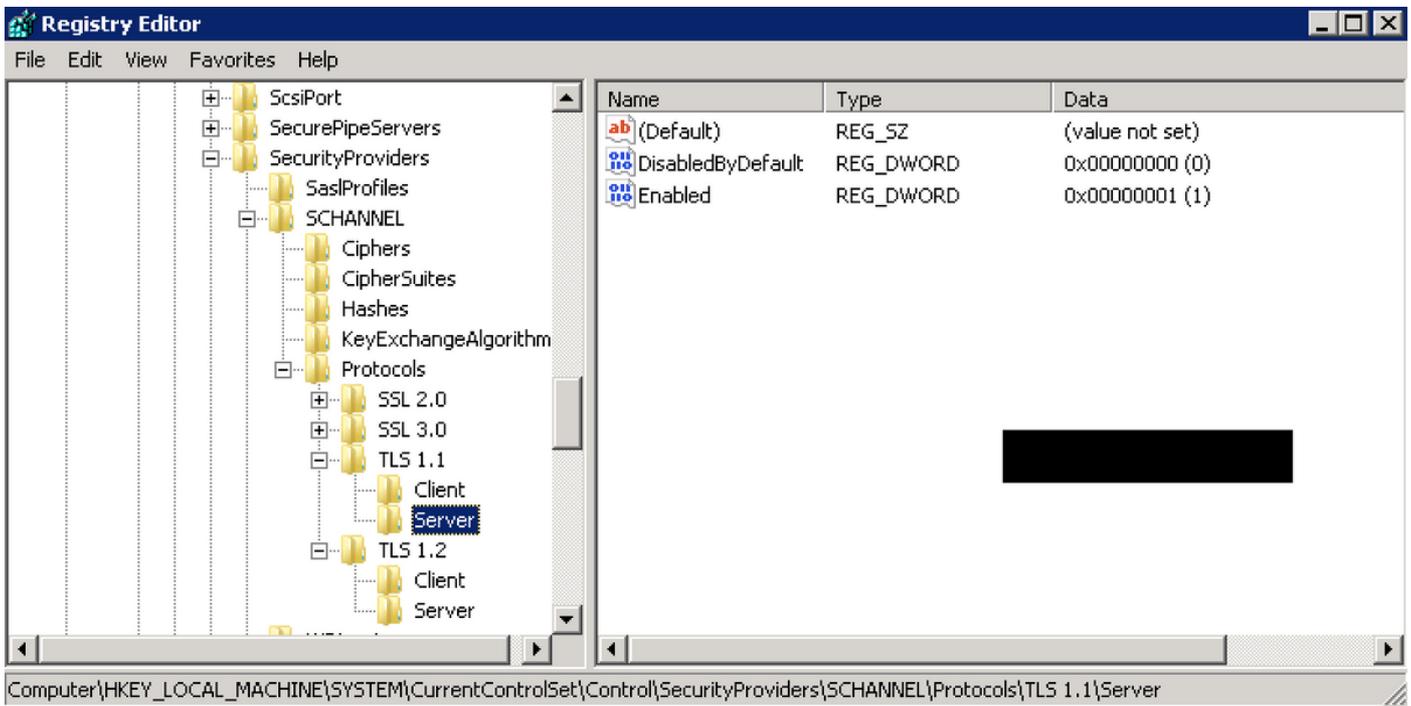
- 根據發行說明，TC 7.3.6和CE 8.1.0及更高版本不再支援TLS 1.0。
http://www.cisco.com/c/dam/en/us/td/docs/telepresence/endpoint/software/tc7/release_notes/tc-software-release-notes-tc7.pdf
- Microsoft Windows伺服器預設禁用TLS版本1.1和1.2。
- 預設情況下，TMS工具在其傳輸層安全選項中使用介質通訊安全。
- 當TLS版本1.0被禁用，同時啟用TLS版本1.1和1.2時，TMS不會在與終端的TCP三次握手成功後傳送安全套接字層(SSL)客戶端hello。但是仍然可以使用TLS 1.2版加密資料。
- 使用工具或在Windows登錄檔中啟用TLS版本1.2是不夠的，因為TMS仍然只在其客戶端hello消息中傳送或通告1.0。

TLSDWORD

DisabledByDefault [Value = 0]

Enabled [Value = 1]

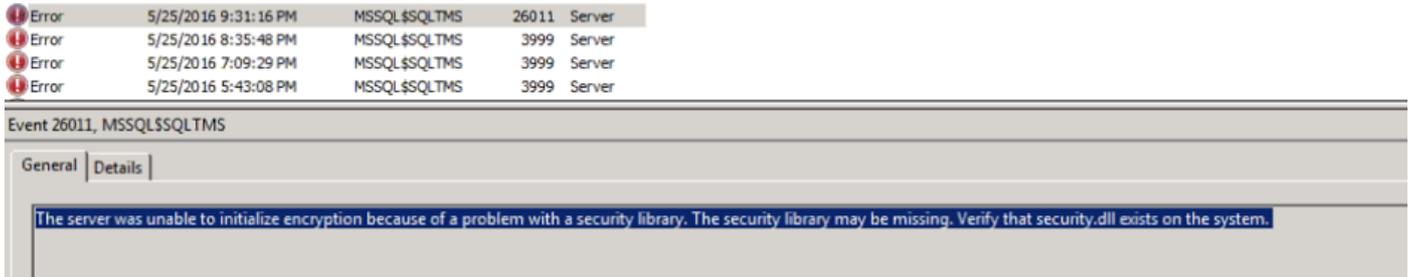
當SQL 2008 R2正在使用中並安裝在TMS Windows伺服器上時，我們需要確保同時啟用TLS1.0和SSL3.0，否則SQL服務停止並且不會啟動。

您必須在事件日誌中看到以下錯誤：

The server was unable to initialize encryption because of a problem with a security library. The security library may be missing. Verify that security.dll exists on the system.

使用SQL 2012時，如果安裝在TMS Windows伺服器上，則需要更新以處理TLS更改 (<https://support.microsoft.com/en-us/kb/3052404>)

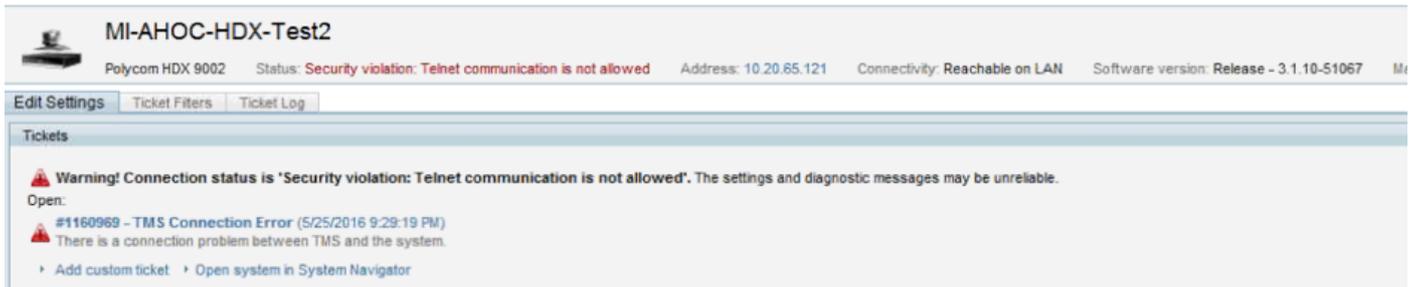
使用SNMP或Telnet管理的端點顯示「Security violation:不允許Telnet通訊」。

Warning! Connection status is 'Security violation: Telnet communication is not allowed'. The settings and diagnostic messages may be unreliable.

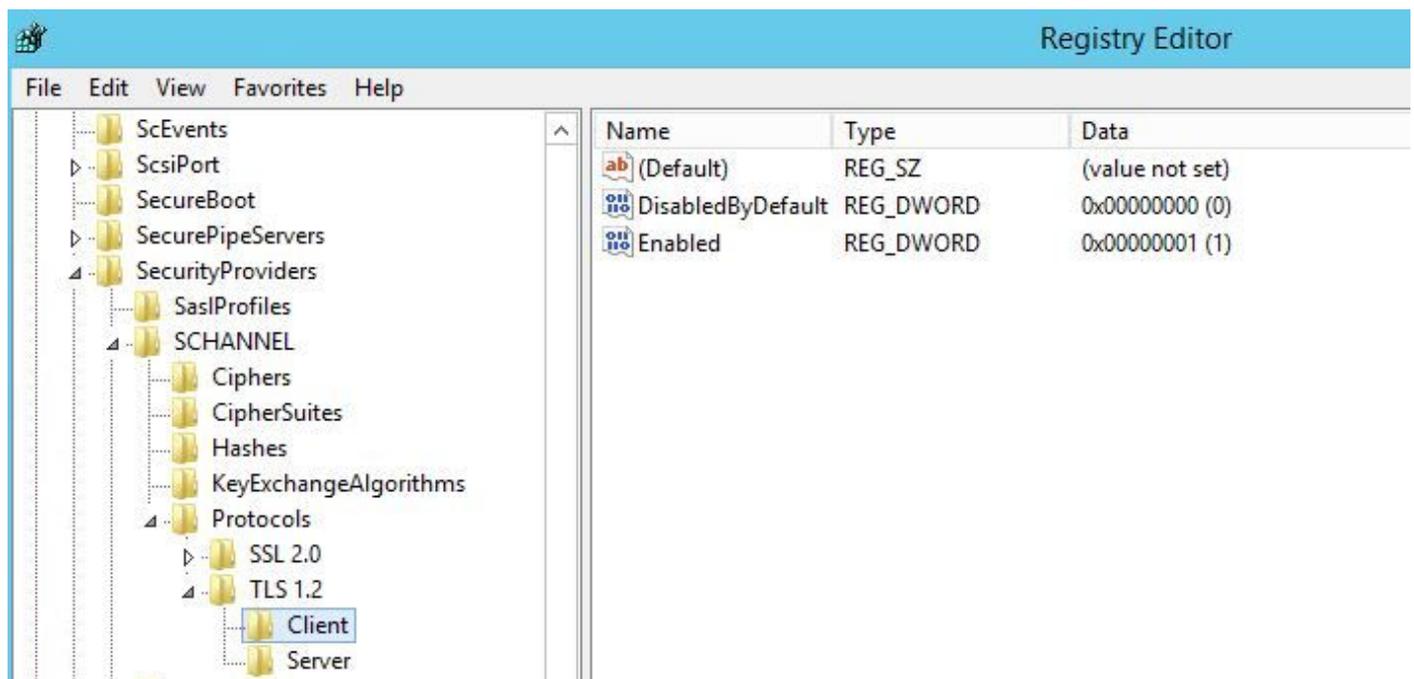
步驟1.即使TLS 1.2版已新增到登錄檔中

步驟2. TMS伺服器仍不傳送終端在其SSL客戶端hello中支援的版本

步驟4. 然後此問題的解決方法是將TMS升級到15.x，或將TC/CE端點降級到7.3.3, [CSCuz71542](#) 軟體缺陷 (為14.6.X版建立) 中會跟蹤此問題。
