疑難排解Cisco Catalyst交換器上的MAC擺動/回圈

本檔案介紹如何對Cisco Catalyst交換器上的MAC擺動/回圈進行疑難排解。

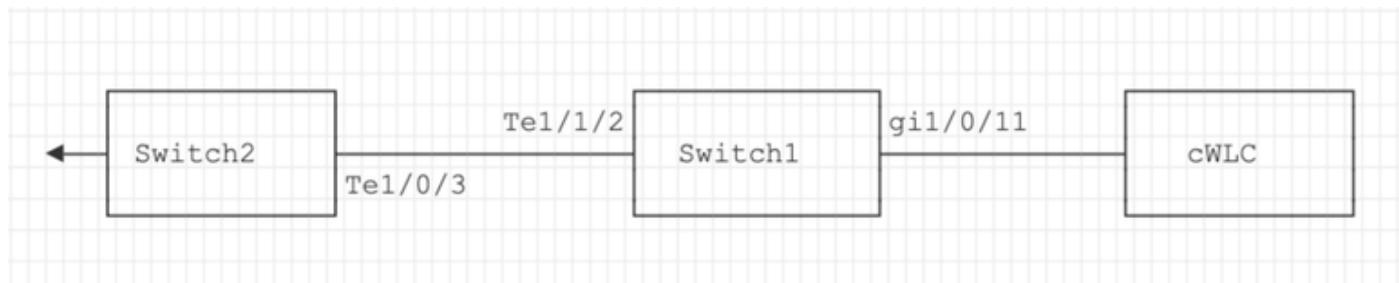
拓撲

eWLC控制器遇到與網關的連線丟失的情況，而丟包正在阻止AP加入控制器。

經驗證，交換器2和eWLC的虛擬路由器備援通訊協定(VRRP)ID相同，因此由VRRP產生相同的虛擬MAC。

更改WLC上的VRRP例項後，問題得到解決，VRRP例項導致交換機上的重複MAC導致與網關的連線丟失和丟包，從而阻止AP加入控制器。

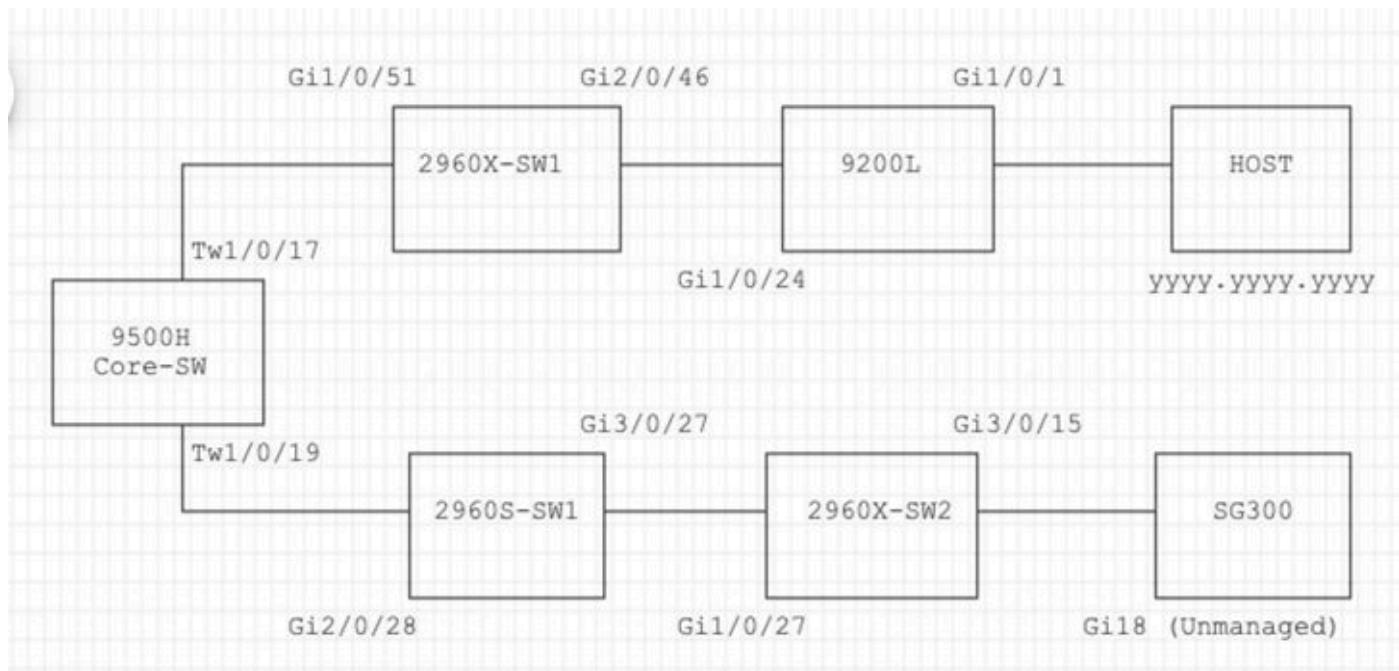
拓撲

有些伺服器無法訪問或遇到大量延遲/丟棄。

由於連線到網路的SG300（非託管）交換機，出現MAC擺動。

通過關閉連線到非託管交換機SG300的埠解決了MAC抖動問題。
