# 對等交換機設定影響評估和配置示例中的Nexus 7000 STP優先順序更改

## 簡介

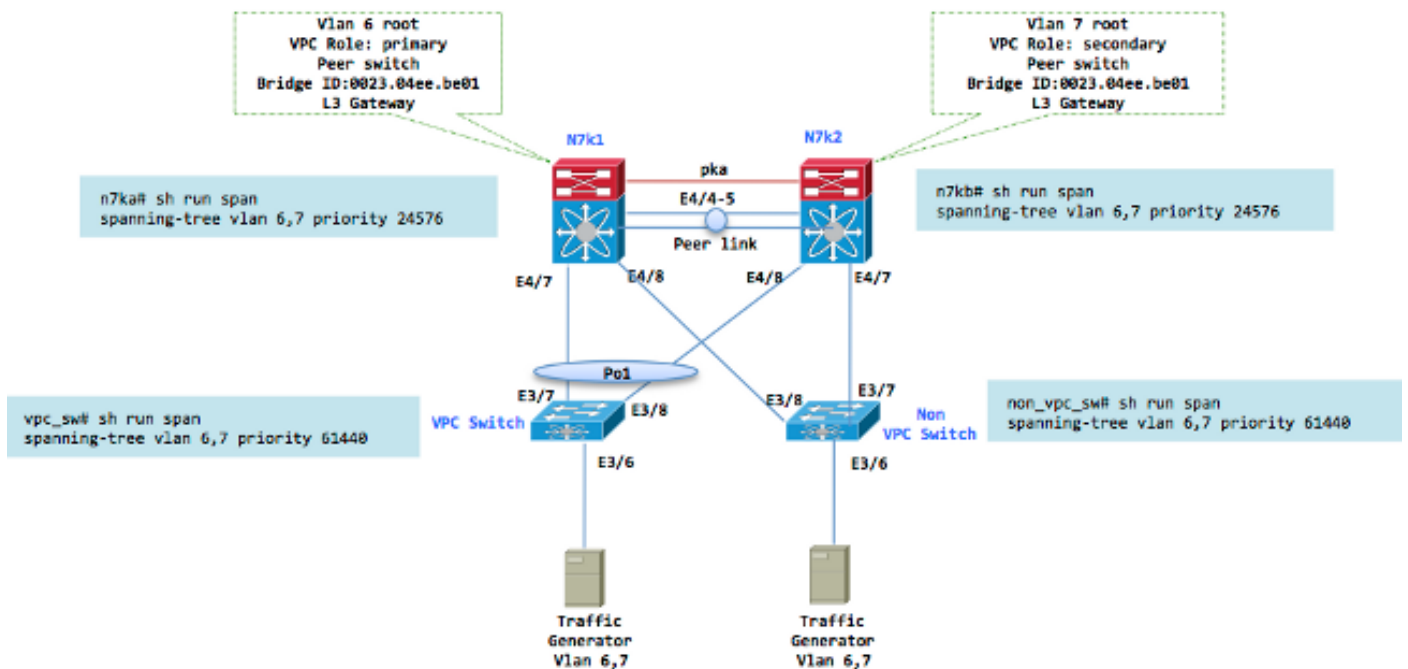
此處顯示的拓撲中，對Nexus 7000上VLAN 6和7的STP優先順序進行了更改。由於在對等交換機設定中，兩台Nexus 7000均獨立生成網橋協定資料單元(BPDU)，因此更改會導致Nexus 7000之一使用與其對等交換機相同的屬性通告BPDU。

非vPC交換機現在可能收到來自不同路徑的上級BPDU，這可能引起特定鏈路的轉發狀態發生更改。狀態更改顯示在下一個示例輸出中，其中e3/7在對等交換機更改後進入轉發狀態。由於RSTP正在使用中，因此此狀態更改是次秒級。但是，它會生成拓撲更改通知(TCN)。
