Nexus 9000和UCS伺服器之間的LACP

本檔案介紹如何在Nexus 9000和整合運算系統(UCS)伺服器之間形成連結彙總控制通訊協定(LACP)連線埠通道。

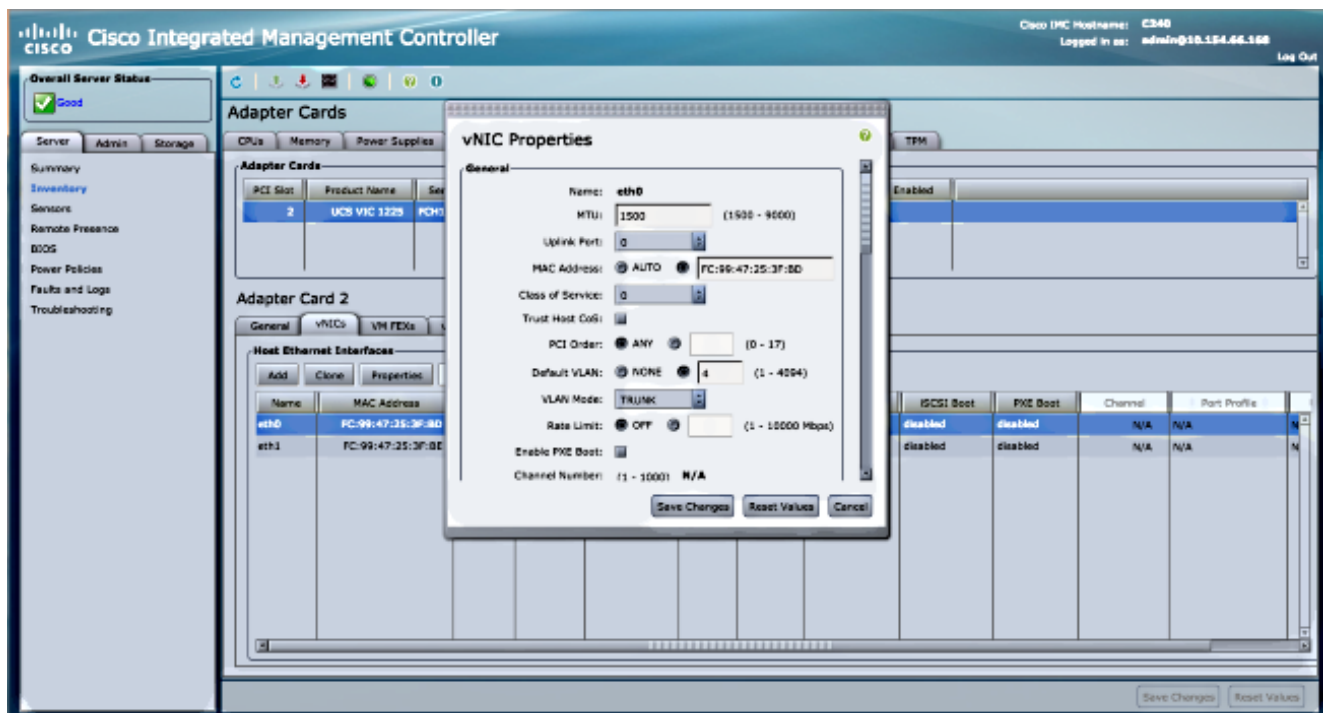
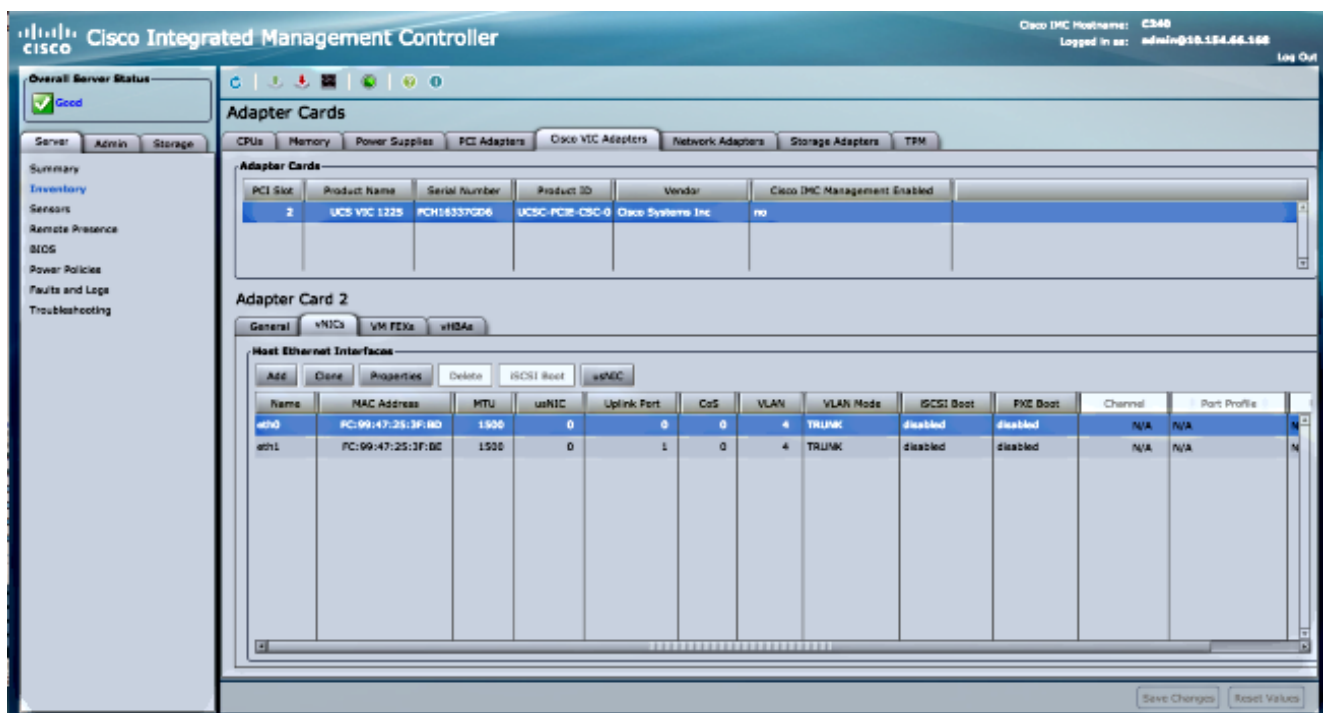
但是，VLAN ID設定為0。現在，當您檢視虛擬網路介面卡(vNIC)的配置時，會看到預設情況下將VLAN設定為**None**，並將VLAN模式設定為**access**。現在，即使在此模式下，它也會傳送帶有dot1q報頭的LACPDU。但是，Nexus 9000無法識別VLAN 0，因此此資料包被丟棄。此行為記錄在[UCS C系列機架式伺服器VIC連線選項中](#)。

為此，您必須將VLAN模式配置為**Trunk**，並將預設VLAN配置為該埠允許的VLAN。要更改此設定，請登入到伺服器的CIMC IP地址。

1. 按一下左窗格中的**Server**頁籤，然後按一下**Inventory**。
2. 按一下右窗格中的**Cisco VIC adapters**，然後按一下**vNICs**。
3. 選擇介面，然後按一下**Properties**。您應該能夠在此處進行更改：

4. 更改完成後，**Save**更改。您必須重置伺服器才能使更改生效。重置後，埠通道應能正確形成
