热备份路由器协议备用命令的重新加载延迟在ASR920上不起作用

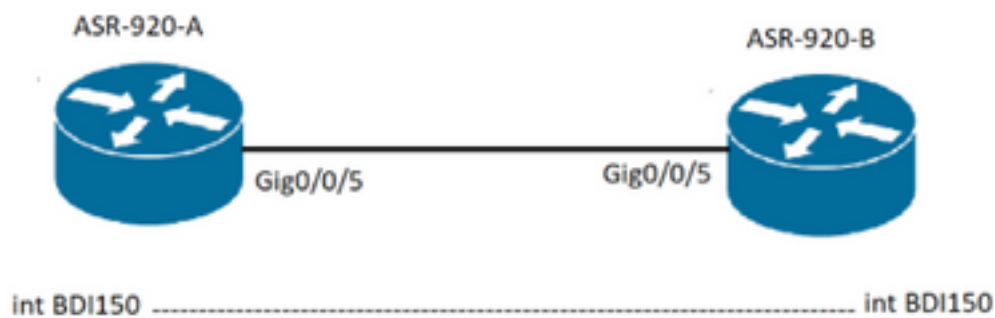
图1

在HSRP组中运行IOS-XE 16.8.1c的备用ASR920路由器会启动并立即抢占活动节点，即使已配置reload-delay命令也是如此。这会导致大型网络上的流量中断，而HSRP应提供高网络恢复能力。

此问题是使用映像1中的路由器拓扑重新造成的。

ASR-920-B是活动的，一旦重新加载，我们将收到如下日志，指示延迟计时器未按预期工作。日志中的时间戳表示路由器在没有90秒延迟的情况下转换为活动状态。

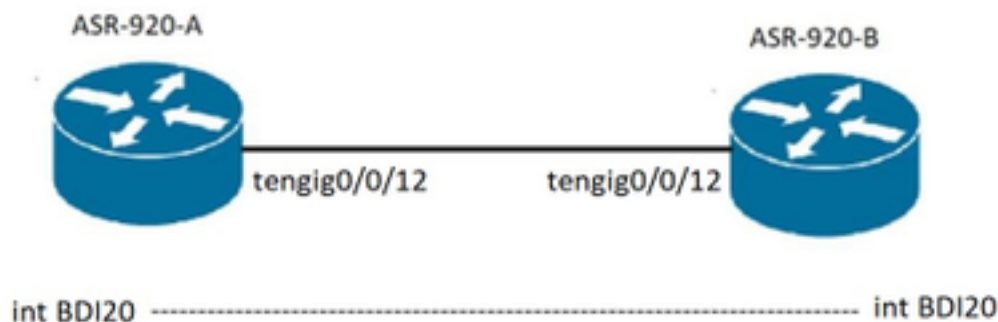
图2

此处说明了工作配置，它使用图2中的拓扑。

ASR-920-B是活动的，一旦重新加载，我们将获得如下日志，指示延迟计时器按预期工作。日志中的时间戳表示路由器已转换为备用。经过90秒的延迟后，路由器再次接管主用状态。

使用Tengig接口作为物理接口。如果HSRP通信通过Tengig链路，即网桥域MAC地址表中两个BDI的MAC地址通过Tengig接口获取，则HSRP计时器将按预期工作。
