Recover from a Nexus 9336PQ Spine Switch Failure

Document ID: 118919

This document describes how to replace a failed Cisco Nexus 9336PQ Application Centric Infrastructure (ACI) Spine switch that runs on an ACI fabric.

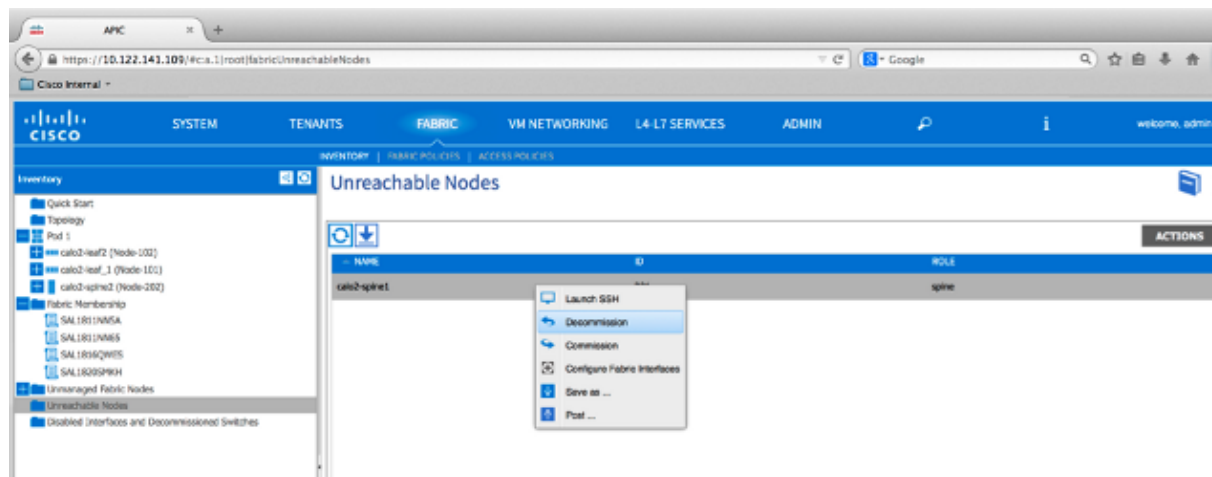
1. From the Application Policy Infrastructure Controller (APIC) GUI, navigate to **Fabric > Inventory > Unreachable Nodes**.
2. The failed spine switch should appear on this page. Record the **Node ID** and **Node Name** of the failed switch.
3. Decommission the failed spine switch and remove it from the controller:
 - A. Click the **Actions** drop down menu and select **Decommission**:

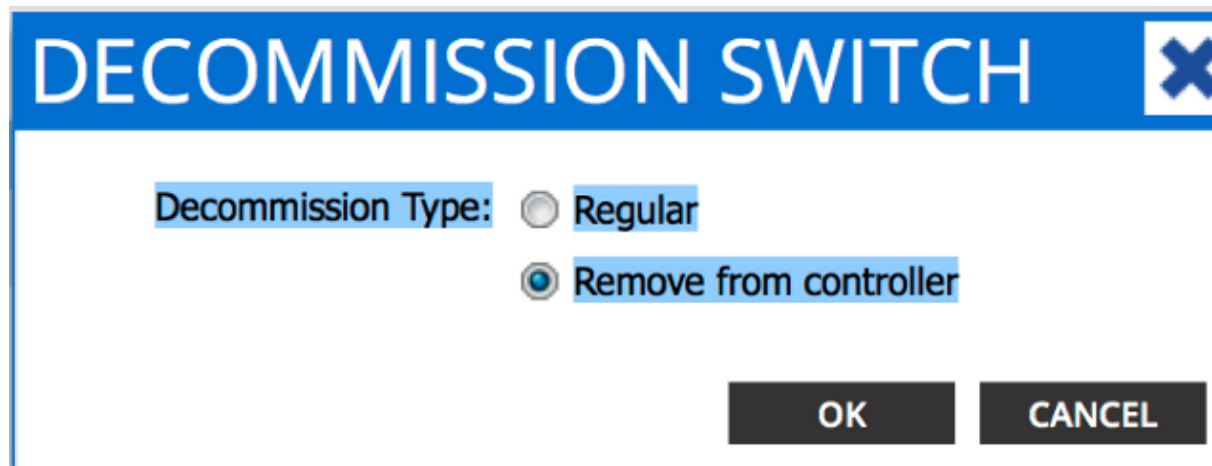
- B. Click the **Remove from controller** radio button, and then click **OK**:

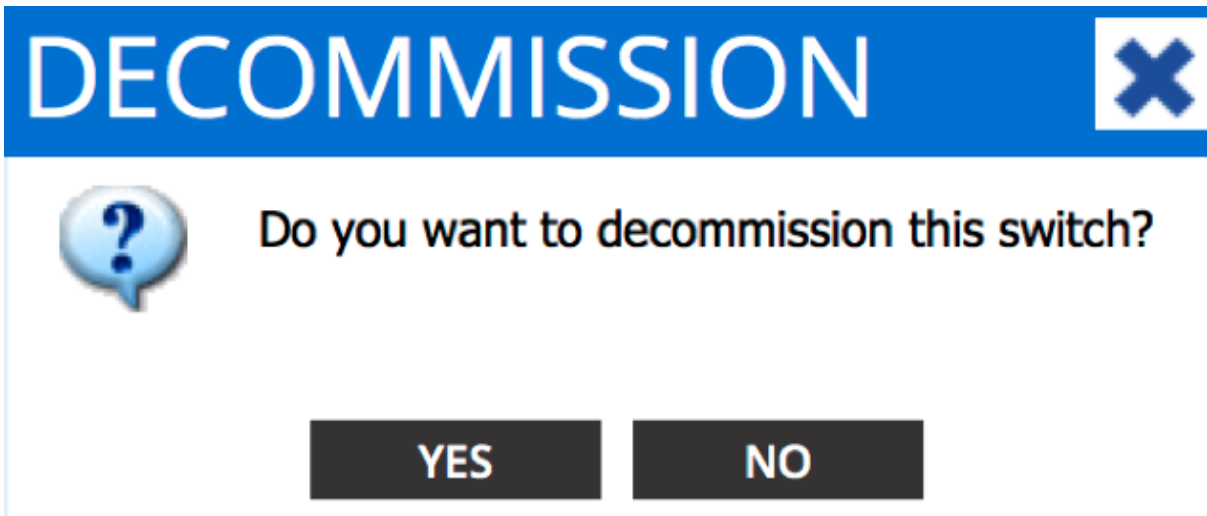
- C. When the **DECOMMISSION** pop-up window appears, click **YES**:

Note: It can take up to ten minutes before the decommissioned node is removed from the APIC GUI. Once the failed node appears in the *Unmanaged Fabric Nodes* folder, it has been properly removed.

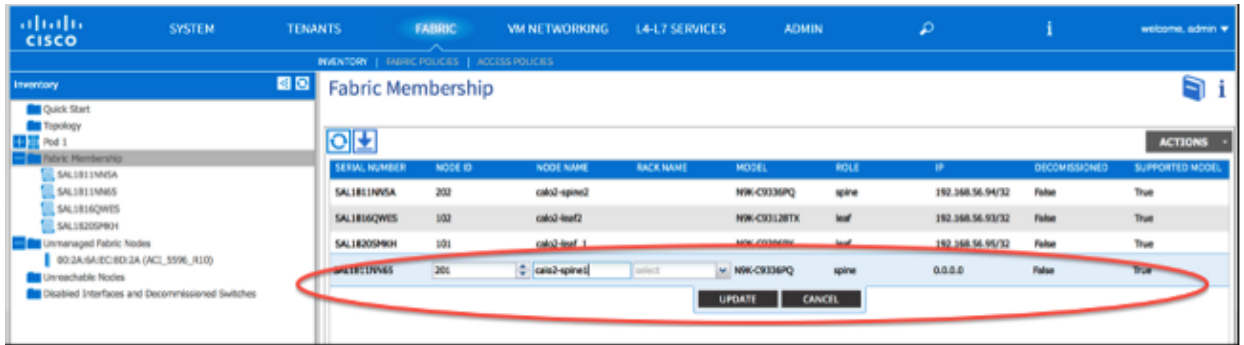
- Double-click the row and enter the same **Node ID** and **Node Name** that you recorded for the old spine switch (Step 2):

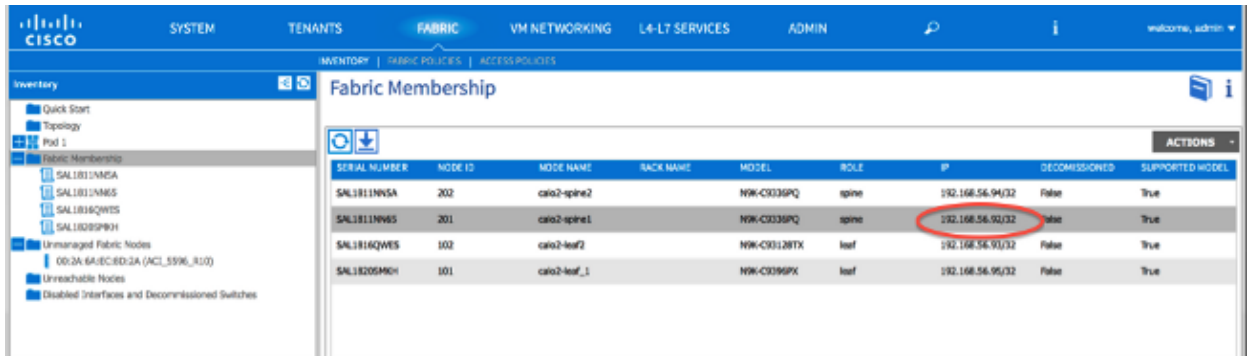
7. From the APIC GUI, verify that the spine switch receives a new IP address:

8. The new spine switch has now fully joined the ACI fabric, and the APIC automatically pushes all relevant policies to the node. In this case, a spine switch with Node ID **201** failed. It was replaced by another spine switch, which was given the same node ID. The APIC then pushes all of the policies that are relevant to Node 201 down to the new spine switch without the need for further configuration.
