Cisco RF Gateway 1 Software Release 5.02.09 Release Note

Cisco RF Gateway 1 (RFGW-1) software version 5.02.09 provides feature additions /enhancements to the Simulcrypt Broadcast version of the RFGW software (Release 5.01.XX) for Cablevision Systems Corporation (CVC).

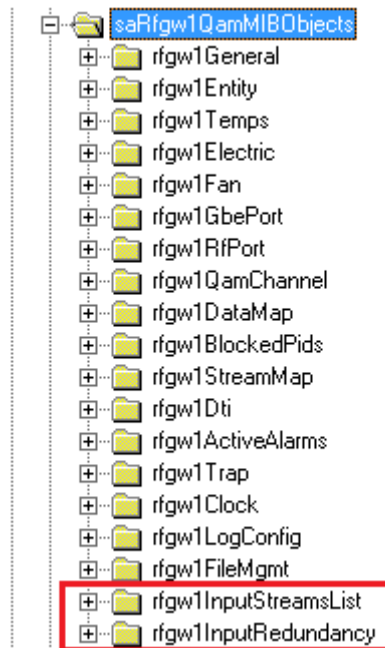
To support this, two MIB objects are added to QAM MIB.

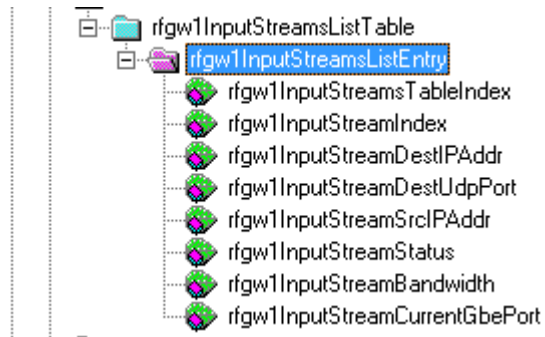
1. rfgw1InputStreamList

This MIB object contains read only leaf objects which lists the details of current input streams along with the stream object indices which are useful to trigger the refresh of sessions. All the fields in this MIB object are read-only.

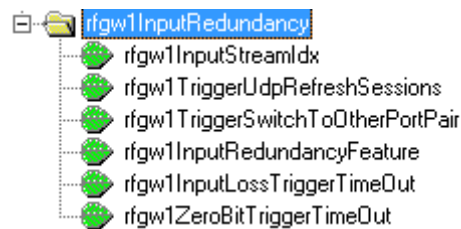
2. `rfgw1InputRedundancy`

This MIB object can be used to trigger UDP refresh or switch to next port.

The detailed explanation for each of the object can be obtained from the descriptions of the MIB file. This MIB object also provides ability to turn on and turn off input redundancy feature and also altering the timeout values.
