GainMaker Line Extender RF Split Upgrade Application Note

This application note describes the RF split upgrade procedure for 1 GHz GainMaker® Line Extenders.

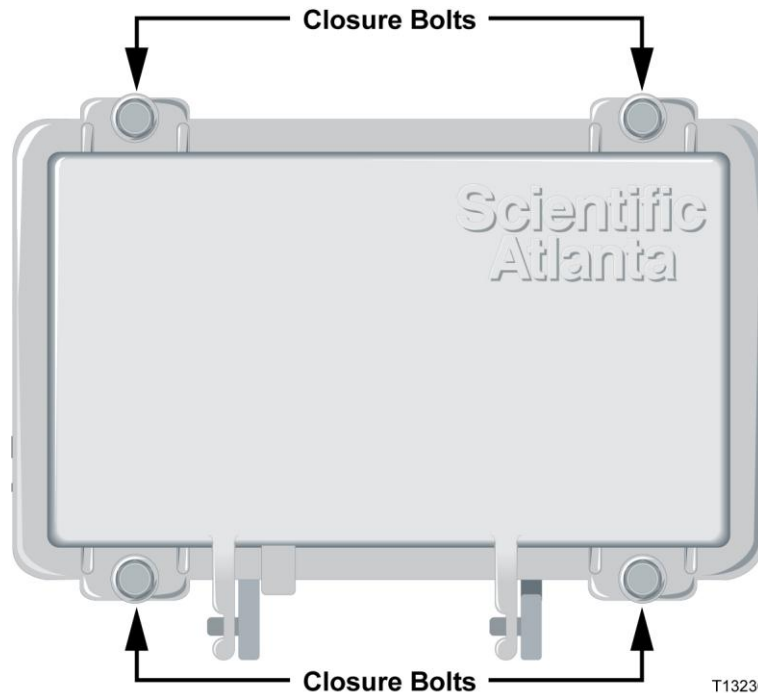
- 1 Unscrew the 1/2-inch housing closure bolts on the housing lid until they are loose.

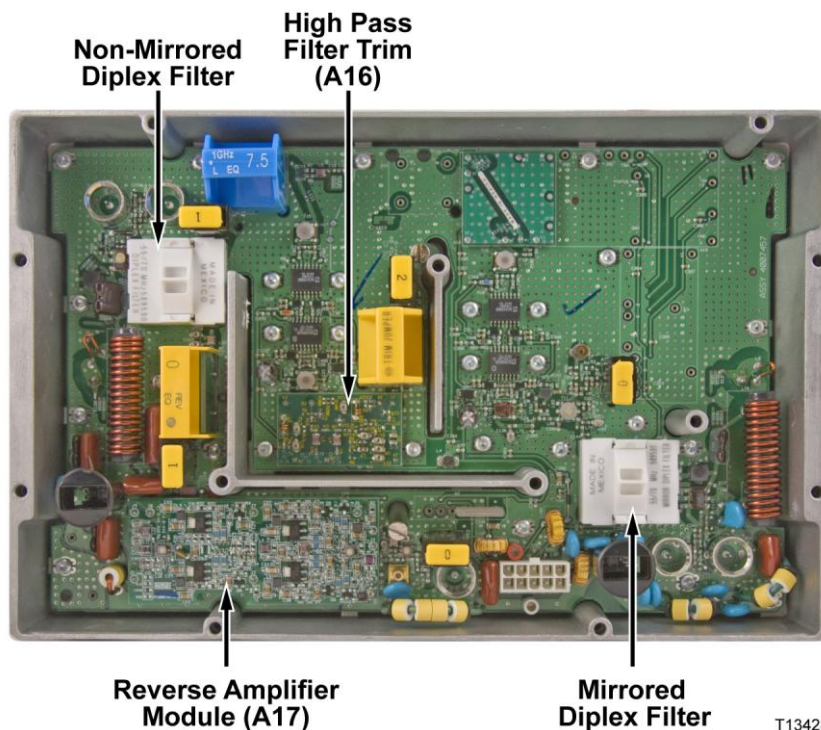
- 2 Remove the two (2) Diplex filters using the plastic handle on the component. There is one (1) “mirrored”/blue PCB material and one (1) “non-mirrored”/green PCB material Diplex filter.

- 3 Install the two (2) new Diplex filters, being careful to match the replacement “mirrored”/blue PCB material at A8 location on the PCB and “non-mirrored”/green PCB material at A9 location on the PCB.

- 4 Remove the High Pass Filter Trim at A16 location on the PCB using the appropriate extractor.
- 5 Install the new High Pass Filter Trim at A16 location on the PCB. Take caution to avoid bending any of the pins on this component during installation.

- 6 Remove the Reverse Amplifier Module at A17 location on the PCB using the appropriate extractor.
- 7 Install the new Reverse Amplifier Module at A17 location on the PCB.

- 8 Remove the current Reverse Equalizer at A7 location on the PCB.
- 9 Replace the Reverse Equalizer at A7 location on the PCB with a Reverse Equalizer that supports the reverse path design.
