# ISR-WAAS-Installationshandbuch für ISR Router der Serie 4000

Dieses Dokument beschreibt die Installationsanleitung für Cisco ISR-WAAS auf dem Cisco Integrated Services Router (ISR). Es ist die Implementierung von Virtual Wide Area Application Services (vWAAS) auf einem Cisco ISR.

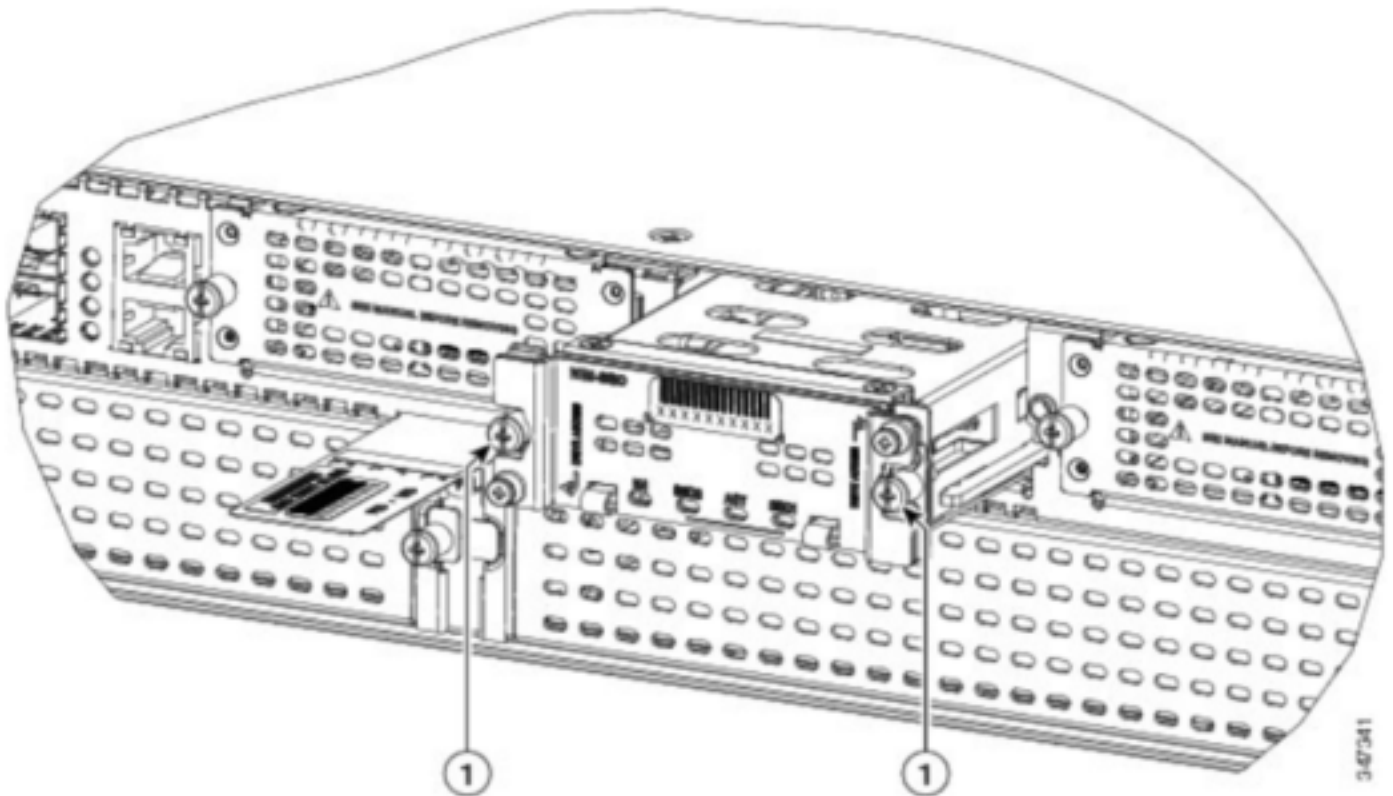
Schritt 2: Entfernen Sie die NIM-SSD oder NIM-HDD von der Route, wie in diesem Bild gezeigt:

1 Captive screws holding the NIM-SSD to the router
