White paper
Cisco public

Cisco HyperFlex Fabric Interconnect Hardware Live Migration Guide

Document summary	Prepared for	Prepared by
Fabric Interconnect (FI) hardware online upgrade with HyperFlex™ cluster	Cisco field	Ganesh Kumar, technical marketing engineer

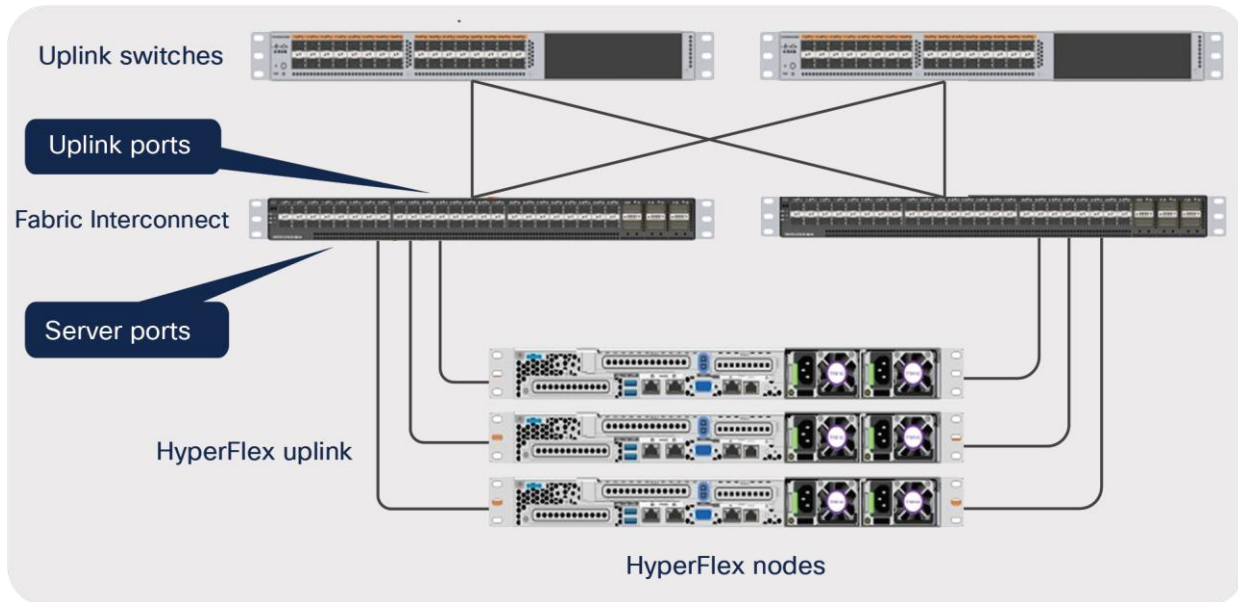
Figure 1.
Cisco HyperFlex network connectivity

Cisco HyperFlex clusters in the data center are deployed with a pair of Cisco UCS Fabric Interconnects (see Figure 1) for server uplink connectivity. The Fabric Interconnects are always Active/Active for data traffic. The Cisco UCS Fabric Interconnects are connected to a pair of network uplink switches for northbound traffic. As you can see in Figure 1 above, the HyperFlex network connectivity is recommended always to be redundant, and hence the Fabric Interconnect migration procedure is a complete online operation without any impact on data traffic.

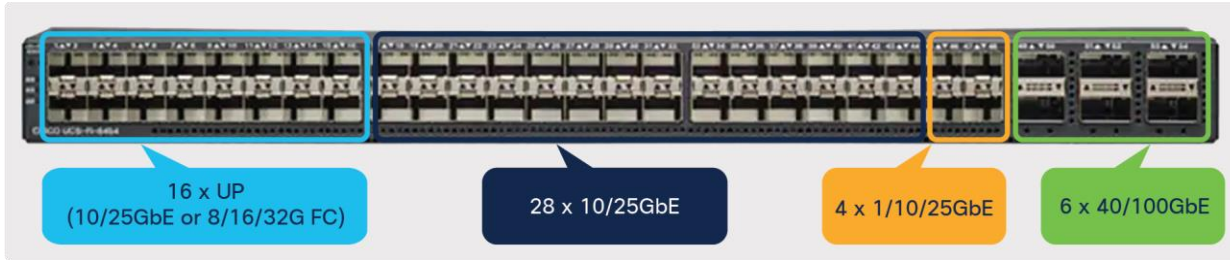
For the purposes of this document, we use the Cisco UCS Fabric Interconnect 6454 model. However, the migration procedure remains the same for the 64108 model. It has 28 10/25-Gbps Ethernet ports, 4 1/10/25-Gbps Ethernet ports, 6 40/100-Gbps Ethernet uplink ports, and 16 unified ports that can support 10/25-Gbps Ethernet ports or 8/16/32-Gbps Fibre Channel ports (see Figure 2). All Ethernet ports are capable of supporting FCoE.

Figure 2.
Cisco UCS 6454 Fabric Interconnect ports (rear view)

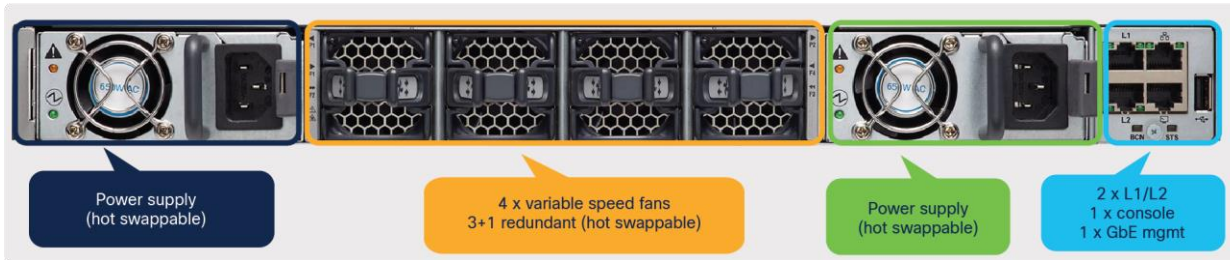
Two hot swappable power supplies and four variable-speed fans insert into the front of the chassis with front-to-back cooling. Server-facing ports are at the rear of the chassis to simplify the connections to the servers. Serial, management, and USB ports are provided at the front of the chassis for easy access at the front of the rack (Figure 3).

Figure 3.
Cisco UCS 6454 Fabric Interconnect (front view)

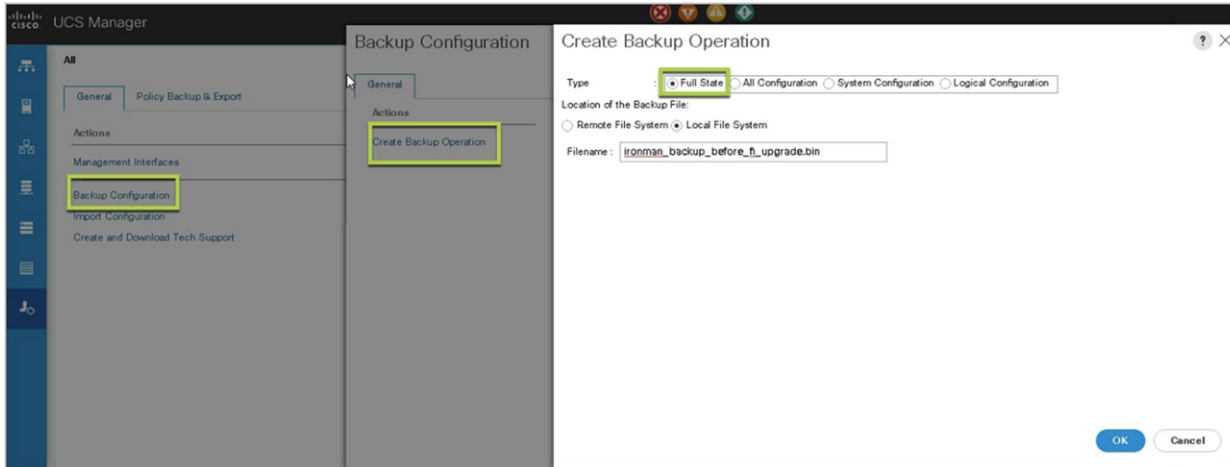
- Connect to UCS Manager and navigate to **Admin menu -> Backup Configuration** and take a “Full State” backup (Figure 4).

Figure 4.
Cisco UCS Manager configuration backup

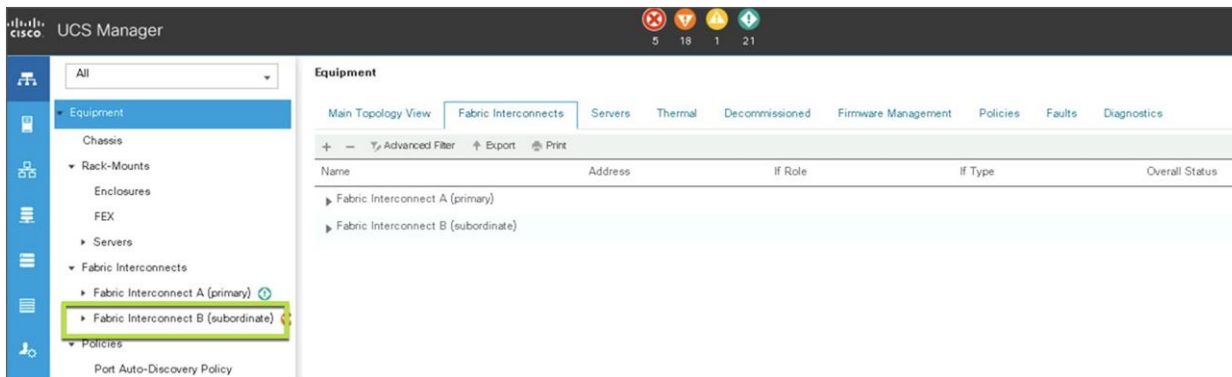
1. Log in to UCS Manager and identify the subordinate Fabric Interconnect, then disable the server ports connected to each HyperFlex node.

Figure 8.
Identifying subordinate Fabric Interconnect

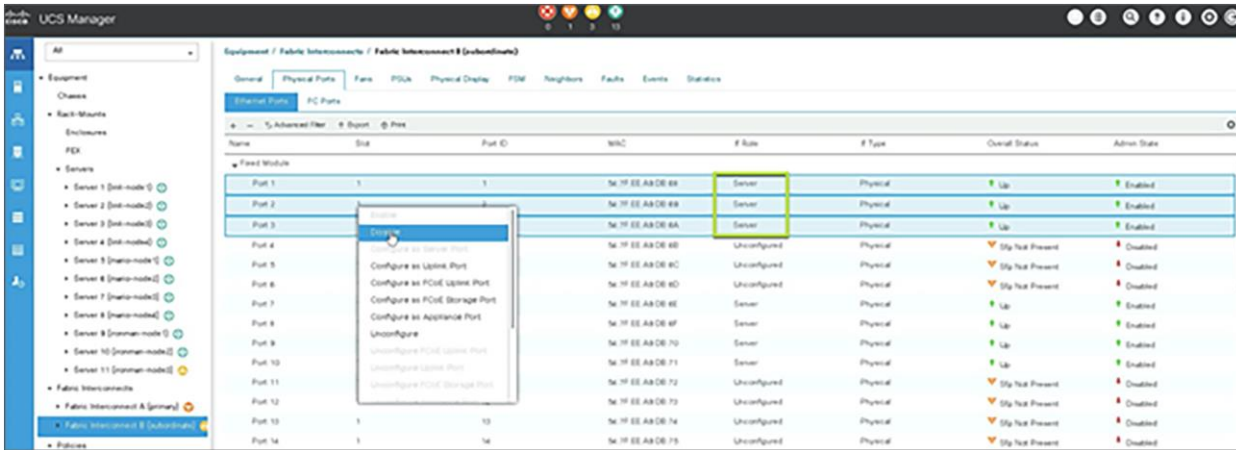
Figure 9. Disable subordinate Fabric Interconnect server ports

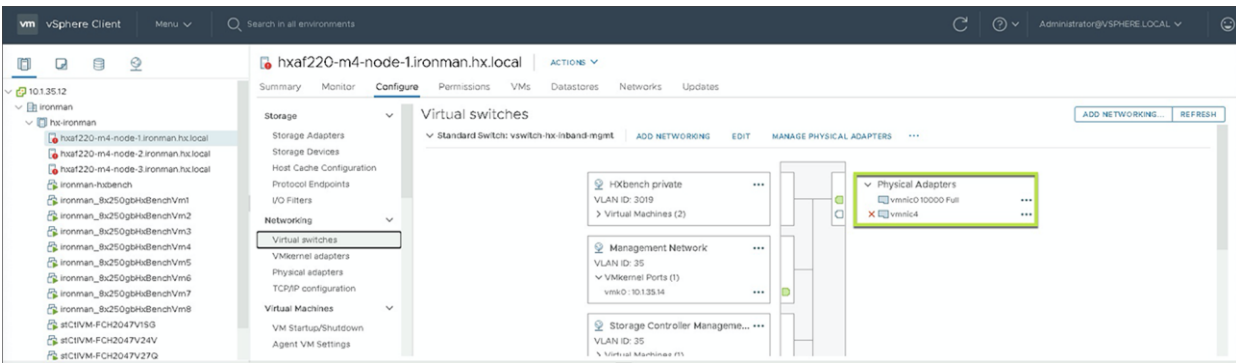
2. Confirm that the data path is failed over and that data traffic is not being disrupted from the hypervisor side.

Figure 10. Hypervisor traffic failover

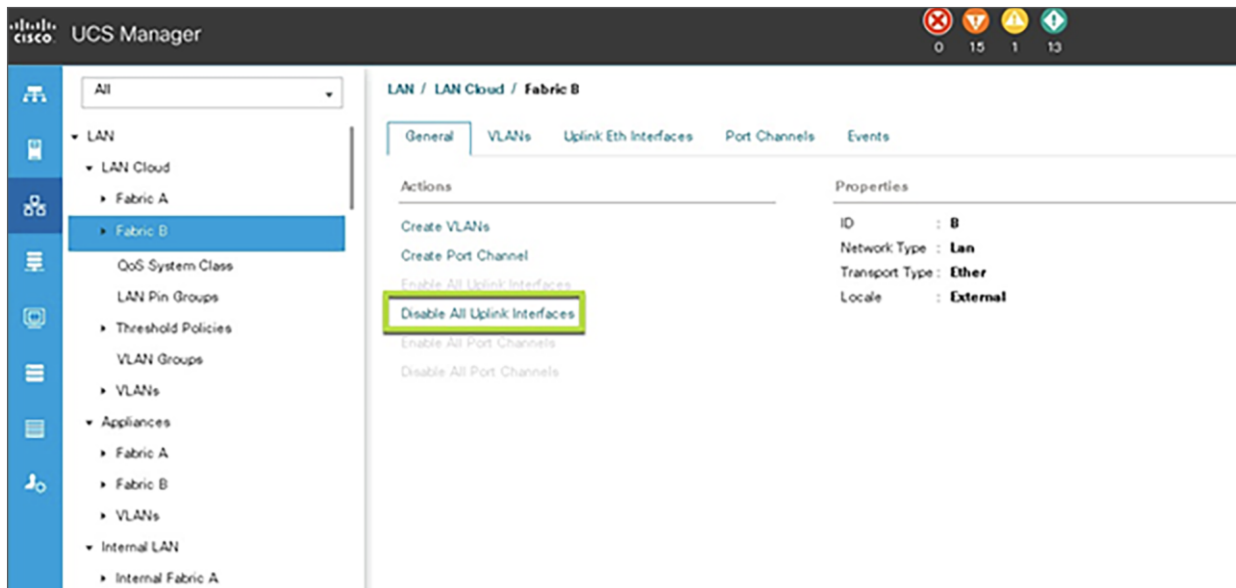
3. Disable all the uplink interfaces. Go to LAN -> Fabric A/B (subordinate fabric) -> click Disable All Uplink Interfaces.

Figure 11.
Disable subordinate Fabric Interconnect uplink ports

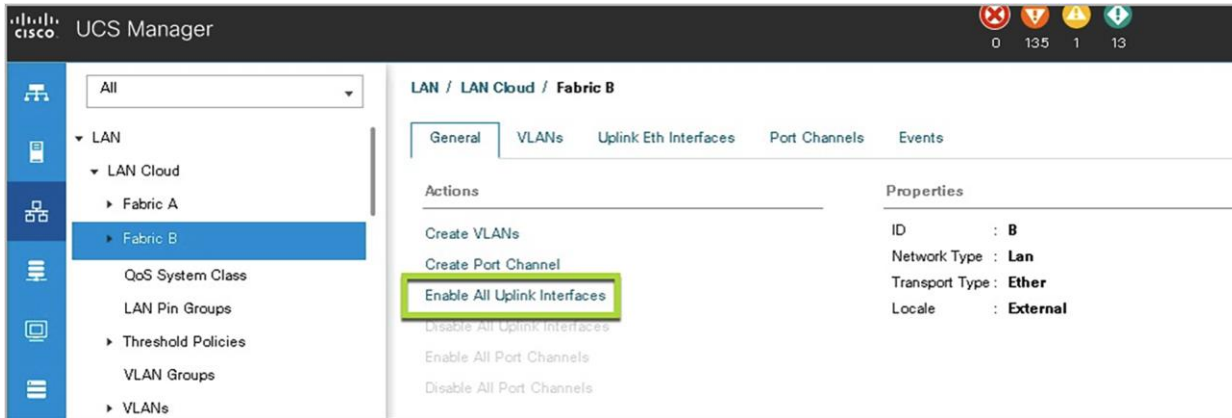
12. Enable the uplink ports from the UCS Manager UI on the subordinate Fabric Interconnect.

Figure 14.
Enable uplink interfaces

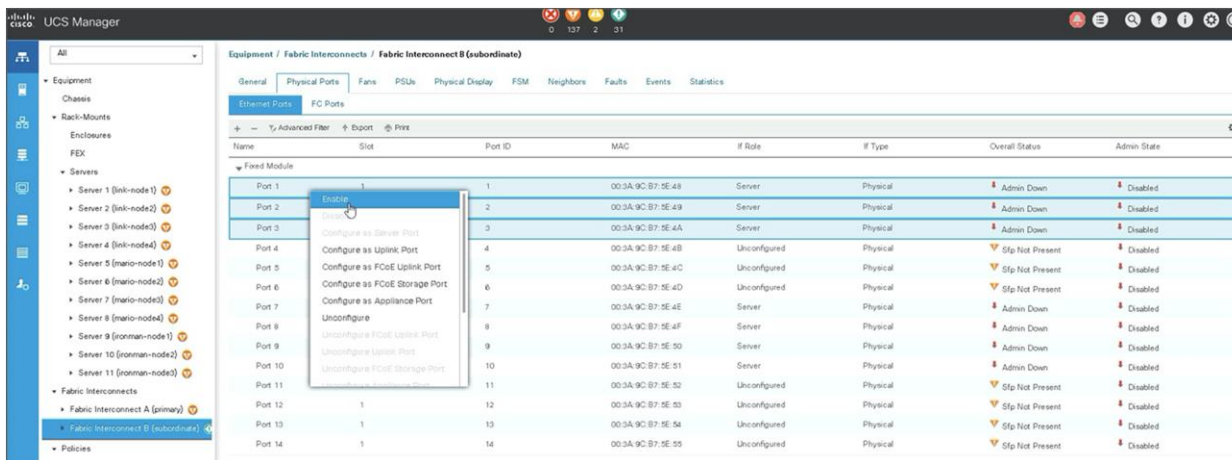
14. Enable the previously disabled server ports from the UCS Manager UI.

Figure 16.
Enable server interfaces

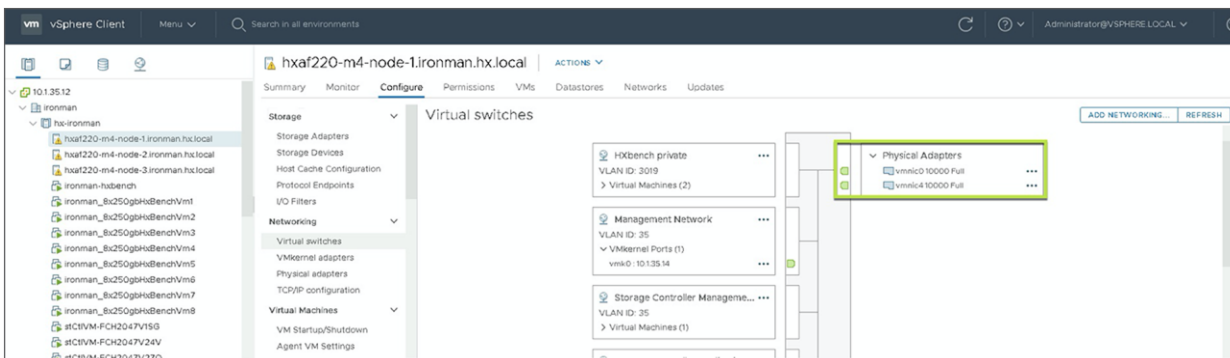
16. Verify that the data path is back up and redundant now from the hypervisor side.

Figure 18.
Data path recovered

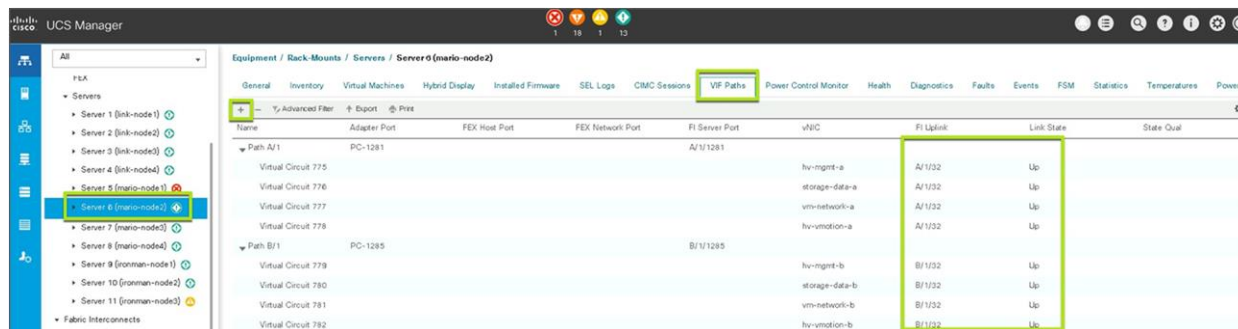
4. Log in to UCS Manager and navigate to **Equipment -> Rack-Mounts -> Servers**, and select the first HyperFlex node. In the right-hand pane, go to VIF paths and expand all the paths. Check and confirm that all the virtual NICs are up and no “unpinned” virtual NICs are present.

Figure 21.
HyperFlex node VIF paths

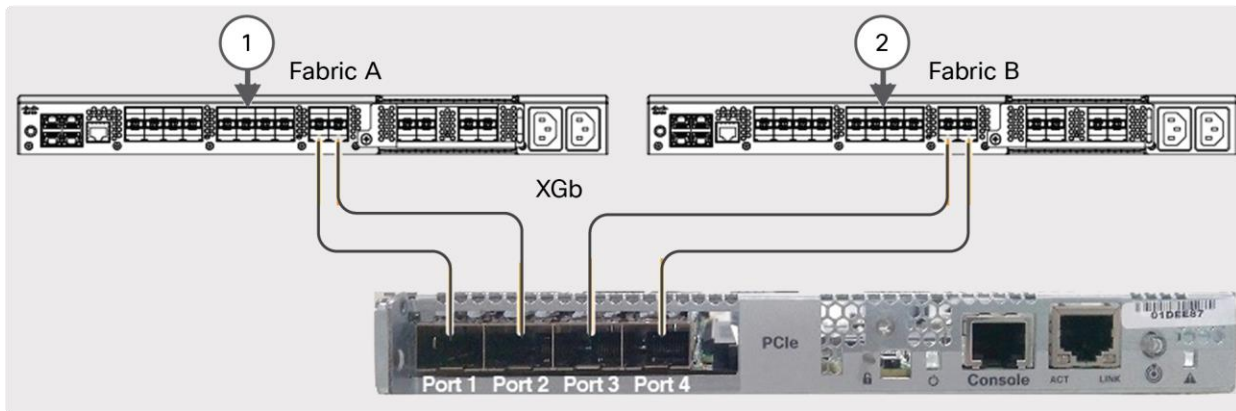
1. Check and confirm that the HyperFlex cluster state is online and healthy by running the command **hxcli cluster health**.
2. Connect the new cables as shown in Figure 24 below.

Figure 24.
Cisco VIC 1457 quad-port connections

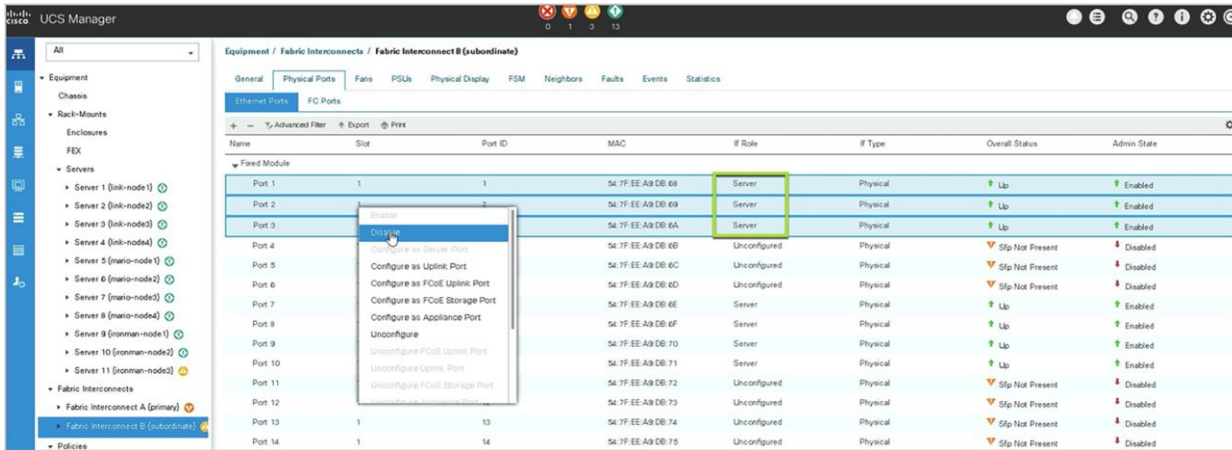
- Log in to UCS Manager and configure the newly connected ports as server ports on both Fabric Interconnects.

Figure 25.
Configure the server ports

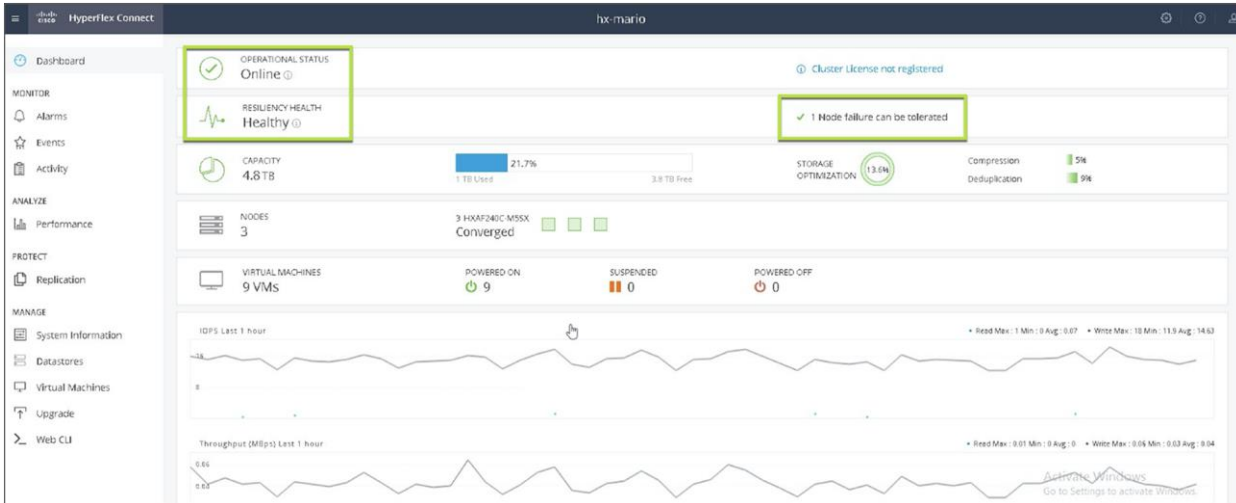
6. Reboot each HyperFlex node one by one.
 - Log in to HyperFlex Connect and confirm that the cluster is online and healthy and that one or more node failures can be tolerated.

Figure 27.
HyperFlex cluster health

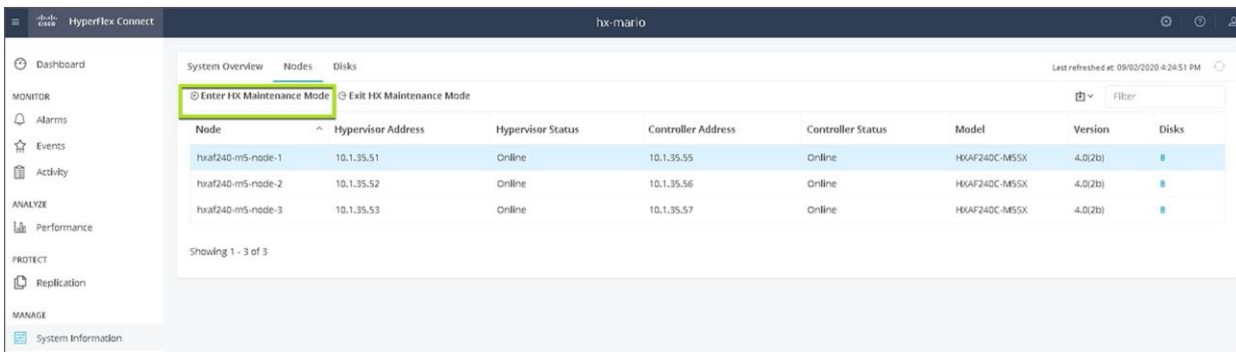
- Place a HyperFlex node in Maintenance Mode.

Figure 28.
Enter HyperFlex Maintenance Mode

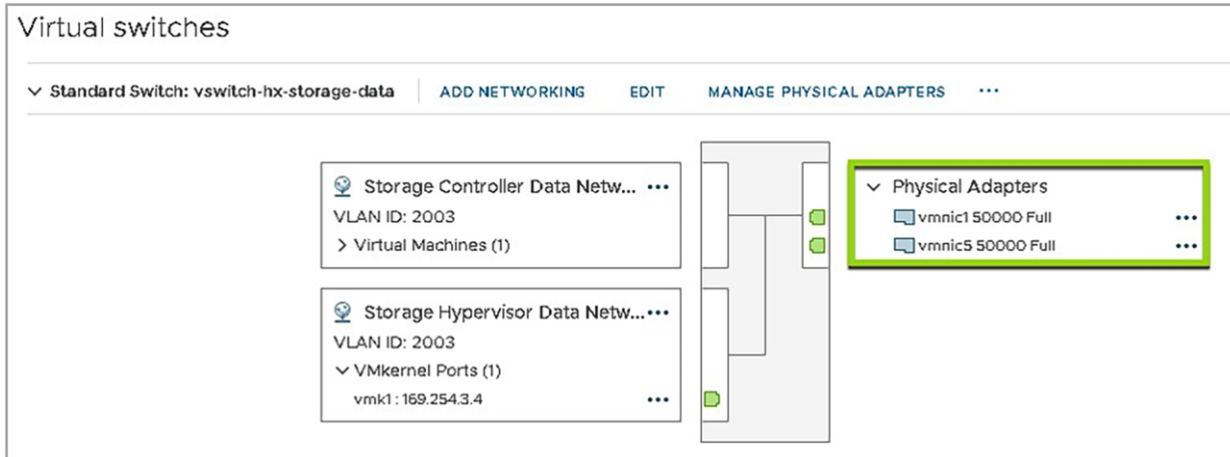
- Once the node is successfully in Maintenance Mode, reboot the node from the vCenter.
- Wait for the node to reboot, and reestablish connectivity back to vCenter.
- Check and confirm that the new updated link speed is displayed in vCenter or the ESXi shell.

Figure 29.
Updated physical NIC bandwidth

Important Note: Due to a known cosmetic defect, both ESXi CLI and vCenter do not update their status to show the new link speed. However, the updated bandwidth is available for the workloads to consume when needed. This display issue can be resolved by a reboot of the server, which can be scheduled during the next planned patch upgrade or any other maintenance window. The steps below for server reboot are optional, if you wish to update the status right away.

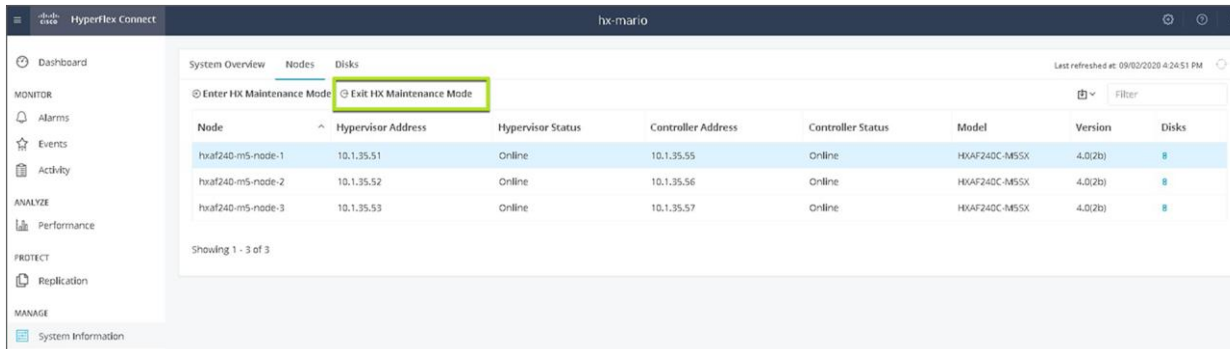
- Exit the node from Maintenance Mode from HyperFlex Connect.

Figure 30.
Exit HyperFlex Maintenance Mode
