White paper
Cisco public

Migrate to Cisco UCS 6400 Series Fabric Interconnect with 10- to 25-Gbps Ports

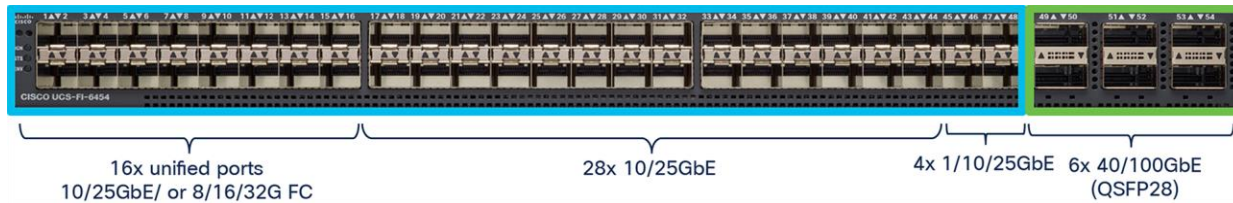
Figure 1.

The fourth-generation Cisco UCS 6454 Fabric Interconnect is a one-rack-unit device with high-density, nonblocking, low-power 10- and 25-Gbps ports. The switch has twenty-eight 10/25-Gbps Ethernet ports, four 1/10/25-Gbps Ethernet ports, six 40/100-Gbps Ethernet uplink ports, and sixteen unified ports that can support 10/25-Gbps Ethernet or 8/16/32-Gbps Fibre Channel ports. All Ethernet ports are capable of supporting FCoE. (See Figure 1.)

Cisco UCS 6454 Fabric Interconnect (rear view)

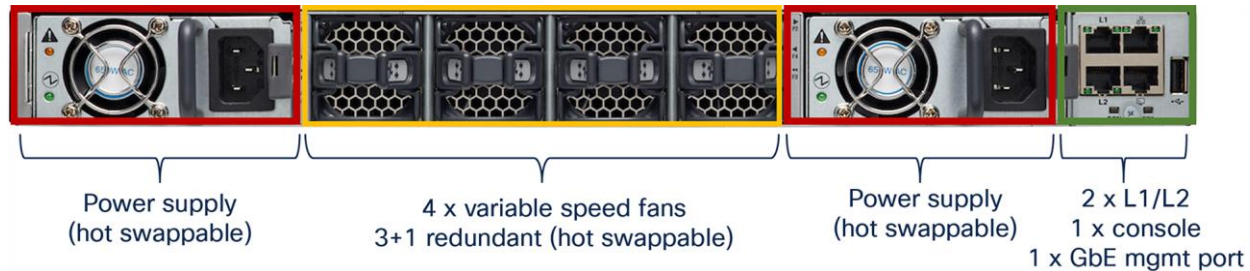
Figure 2.

Cisco UCS 6454 Fabric Interconnect have two power supplies (hot swappable, 1+1) and four variable-speed fans (hot swappable, 3+1) that insert into the front of the chassis with fan-side intake and port-side exhaust. Server-facing ports are at the rear of the chassis to simplify connections to servers and fabric extenders. Serial, management, and USB ports are provided at the front of the chassis for easy access at the front of the rack. (See Figure 2.)

Cisco UCS 6454 Fabric Interconnect (front view)

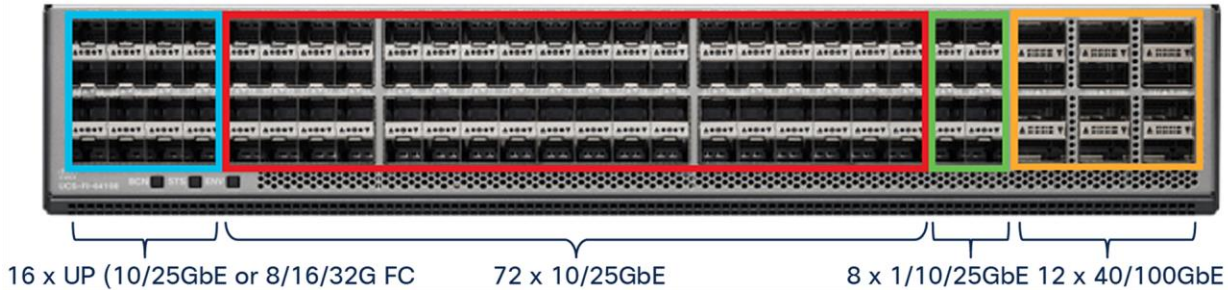
The Cisco UCS 64108 Fabric Interconnect is a two-rack-unit device with seventy-two 10/25-Gbps Ethernet ports, eight 1/10/25-Gbps Ethernet ports, twelve 40/100-Gbps Ethernet uplink ports, and sixteen unified ports that can support 10/25-Gbps Ethernet or 8/16/32-Gbps Fibre Channel ports. All Ethernet ports are capable of supporting FCoE. (See Figure 3.)

Figure 3.
Cisco UCS 64108 Fabric Interconnect (rear view)

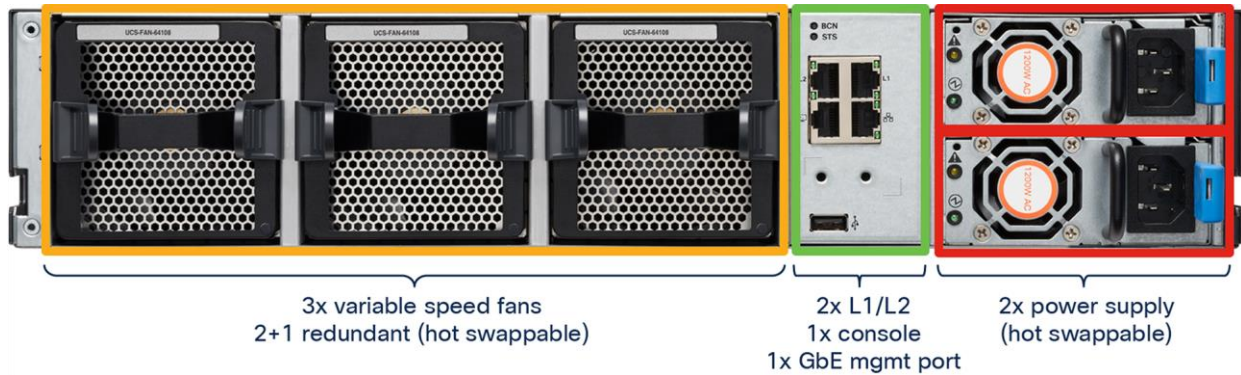
Cisco UCS 64108 Fabric Interconnect has two power supplies (hot swappable, 1+1) and three variable-speed fans (hot swappable, 2+1) that insert into the front of the chassis with front-to-back cooling. Server-facing ports are at the rear of the chassis to simplify connections to servers and fabric extenders. Serial, management, and USB ports are provided at the front of the chassis for easy access at the front of the rack. (See Figure 4.)

Figure 4.
Cisco UCS 64108 Fabric Interconnect (front view)

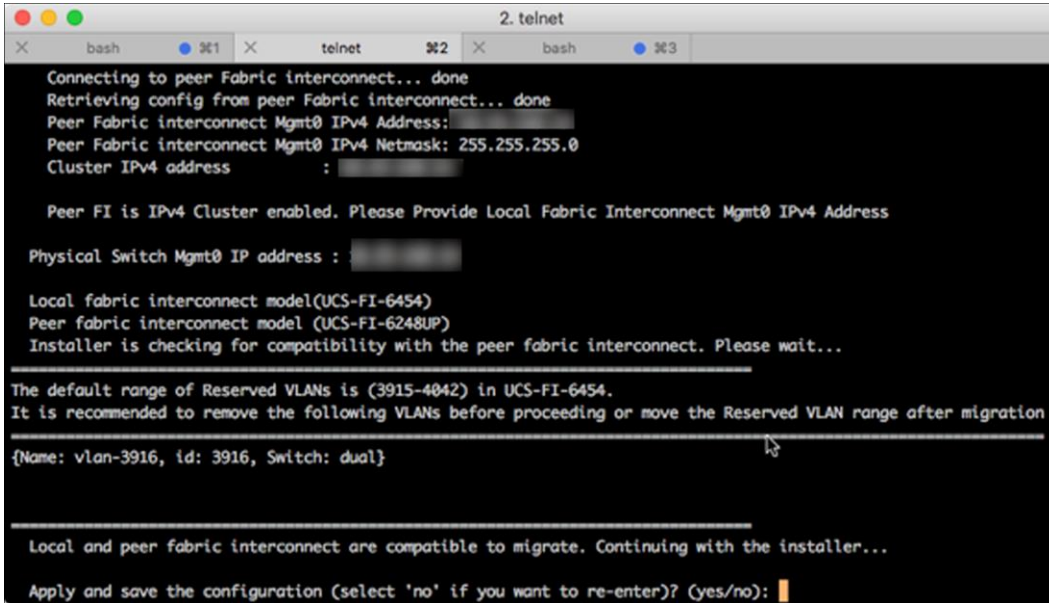
Figure 5 shows an example from the Cisco UCS Manager installer in which active VLANs overlapped with the default VLANs reserved for the Cisco UCS 6400 series.

Figure 5. Example showing active VLANs overlapping with the default VLANs reserved for the Cisco UCS 6400 Series Fabric Interconnects

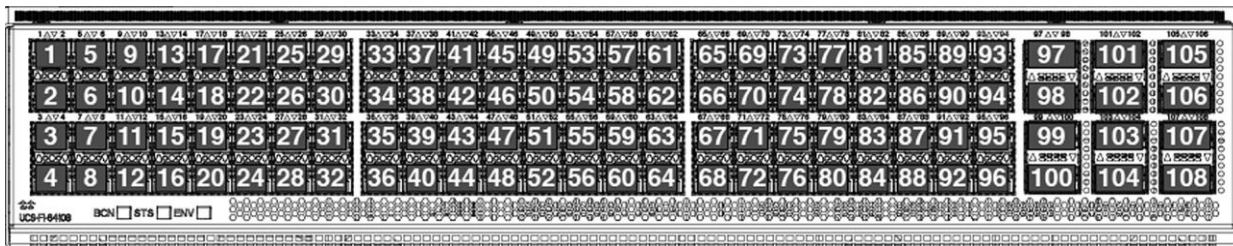
Figure 8. Ports on the Cisco UCS 64108 Fabric Interconnect

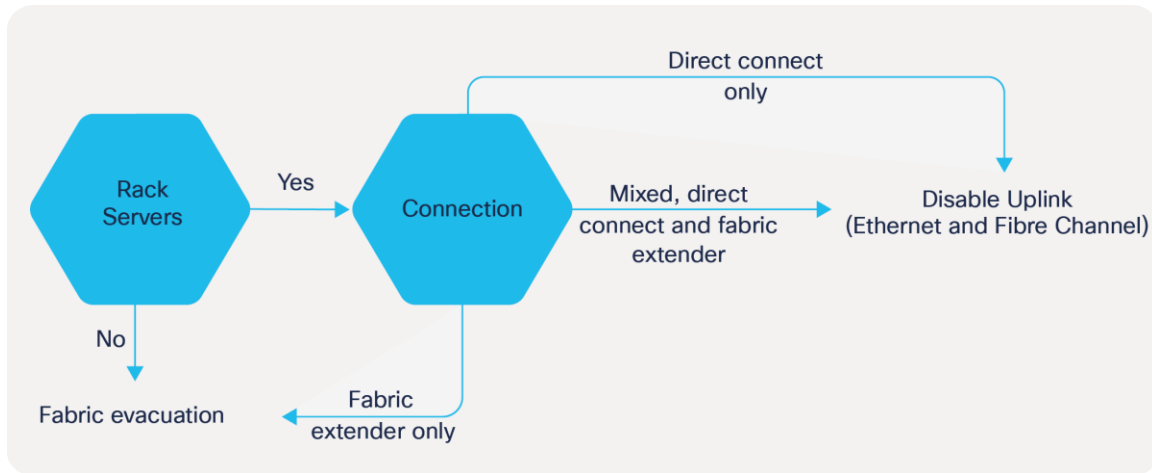
Step 1: Move the traffic to the primary fabric interconnect. This change can be accomplished in several ways. This document describes two of these approaches: fabric evacuation and uplink disablement. Use the flowchart in Figure 6 to choose between the two based on your Cisco UCS domain server and connectivity.

Figure 9.
Flowchart for choosing the best method for moving traffic

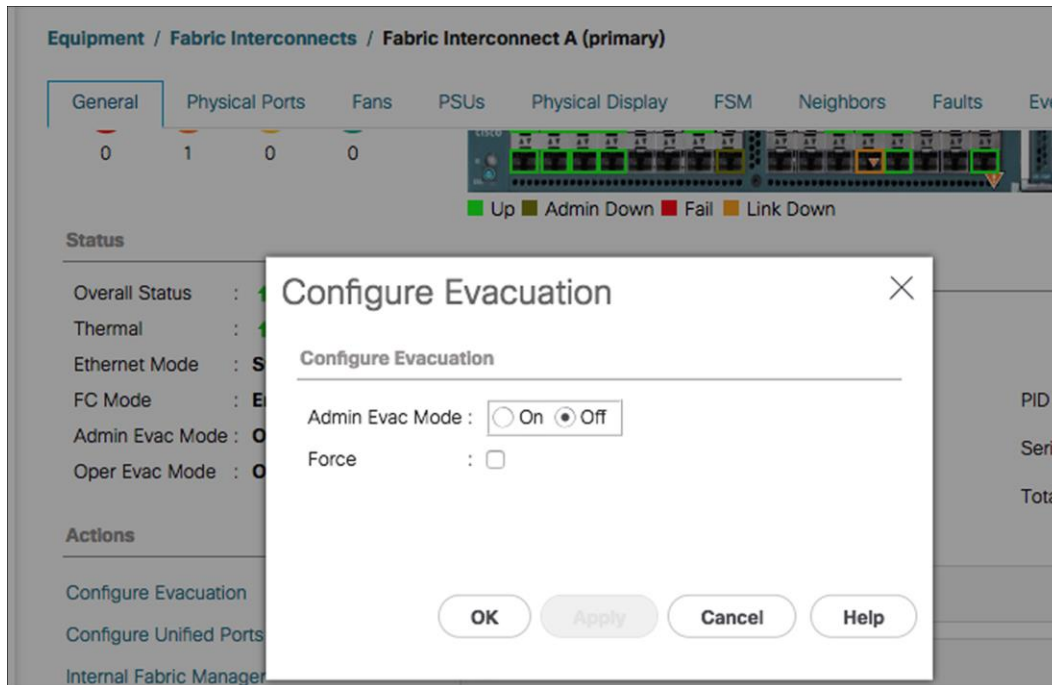
Figure 10 shows the fabric evacuation method.

Figure 10.
Fabric evacuation

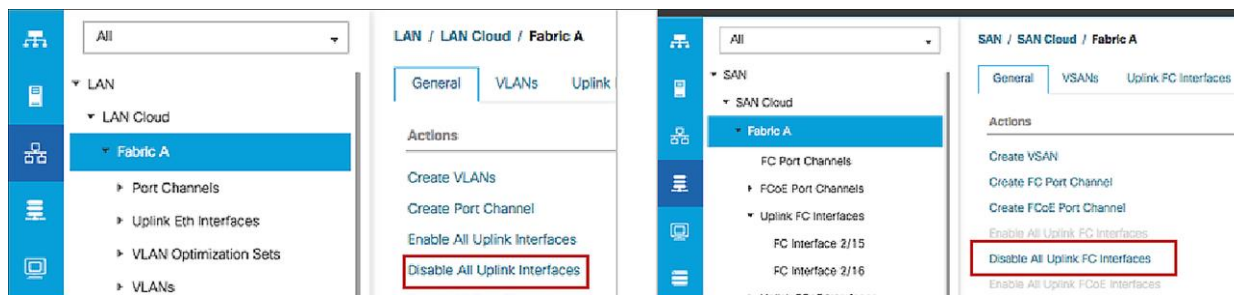
Figure 11 shows the uplink disablement method.

Figure 11.
Uplink disablement

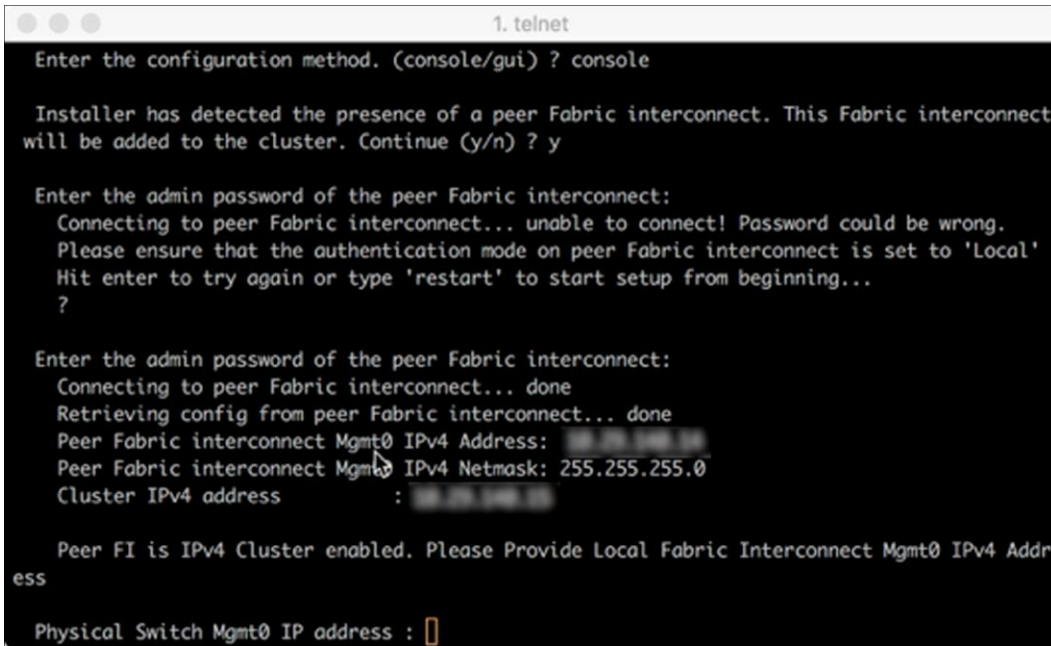
Step 7: Enter the IP address information for the new subordinate fabric interconnect (Figure 12).

Figure 13.
Entering the IP address information

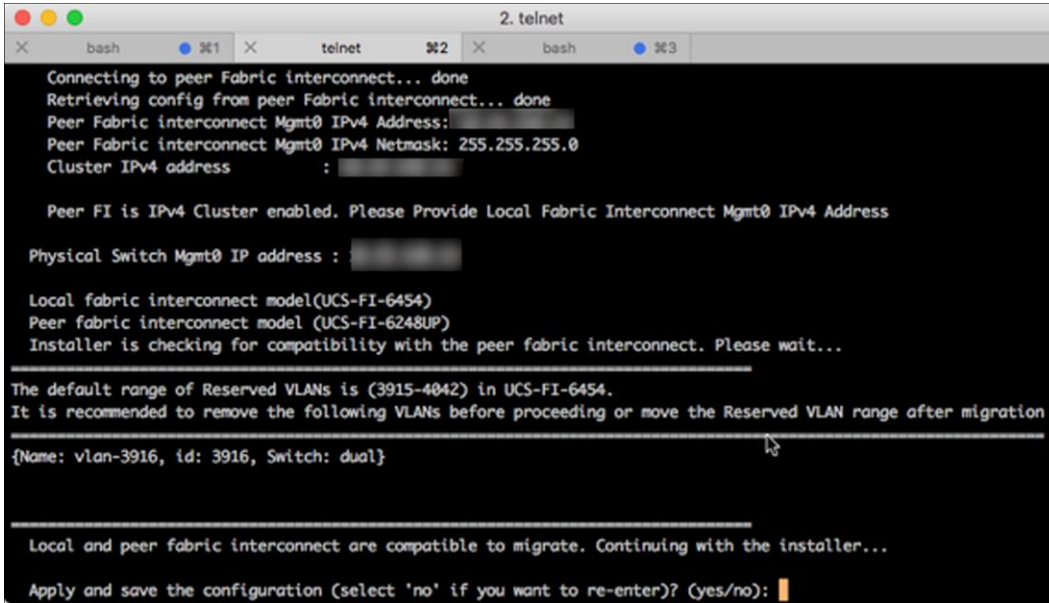
If the active VLANs overlapped with the default reserved VLANs for the Cisco UCS 6400 Series Fabric Interconnect, the warning message shown in Figure 15 will be displayed.

Figure 15. Warning message for overlapping VLANs

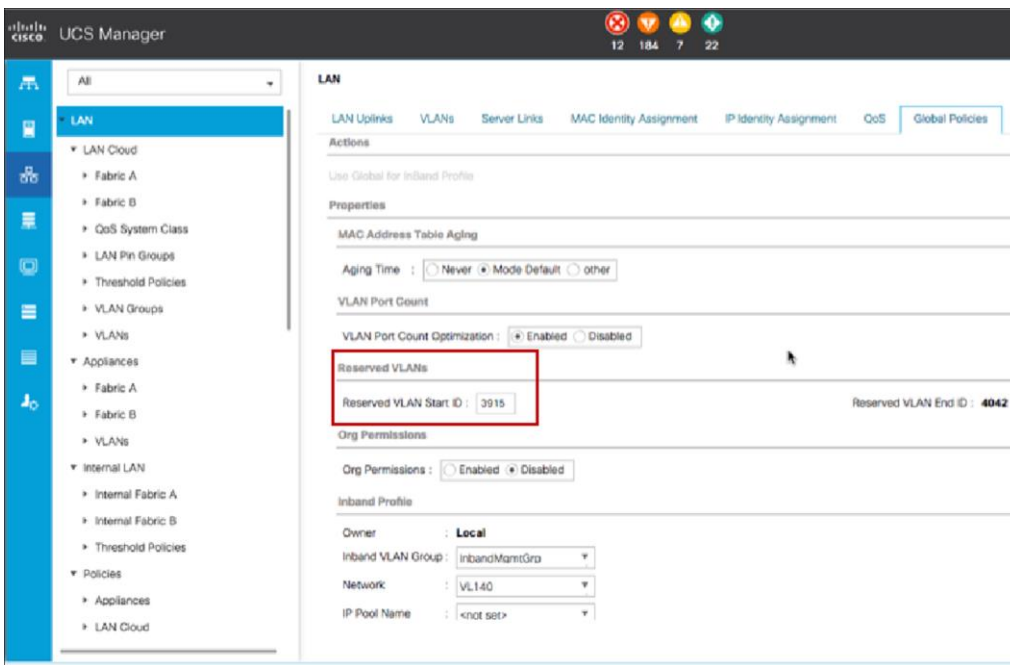
If VLANs overlap, change the reserved VLANs after the new subordinate fabric interconnect joins the cluster. The change can be implemented through the GUI or the Command-Line Interface (CLI), as shown in Figures 16 and 17.

Figure 16. Changing the reserved VLANs in the GUI

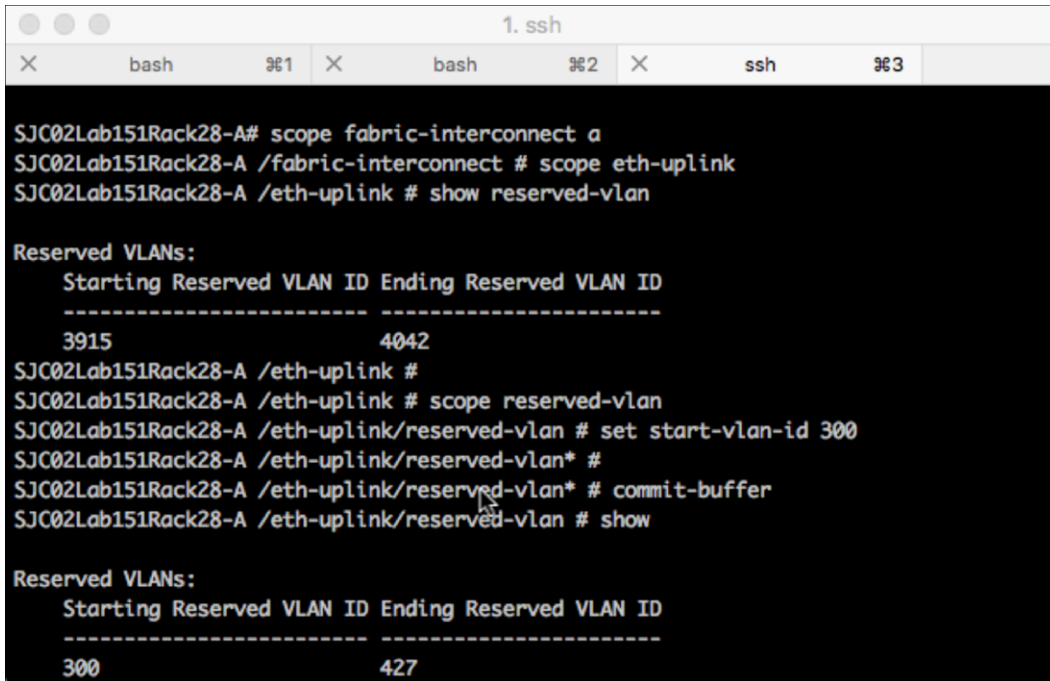
A terminal window titled "1. ssh" with three tabs labeled "bash", "bash", and "ssh". The terminal output shows the following commands and results:

```
SJC02Lab151Rack28-A# scope fabric-interconnect a
SJC02Lab151Rack28-A /fabric-interconnect # scope eth-uplink
SJC02Lab151Rack28-A /eth-uplink # show reserved-vlan

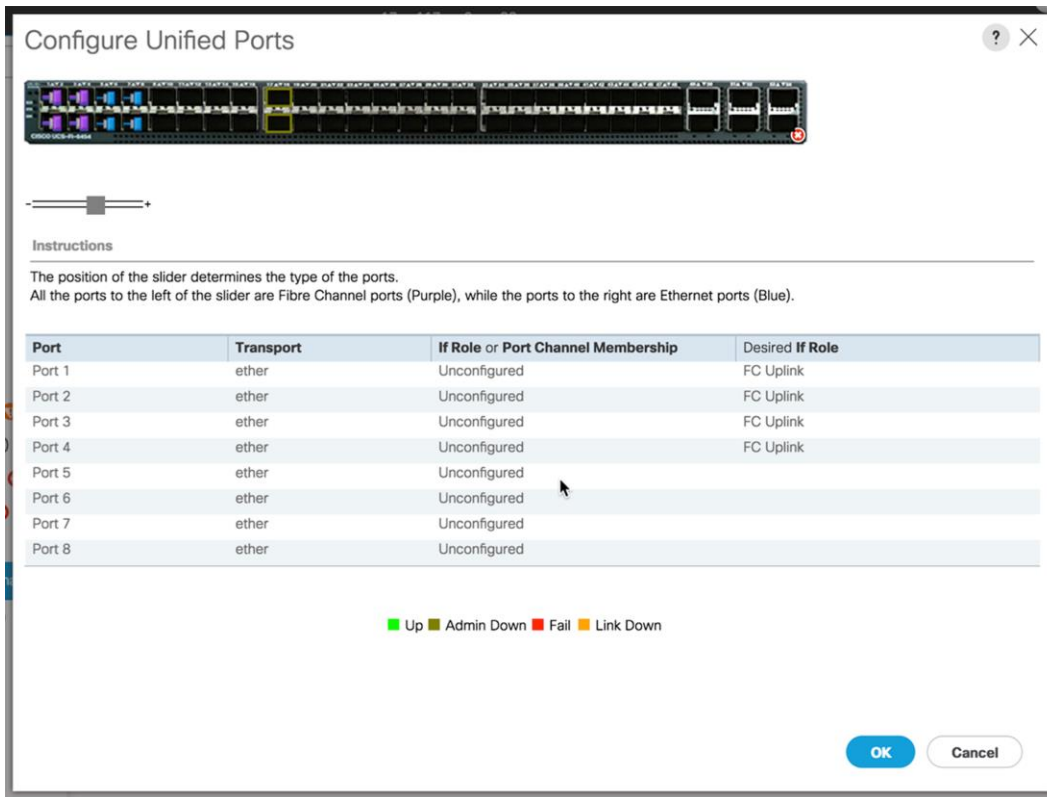
Step 9: Convert Ethernet ports to Fibre Channel ports and reboot (Figure 18). The default speed will be 16 Gbps. If 8-Gbps Fibre Channel optics are used, then the port will be error-disabled. Manually set the speed to 8 Gbps and disable and reenab the port. If the system is connected to a Cisco MDS 9000 Family switch, then you need to configure the “fill-pattern IDLE speed 8000” setting.

Note: When you convert from Ethernet ports to Fibre Channel ports, a reboot is required. Fibre Channel ports are converted in blocks of four.

Figure 18.
Converting the ports

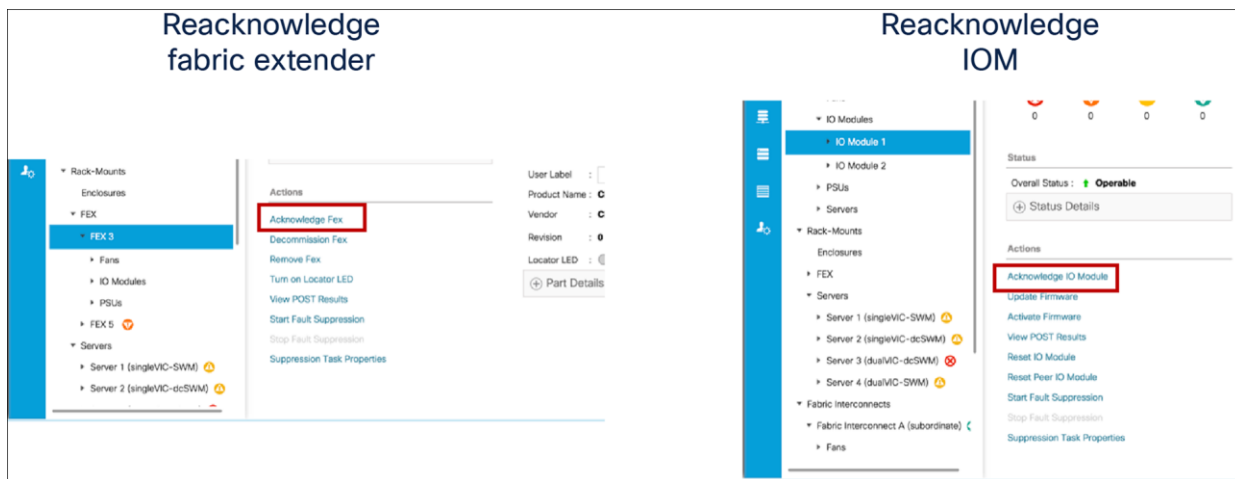
In most cases, an IOM or a fabric extender would not require reacknowledgement, but if they do not become operational, reacknowledgement may be required. You can perform this step on a per-device basis, so reacknowledge just the IOMs and fabric extenders that were migrated to the 6400 series fabric interconnect (Figure 19). Reacknowledgement of IOM/FEX does not result in server reboot.

Figure 19.
Re-acknowledging fabric extender and IOM

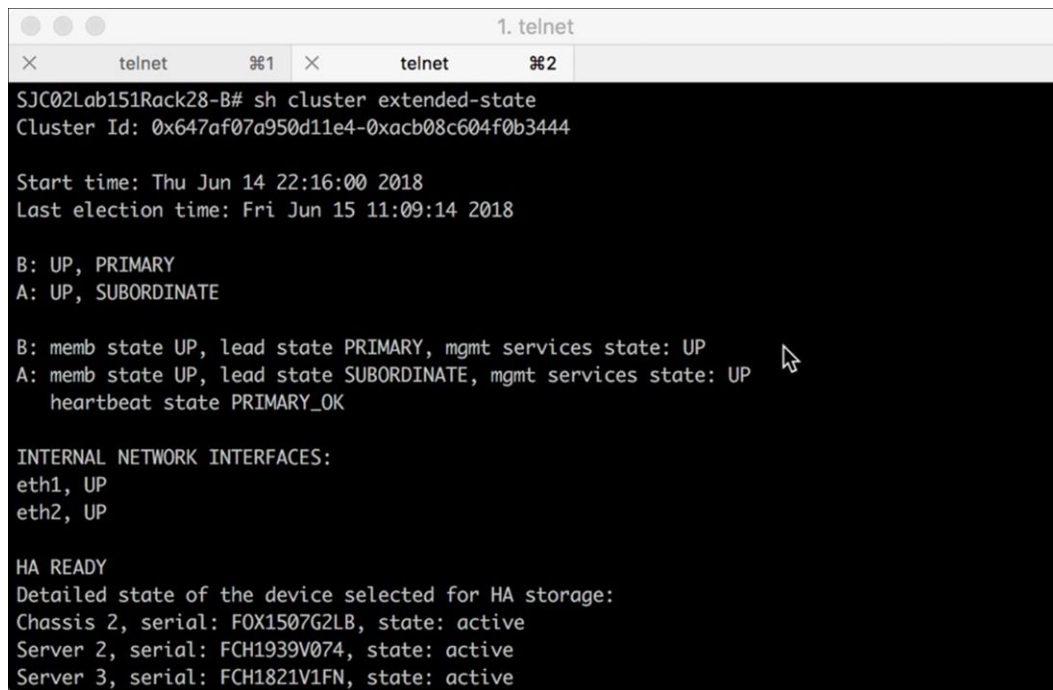
Verify that the primary fabric interconnect is now the 6400 series (Figure 20).

A screenshot of a telnet session window titled "1. telnet". The window contains two tabs, both labeled "telnet" with a keyboard shortcut symbol. The main content area shows the output of the command "sh cluster extended-state" on a device named "SJC02Lab151Rack28-B". The output includes the cluster ID, start and last election times, member states (B: UP, PRIMARY; A: UP, SUBORDINATE), detailed member states (B: memb state UP, lead state PRIMARY, mgmt services state: UP; A: memb state UP, lead state SUBORDINATE, mgmt services state: UP, heartbeat state PRIMARY_OK), internal network interfaces (eth1, UP; eth2, UP), HA status (HA READY), and detailed state of the device selected for HA storage (Chassis 2, serial: FOX1507G2LB, state: active; Server 2, serial: FCH1939V074, state: active; Server 3, serial: FCH1821V1FN, state: active).

```
SJC02Lab151Rack28-B# sh cluster extended-state
Cluster Id: 0x647af07a950d11e4-0xacb08c604f0b3444

Figure 20.
Verifying that the Cisco UCS 6400 series is the primary fabric interconnect

Verify that the FI cluster state is “HA ready” using the CLI command “show cluster extended-state,” as shown in Figure 20. Additionally from UCSM, check that there are no new active faults after the uplinks are UP. You can also check that no vNICs are DOWN that were previously UP, from UCSM Equipment >> Server >> VIF Paths. Also follow the traffic verification steps outlined in the UCSM firmware management guide.¹ Reacknowledgement of the corresponding IOM, FEX, or direct-connect rack servers would be required if these checks fail.
