RateMux - No Video Output and the Significance of NIT PID PassThru and CASysID

Document ID: 12549

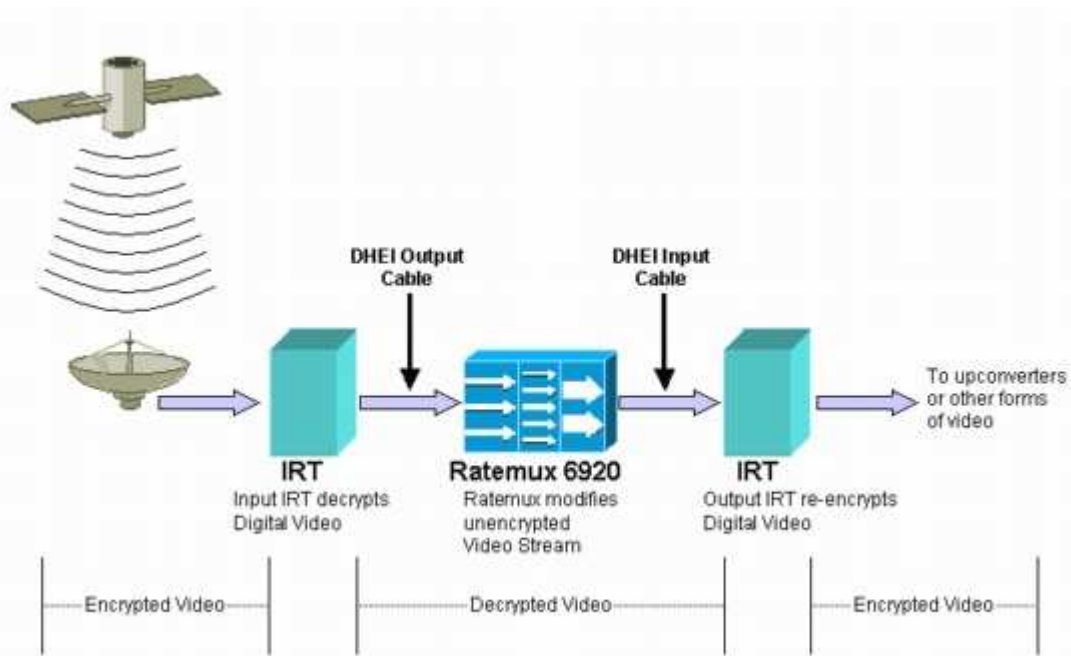
The RateMux 6920 multiplexer is unable to perform any remultiplexing or compression on encrypted video streams, so an incoming MPEG video stream from a satellite feed (such as Headends In The Sky (HITS)) must be unencrypted before being fed to the RateMux 6920 multiplexer. This can be done by a Motorola IRT device connected to the input of the RateMux multiplexer. If DigiCable Headend Expansion Interface (DHEI) interfaces are used, then a DHEI output cable must be connected between the output of the Motorola IRT and the input of the RateMux multiplexer.

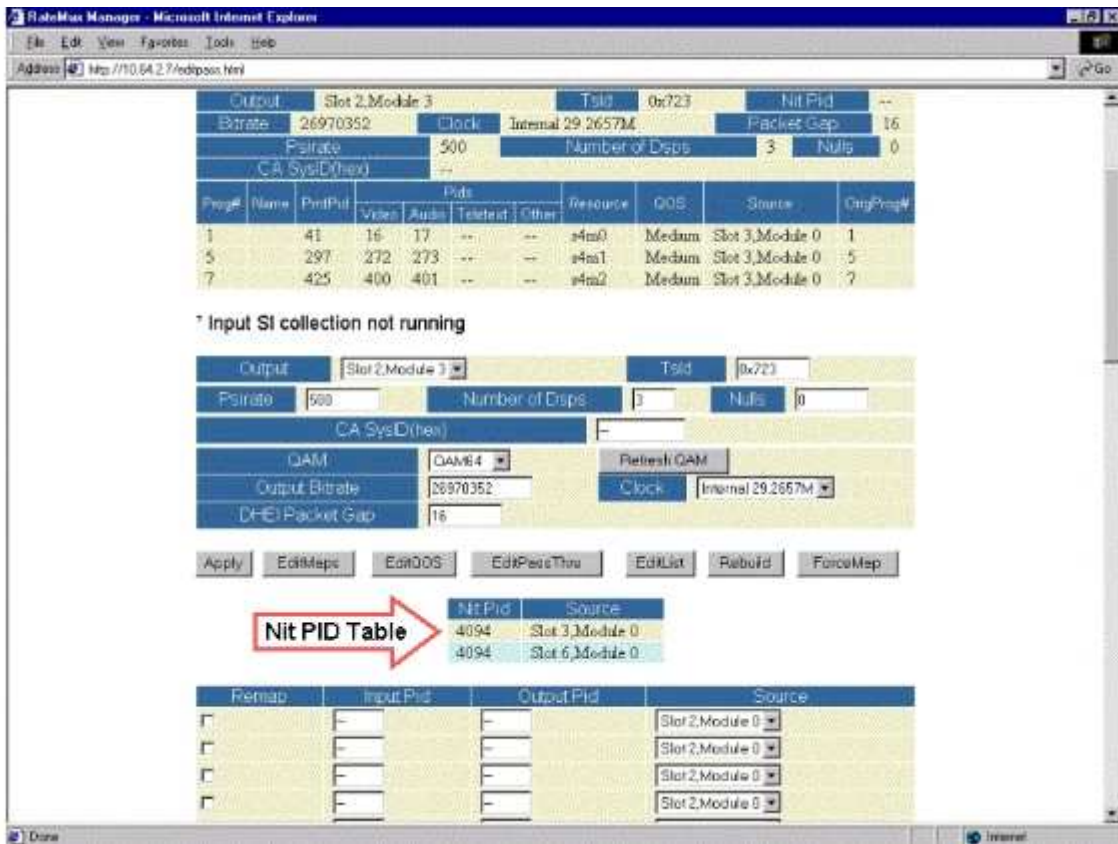
- Click the **EditPassThru** button and scroll down to the middle of the displayed web pages. You should see something similar to the following figure:

- Toward the bottom of the page, the RateMux multiplexer shows a table indicating the PID number and input ports on which NIT PIDs are present. In this case, input ports Slot3, Module 0 and Slot 6, Module 0 have NIT PIDs present. The number of the NIT PID is usually 4094.
- At this stage, you must decide which input port to pass the NIT PID from to our selected output port. In the case shown in the diagram below, it has been decided to pass through the NIT PID from Slot 6, Module 0 because the stream coming in from this input port tends to be more reliable. The Input PID and Output PID numbers are the same as those seen in the NIT PID table.
