Understanding the Output of show controllers on Cisco 12000 Series ATM Line Cards

Document ID: 19880

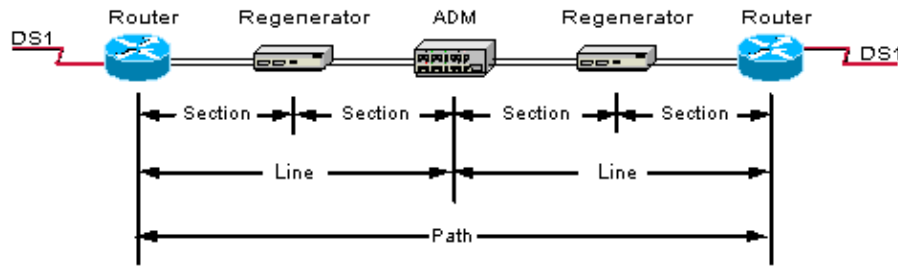
SONET is a protocol that uses a three layer architecture, namely section, line and path. The SONET layers are shown below.

Each layer adds a certain amount of overhead bytes to the SONET frame. As a result, the show controller atm output is broken down into the following:
