ONS 15454 Release 2.2.x to 2.2.2 and 3.0 Software Upgrades

With the Optical Network System (ONS) 15454 running release 2.2.x software, it is now possible for users to perform their own software upgrades to either release 2.2.2 or 3.0. This top issue documents a lab setup, which walks the reader through all of the necessary steps to complete these software upgrades.

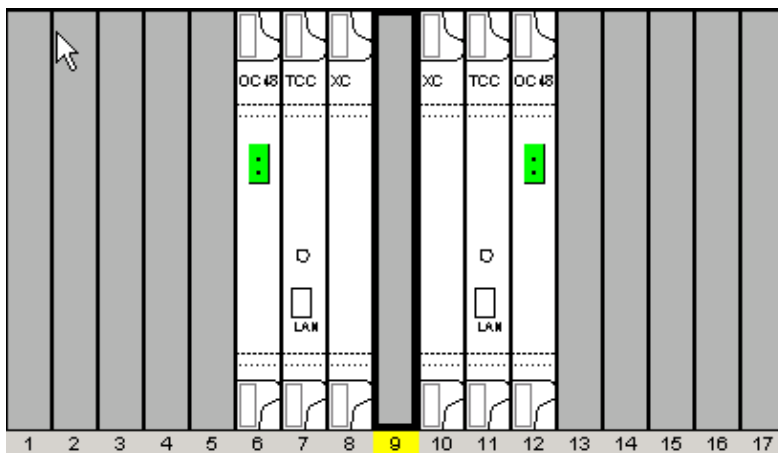
1. Log into the node.
2. Ensure that slots 7, 8, 10, and 11 have duplicate TCC+ and Cross Connect (XC) or Cross Connect Virtual Tributary (XC-VT) cards installed. Release 2.2.x does not support simplex operation.

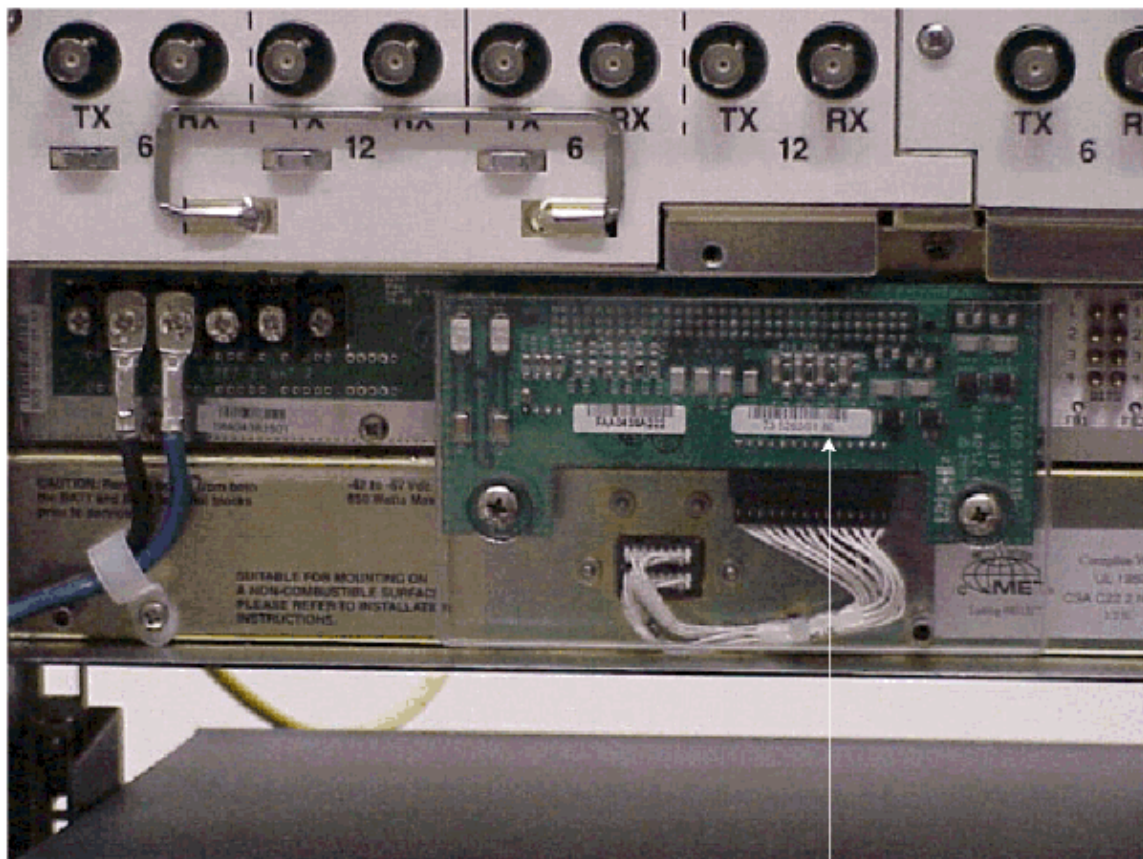
1. Look at the back of your ONS 15454 node and locate the green board with ATM Interface Processor (AIP) stamped into the right hand side (the writing will be sideways as you face the board).
2. Locate the sticker with the part number. The number should be preceded by P/N on the sticker.

3. If the part number is 67-11-00015, the AIP board should be replaced. Otherwise, the AIP board will support the software upgrade.
4. Repeat steps 1-3 for all nodes in the network.

If the part number is 67-11-00015 then the AIP board needs to be replaced before the software upgrade. Any other part number on the AIP board will support both the release 2.2.2 and 3.0 software upgrades

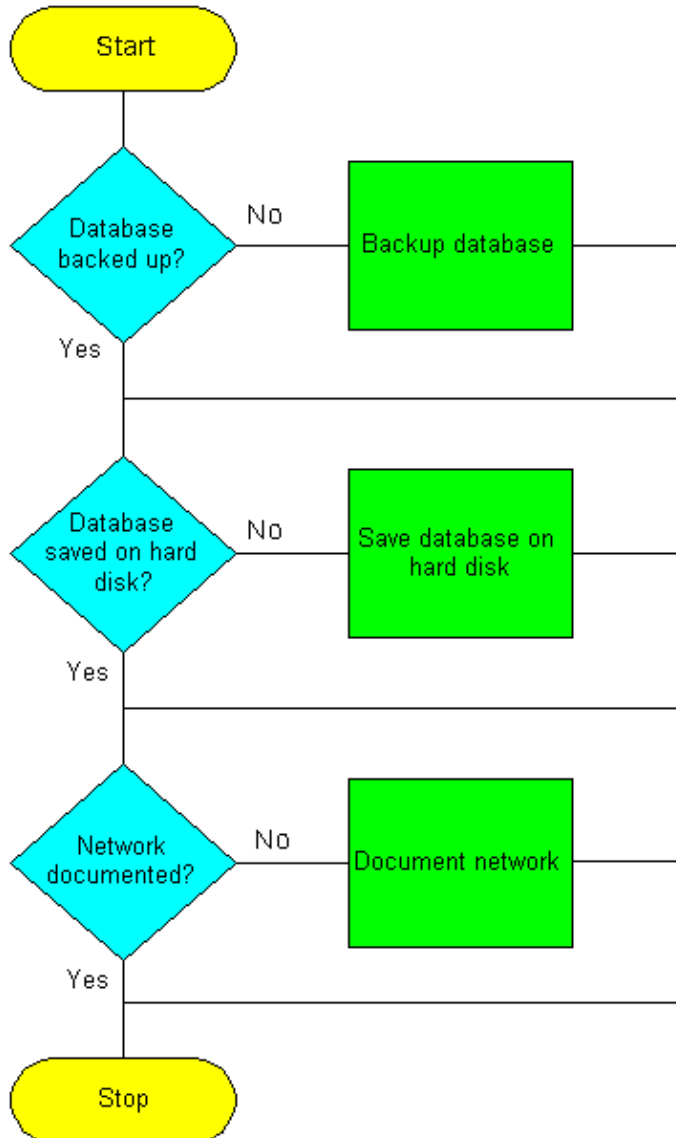
Use the flowchart below to assist you with the pre-upgrade procedures.

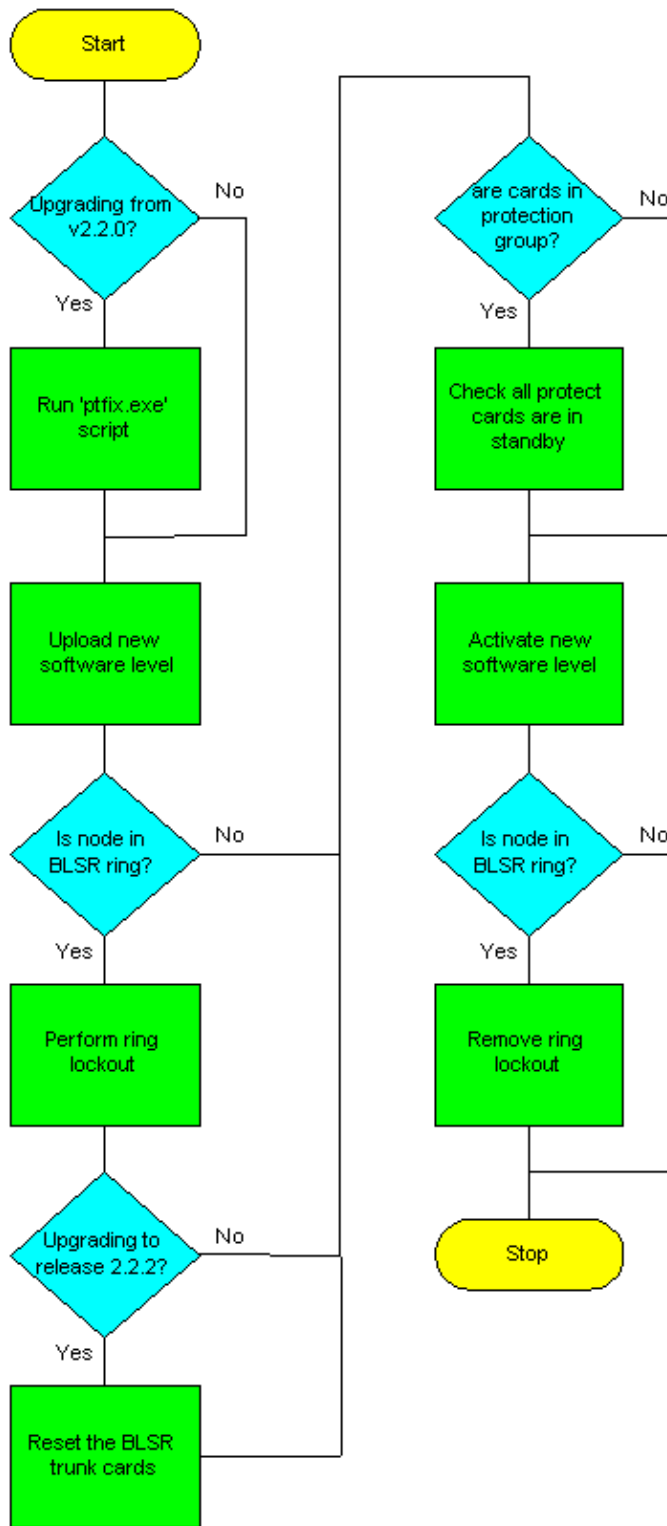
Use the flowchart below to assist you with the upgrade procedures.

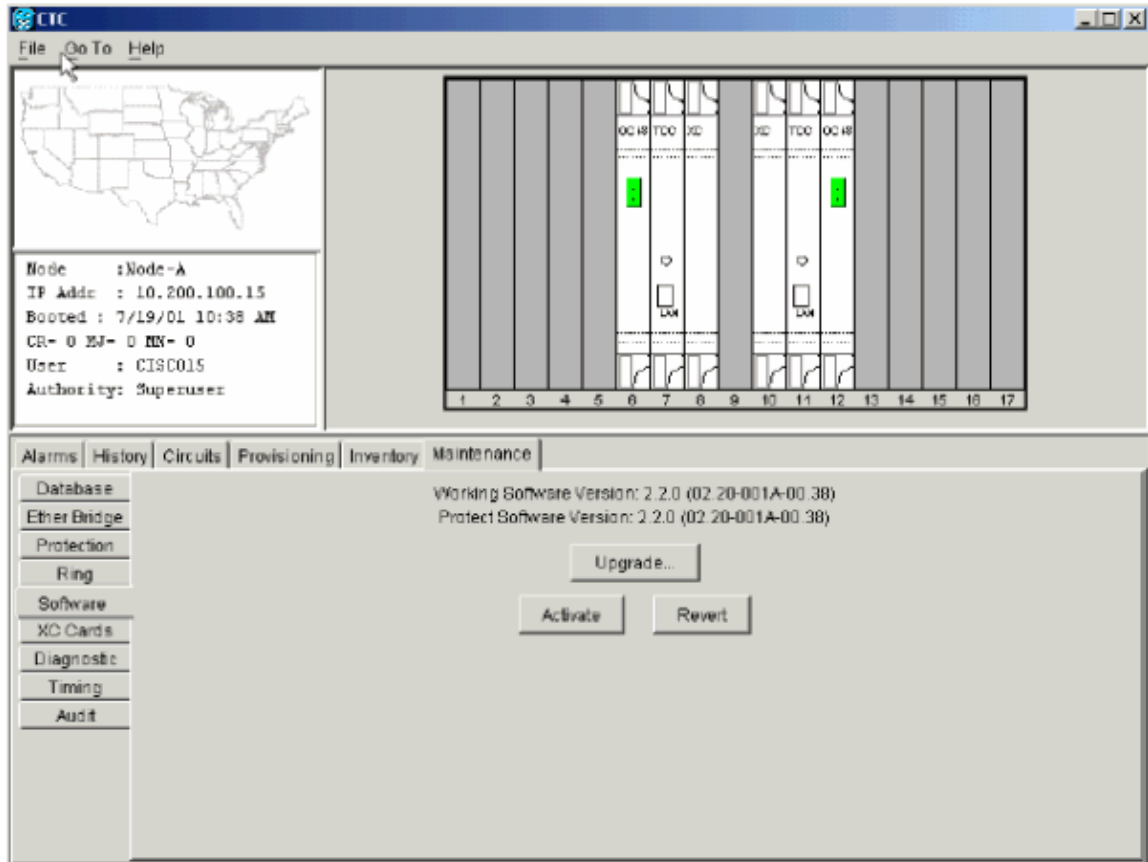
1. Using CTC release 2.2.0, log into the farthest node from the node connected to the workstation.
2. Check the ONS 15454 for existing alarms. Resolve any outstanding alarms before proceeding.
3. From the node view, click the **Maintenance** > **Software** tabs, as shown below:

4. Verify that the active load is 2.2.0 (02.20-001A-00.38). Note that the script will only work for the release 2.2.0 (02.20-001A-00.38) load.
5. Close all active Telnet connections to the ONS 15454.
6. In a command window, from the CD software Cisco15454 directory, run `ptfix.exe` using the IP address of the node you are running the script on, as shown below:

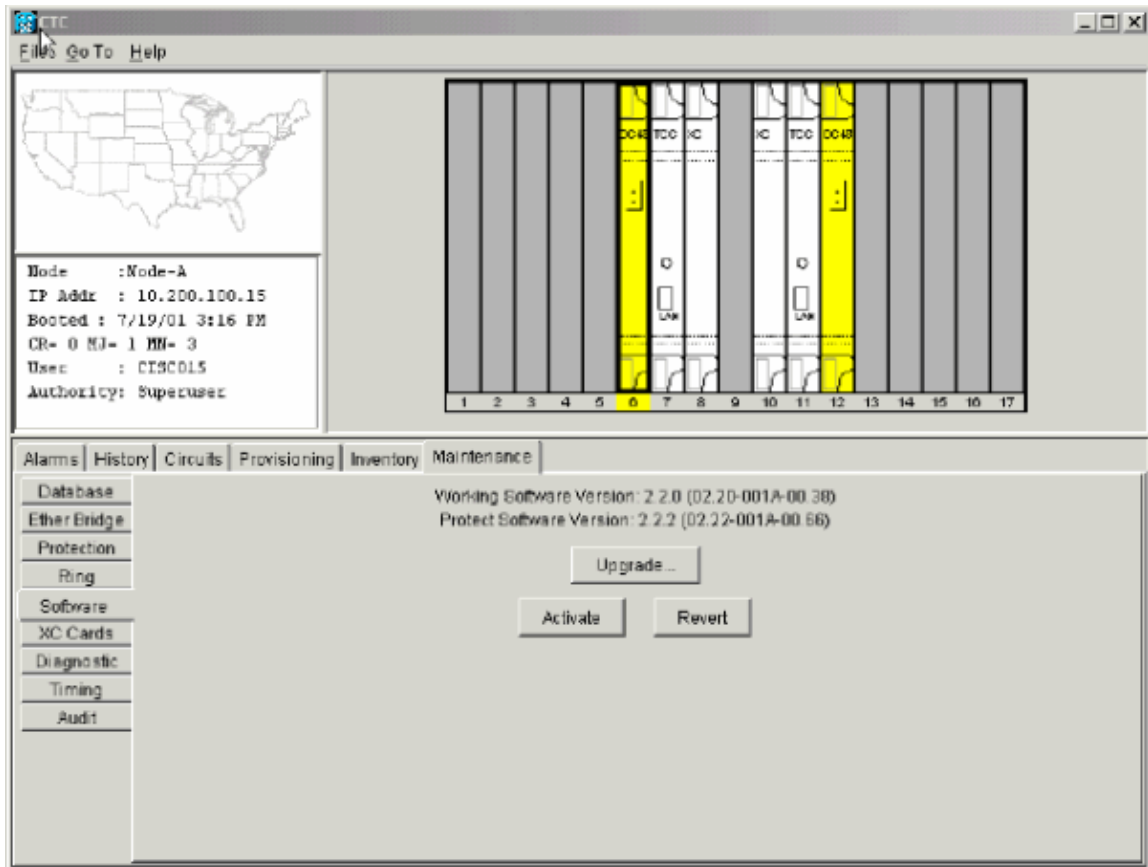
1. Log into the node you ran the script on.
2. Record the IP address of that node.
3. Verify that the node has no active alarms.
4. From the node view, click the **Maintenance > Software** tabs.
5. Verify that the protect software displays release 2.2.2 or 3.0, depending on the software level chosen for your upgrade, as shown below:

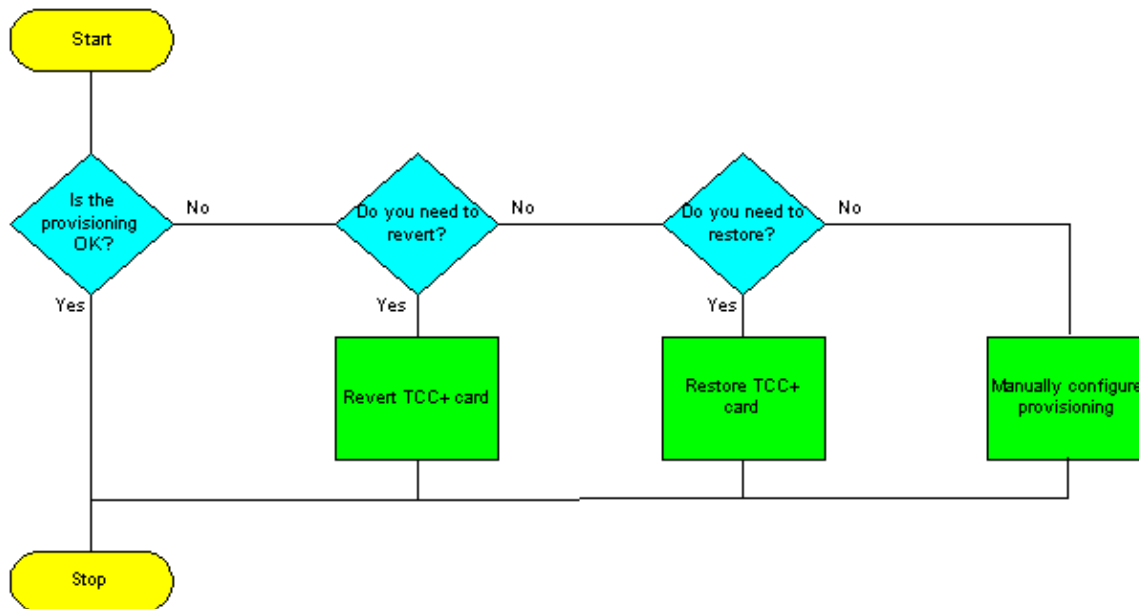
Use the flowchart below to assist you with the upgrade recovery procedures.

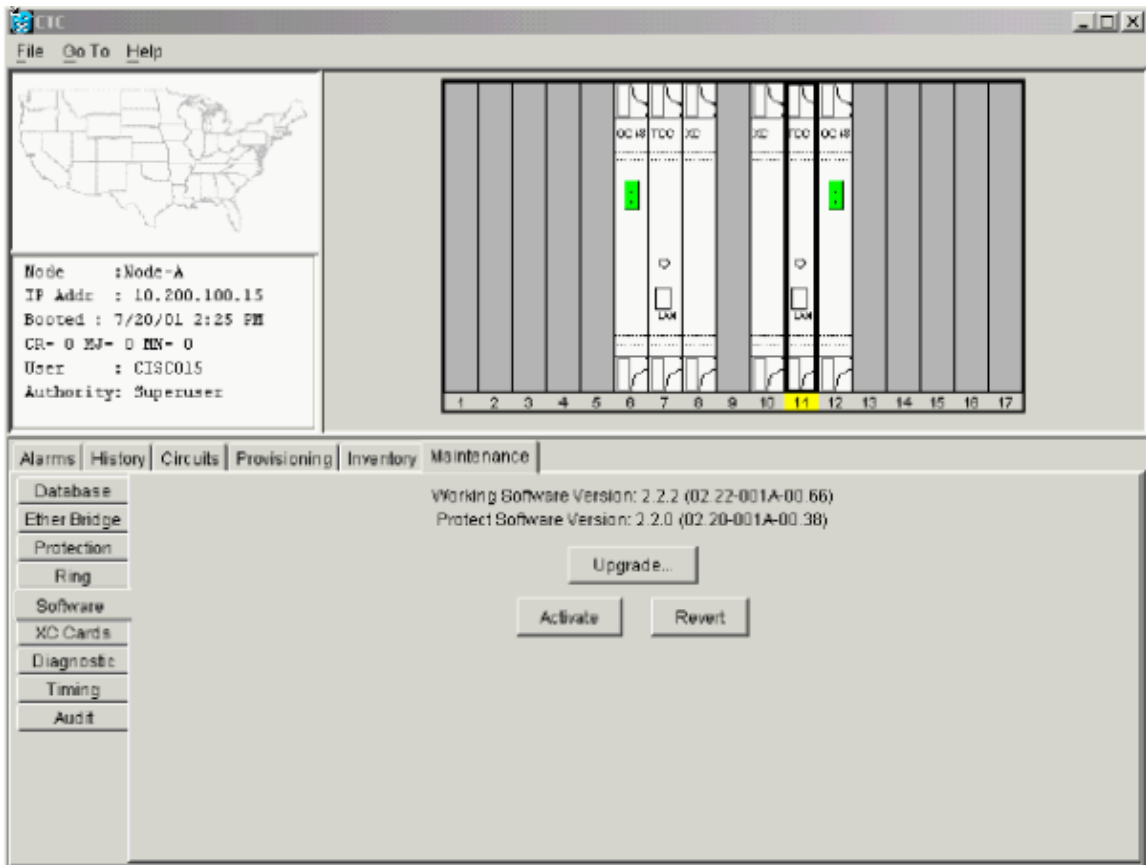
4. Wait for the TCC+ to finish rebooting (this will take approximately four minutes). After the TCC+ has completed rebooting, the above system reset and TCC+ communications failure alarms will white out.
5. From the node view, click the **Maintenance > Software** tabs.
6. Verify that the protect software displays 2.2.x (the release you were upgrading from), as shown below:

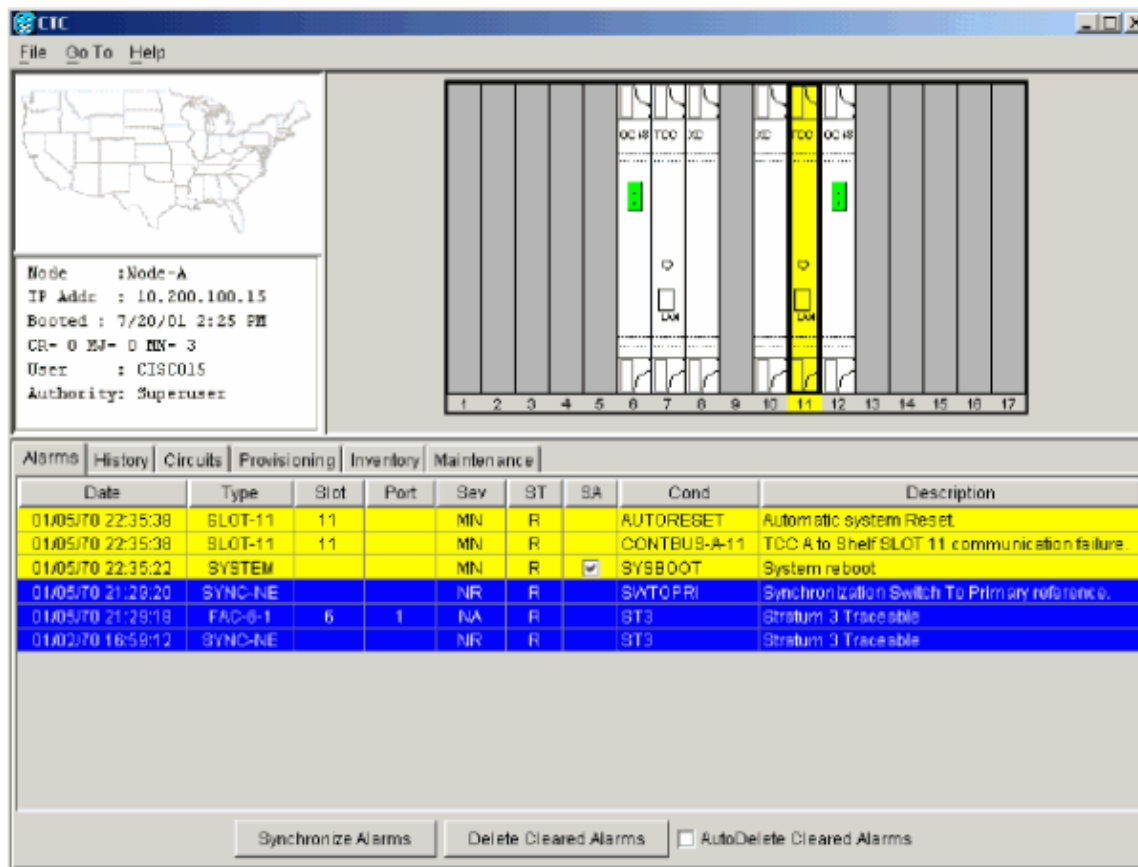
Performing the system reboot causes the system reboot alarm and multiple other alarms on the node as the individual cards are rebooted, as shown below:

After the reboot is complete, all alarms should white out.

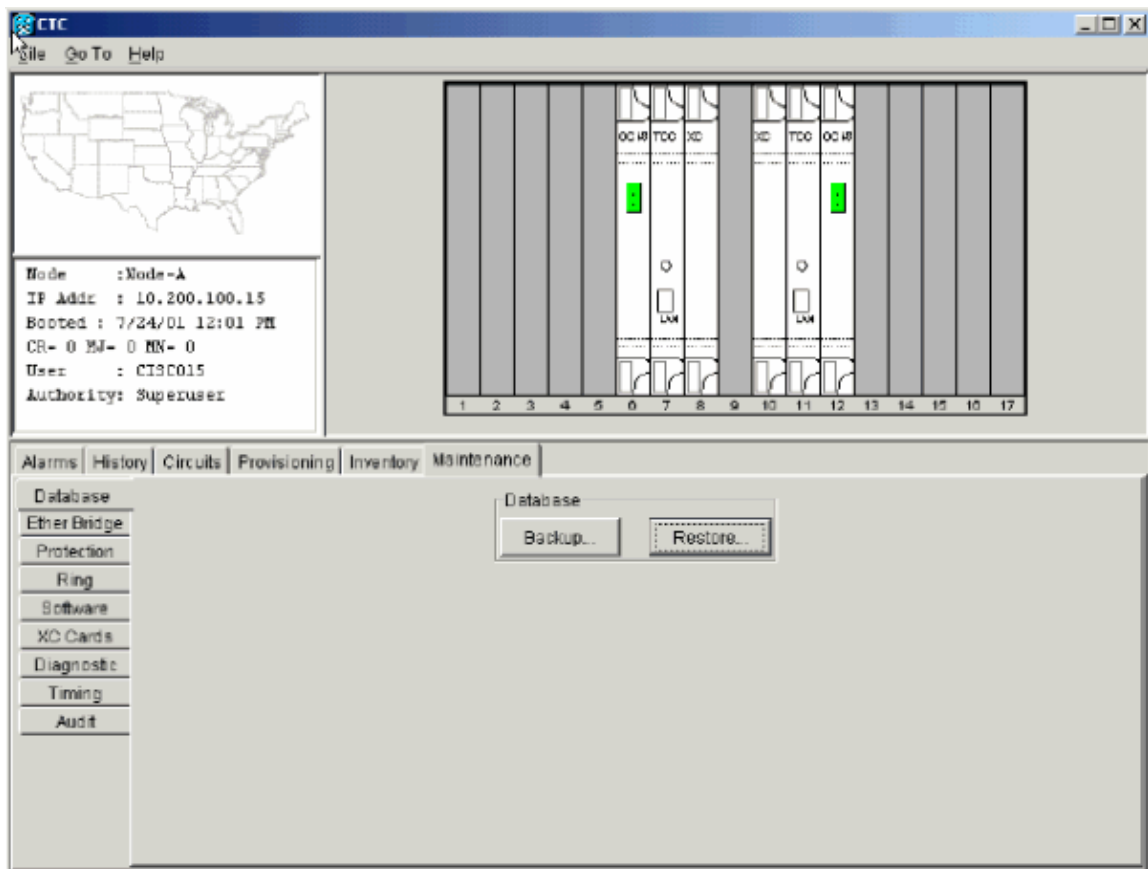
1. From the CTC node view, click the **Maintenance > Database** tabs, as shown below:

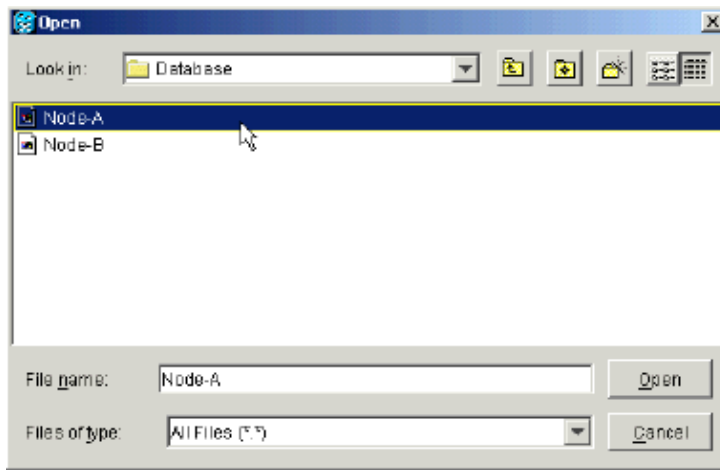
2. Click **Restore**. The **Open** dialog box appears.
3. Select the previously-saved file and choose **Open**, as shown below:

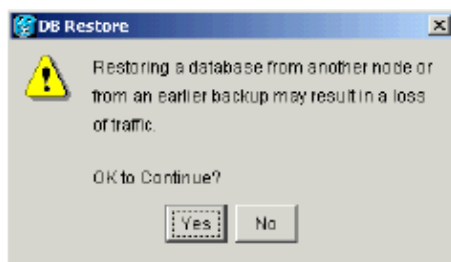
The warning panel below appears, telling you that the restore may cause a loss of traffic is displayed. Click on **Yes** to continue, as shown below:
