Configure Cluster Serviceability Improvements in Firewall Management Center 7.4

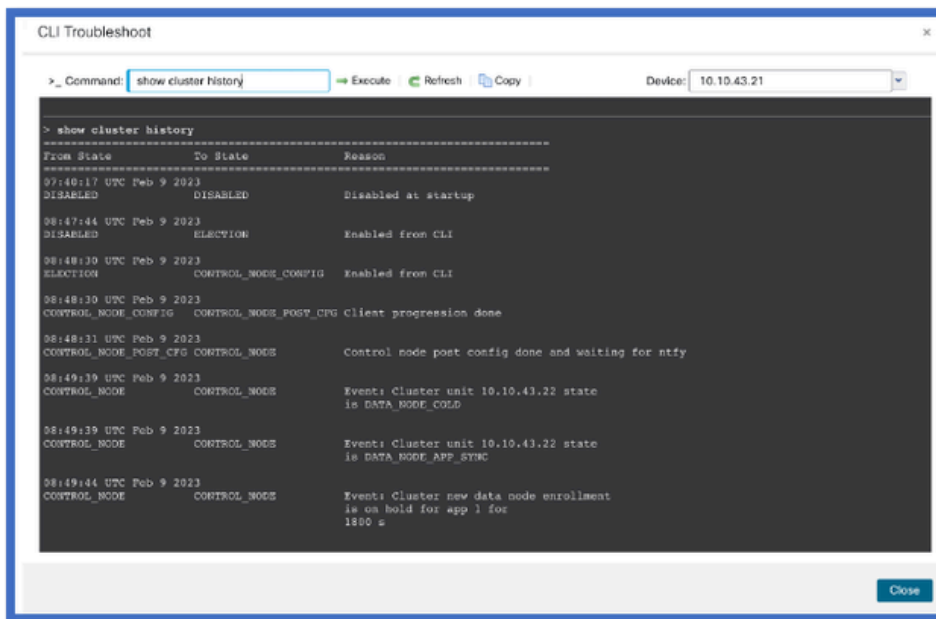
Manual Entry of Commands Available

The screenshot shows a 'CLI Troubleshoot' window with the command 'show cluster history' entered. The output is as follows:

```
> show cluster history
-----
From State      To State      Reason
-----
09:40:17 UTC Feb 9 2023
DISABLED        DISABLED        Disabled at startup

08:47:44 UTC Feb 9 2023
DISABLED        ELECTION        Enabled from CLI

08:48:30 UTC Feb 9 2023
ELECTION        CONTROL_MODE_CONFIG  Enabled from CLI

08:48:30 UTC Feb 9 2023
CONTROL_MODE_CONFIG  CONTROL_MODE_POST_CFG  Client progression done

08:48:31 UTC Feb 9 2023
CONTROL_MODE_POST_CFG  CONTROL_MODE        Control node post config done and waiting for ntp

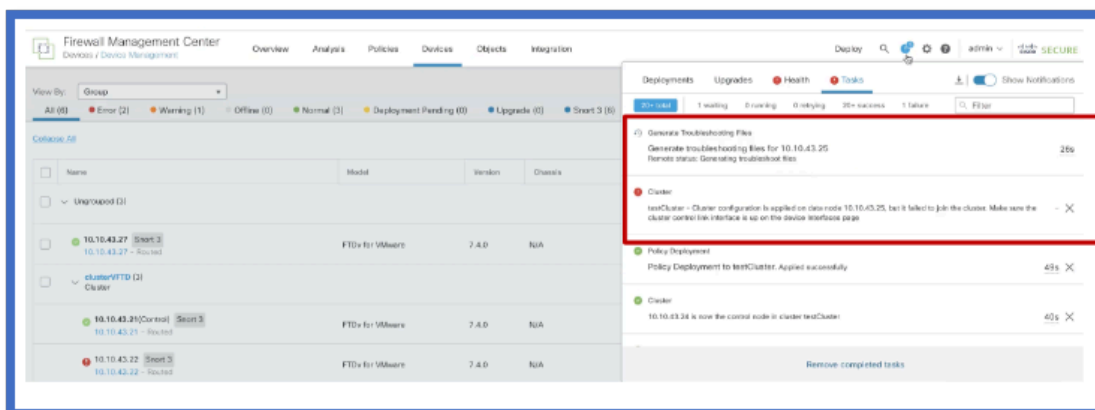
Automatic Troubleshoot Generation on Node Join Failure

- When a node fails to join the cluster, a device Troubleshoot is automatically generated.
- A notification is shown in Task Manager.

The screenshot shows the 'Firewall Management Center' interface. In the 'Tasks' section, a notification is highlighted with a red box:

```
Generate Troubleshooting Files
Generate troubleshooting files for 10.10.43.25
Refresh status: Generating troubleshooting files

Cluster
testCluster - Cluster configuration is applied on data node 10.10.43.25, but it failed to join the cluster. Make sure the
cluster control interface is up on the device interface page

- Task manager shows
- Cluster node join failure
 - That a Troubleshoot has been generated.
