Cisco uBR10012 Universal Broadband Router Troubleshooting Guide

October 2004

Text Part Number: OL-1237-01

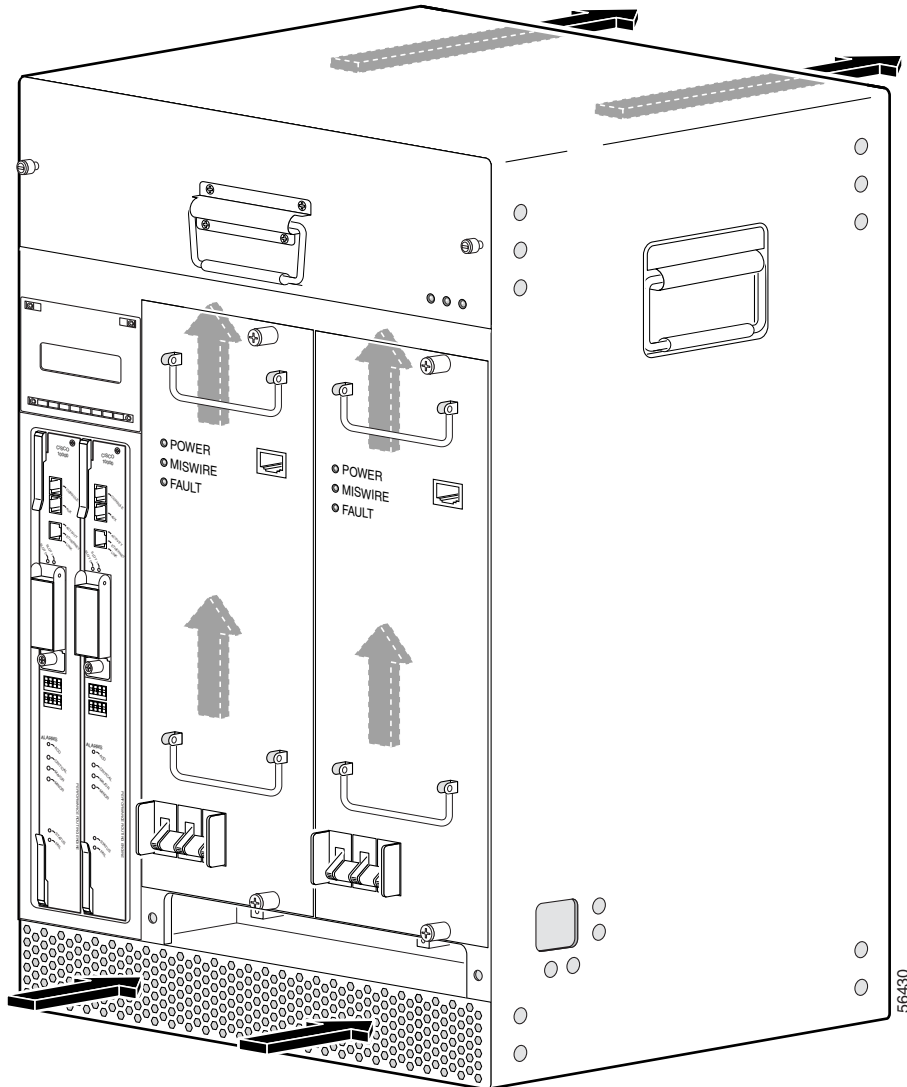
Figure 2-6 Fan Assembly Air Circulation Pattern

The fan assembly module draws air in from the bottom front of the Cisco uBR10012 router, through the air filter at the bottom of the front bezel. The air is drawn up through the line cards, and then exits through the vents at the top rear of the router.

Figure 2-6 shows the air circulation pattern of the Cisco uBR10012 router when two DC PEMs are installed. The air flow when two AC PEMs are installed is similar. The front bezel is not shown for clarity.
