# Release Notes for Cisco IOS Release 12.2(10)DA9 for Cisco DSLAMs with NI-2

These release notes describe features and caveats in Cisco IOS Release 12.2(10)DA9 for the Cisco 6015, Cisco 6160, and Cisco 6260 digital subscriber line access multiplexers (DSLAMs).

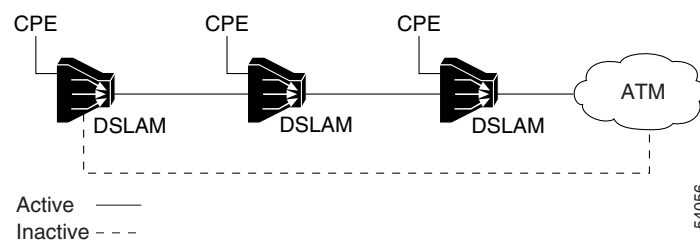
Ring topology is achieved when a node in the subtend tree is attached to the ATM access to provide a physically redundant loop. Thus, when the primary ATM access or one of the ATM trunks in the subtend tree fails, the soft permanent virtual circuits (SPVCs) can be dynamically rerouted through the use of Private Network-Network Interface (PNNI). See [Figure 1](#).

*Figure 1 SPVCs Prior to Failure*

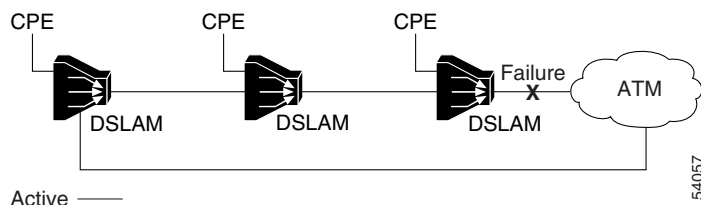
This redundancy requires the use of SPVCs. If you use permanent virtual circuits (PVCs) or permanent virtual paths (PVPs), redundancy cannot be provided. The use of the SPVCs allows traffic to be rerouted around the failed access point, because SPVCs leverage this feature of PNNI. When the failure occurs, the SPVCs are disconnected and dynamically reconnected across the new path. See [Figure 2](#).

Figure 2 SPVCs Dynamically Rerouted
