Alarm Troubleshooting

This chapter gives a description, severity, and troubleshooting procedure for each commonly encountered Cisco ONS 15454 alarm and condition. Tables 2-1 through 2-4 provide lists of ONS 15454 alarms organized by severity. Table 2-5 on page 2-5 provides a list of alarm organized alphabetically. Table 2-7 on page 2-10 provides a list of alarms organized by alarm type. For a comprehensive list of all conditions, refer to the *Cisco ONS 15454 and Cisco ONS 15327 TL1 Command Guide*.

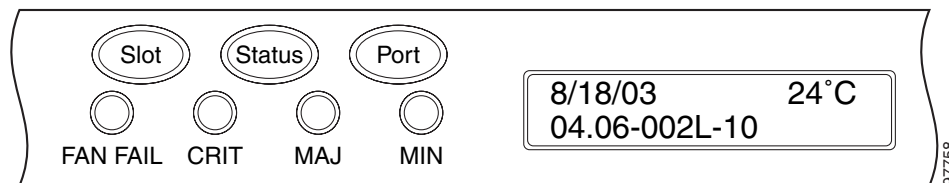
Figure 2-1 Shelf LCD Panel

- Step 1** View the temperature displayed on the ONS 15454 LCD front panel (Figure 2-1).

- Step 2** If the temperature of the shelf exceeds 194° F (90° C), the alarm should clear if you solve the ONS 15454 temperature problem. Complete the “[Clear the HITEMP Alarm](#)” procedure on page 2-97.
- Step 3** If the temperature of the shelf is under 194° F (90° C), the HITEMP alarm is not the cause of the AUTOLSROFF alarm. Complete the “[Physically Replace a Card](#)” procedure on page 2-198 for the OC-192 card.

- Step 2** Determine whether the LCD display on the fan tray ([Figure 2-1 on page 2-35](#)) is blank or if the text is garbled. If so, proceed to [Step 8](#). If not, continue with Step 3.
- Step 3** At the earliest maintenance window, reset the standby TCC+/TCC2:
