Alarm Troubleshooting

This chapter gives a description, severity, and troubleshooting procedure for each commonly encountered Cisco ONS 15454 alarm and condition. Tables 2-1 through 2-4 provide lists of ONS 15454 alarms organized by severity. Table 2-6 on page 2-6 provides a list of alarms organized alphabetically. Table 2-8 on page 2-11 provides a list of alarms organized by alarm type. For a comprehensive list of all conditions, refer to the *Cisco ONS 15454 and Cisco ONS 15327 TL1 Command Guide*.

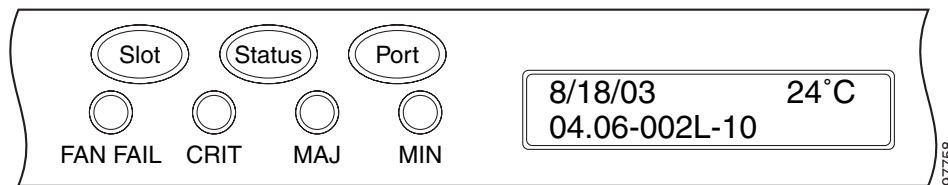
Figure 2-1 Shelf LCD Panel

- Step 1** View the temperature displayed on the ONS 15454 LCD front panel ([Figure 2-1](#)).

- Step 1** View the temperature displayed on the ONS 15454 LCD front panel ([Figure 2-1 on page 2-35](#)).
- Step 2** Verify that the environmental temperature of the room is not abnormally high.
- Step 3** If the room temperature is not abnormal, physically ensure that nothing prevents the fan-tray assembly from passing air through the ONS 15454.
- Step 4** If airflow is not blocked, physically ensure that blank faceplates fill the ONS 15454 empty slots. Blank faceplates help airflow.
- Step 5** If faceplates fill the empty slots, determine whether the air filter needs replacement. Refer to the [“Inspect, Clean, and Replace the Reusable Air Filter” procedure on page 3-5](#).
- Step 6** If the filter is clean, complete the [“Remove and Reinsert Fan-Tray Assembly” procedure on page 2-220](#).

-
- Step 1** Check for any outstanding alarms that were raised against the active and standby TCC2 and resolve them.
- Step 2** Determine whether the LCD display on the fan tray is blank or if the text is garbled. If so, proceed to [Step 8 \(Figure 2-1 on page 2-35\)](#). If not, continue with Step 3.
- Step 3** At the earliest maintenance window, reset the standby TCC2:
