## **Cisco ONS 15454 SONET and DWDM Troubleshooting Guide**

Product and Documentation Release 4.7  
Last Updated: August 21, 2007

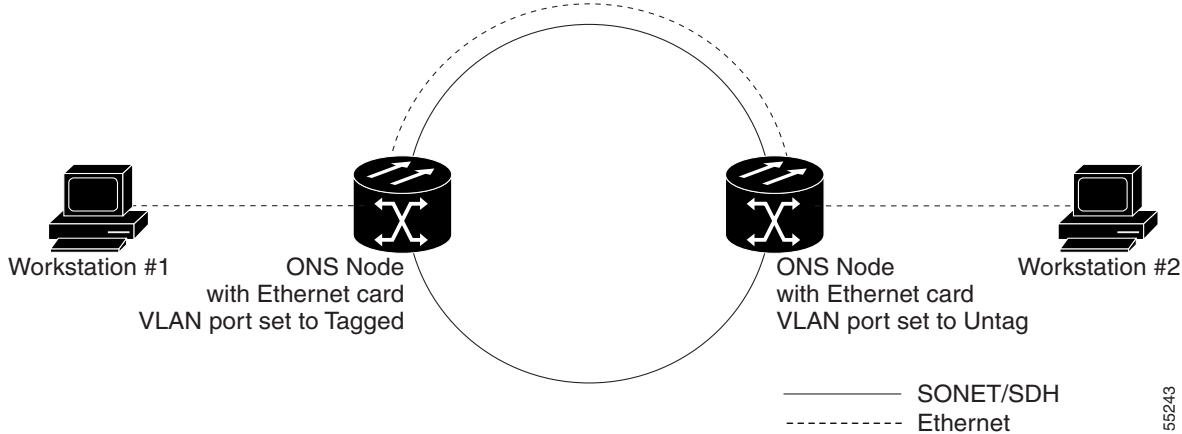
Figure 1-23 VLAN with Ethernet Ports at Tagged and Untag

**Symptom** Networks that have a VLAN with one ONS 15454 Ethernet card port set to Tagged and one ONS 15454 Ethernet card set to Untag might have difficulty implementing Address Resolution Protocol (ARP) for a network device attached to the Untag port ([Figure 1-23](#)). They might also see a higher than normal runt packets count at the network device attached to the Untag port. This symptom/limitation also exists when ports within the same card or ports within the same chassis are put on the same VLAN, with a mix of tagged and untagged.

**Recommended Action** The solution is to set both ports in the VLAN to Tagged to stop the stripping of the 4 bytes from the data packet and prevent the NIC card in the network access device from recognizing the packet as a runt and dropping it. Network devices with IEEE 802.1Q-compliant NIC cards accept the tagged packets. Network devices with non-IEEE 802.1Q compliant NIC cards still drop these tagged packets. The solution might require upgrading network devices with non-IEEE 802.1Q compliant NIC cards to IEEE 802.1Q compliant NIC cards. You can also set both ports in the VLAN to Untag, but you will lose IEEE 802.1Q compliance.
