Alarm Troubleshooting

This chapter gives a description, severity, and troubleshooting procedure for each commonly encountered Cisco ONS 15454 alarm and condition. Tables 2-1 through 2-5 provide lists of ONS 15454 alarms organized by severity. Table 2-6 on page 2-7 provides a list of alarms organized alphabetically. Table 2-7 gives definitions of all ONS 15454 alarm logical objects, which are the basis of the alarm profile list in Table 2-8 on page 2-14. For a comprehensive list of all conditions, refer to the *Cisco ONS SONET TL1 Command Guide*.

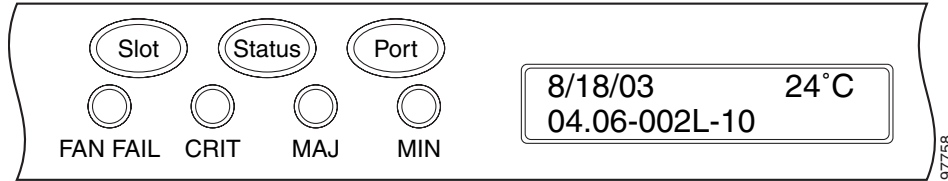
Figure 2-1 Shelf LCD Panel

-
- Step 1** View the temperature displayed on the ONS 15454 LCD front panel ([Figure 2-1](#)).

Step 2 If the temperature of the shelf exceeds 194 degrees F (90 degrees C), the alarm should clear if you solve the ONS 15454 temperature problem. Complete the [“Clear the HITEMP Alarm” procedure on page 2-124](#).

Step 3 If the temperature of the shelf is under 194 degrees F (90 degrees C), the HITEMP alarm is not the cause of the AUTOLSROFF alarm. Complete the [“Physically Replace a Traffic Card” procedure on page 2-271](#) for the OC-192 card.

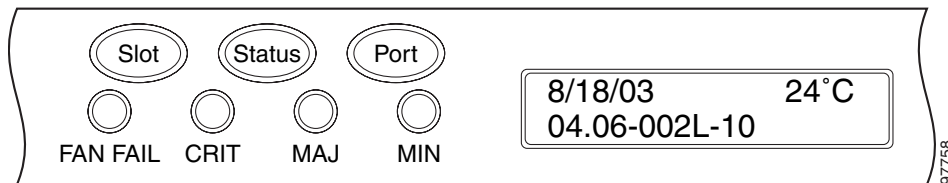
Figure 2-2 Shelf LCD Panel

- Step 1** View the temperature displayed on the ONS 15454 LCD front panel ([Figure 2-2](#)).

- Step 2** Verify that the environmental temperature of the room is not abnormally high.
- Step 3** If the room temperature is not abnormal, physically ensure that nothing prevents the fan-tray assembly from passing air through the ONS 15454 shelf.
- Step 4** If airflow is not blocked, physically ensure that blank faceplates fill the ONS 15454 shelf empty slots. Blank faceplates help airflow.
- Step 5** If faceplates fill the empty slots, determine whether the air filter needs replacement. Refer to the [“Inspect, Clean, and Replace the Reusable Air Filter”](#) procedure on page 2-275.

Step 2 If the alarm does not clear, determine whether the LCD display on the fan tray ([Figure 2-2 on page 2-124](#)) is blank or if the text is garbled. If so, proceed to [Step 8](#). If not, continue with [Step 3](#).
