Cisco ONS 15454 DWDM Troubleshooting Guide

Product and Software Release 7.0.1
June 2012

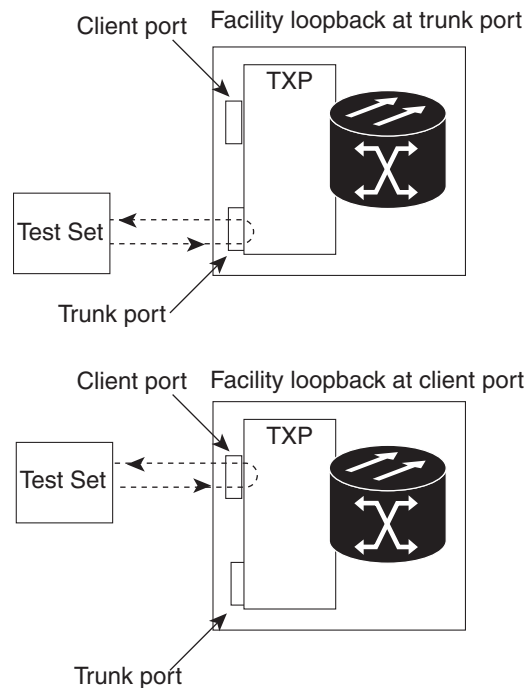
Figure 1-1 Facility Loopback Path on a Near-End Transponder Card

To test a card LIU, connect an optical test set to a trunk or client port and perform a facility loopback. Alternately, use a loopback or hairpin circuit on a card that is farther along the circuit path. For example, [Figure 1-1](#) shows a facility loopback at a trunk port and at a client port on a TXP card.

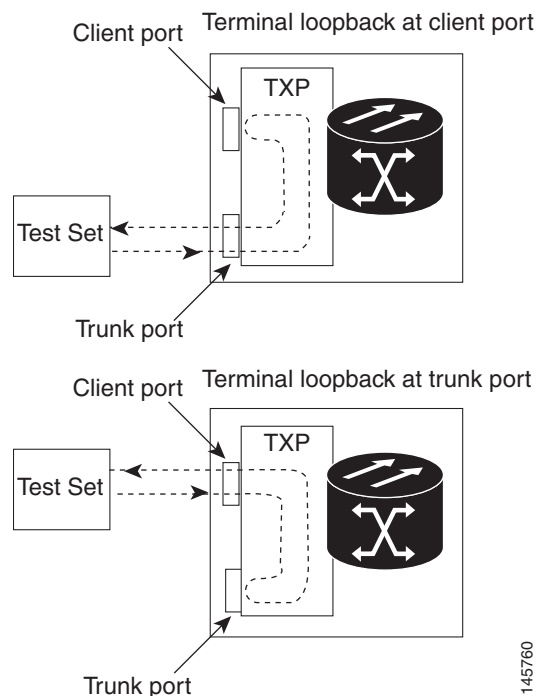
Figure 1-2 Terminal Loopback on a TXP Card

A terminal loopback tests a circuit path as it passes through a TXP or MXP card and loops back. For example, as shown in [Figure 1-2](#), there are two types of terminal loopbacks shown for a TXP card.

This test verifies that the terminal circuit paths are valid, but does not test the LIU on the TXP card.

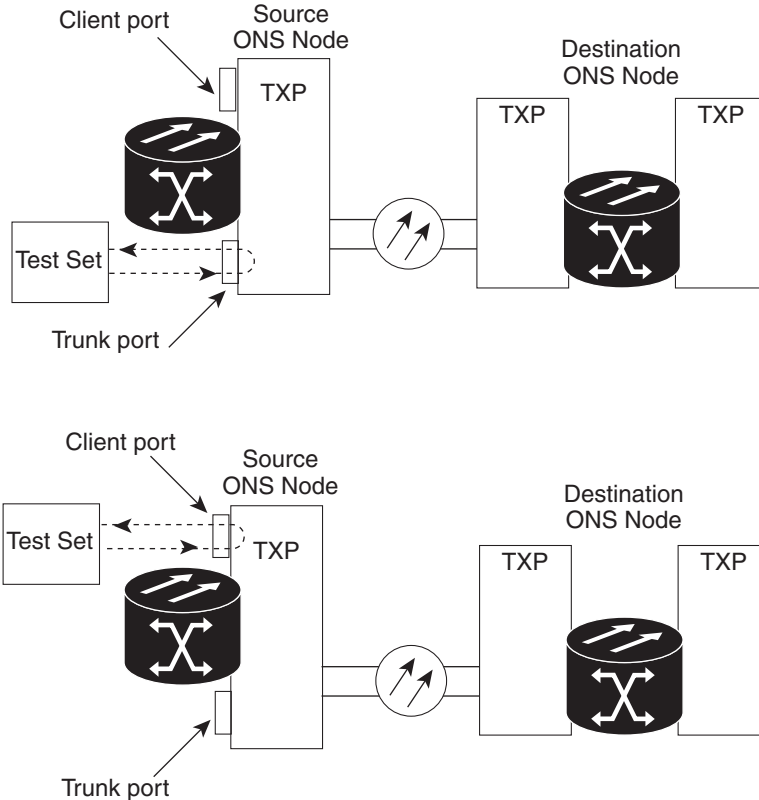
Figure 1-3 Facility Loopback on a Circuit Source MXP or TXP Port

This facility loopback test is performed on the node source port in the network circuit. In the testing situation used in this example, the source muxponder or transponder port under test is located in the source node. Facility loopback can be performed at the trunk port or at a client port. Completing a successful facility loopback on this port isolates the source MXP or TXP port as a possible failure point. [Figure 1-3](#) shows the facility loopback examples on source ONS node TXP ports (client and trunk).

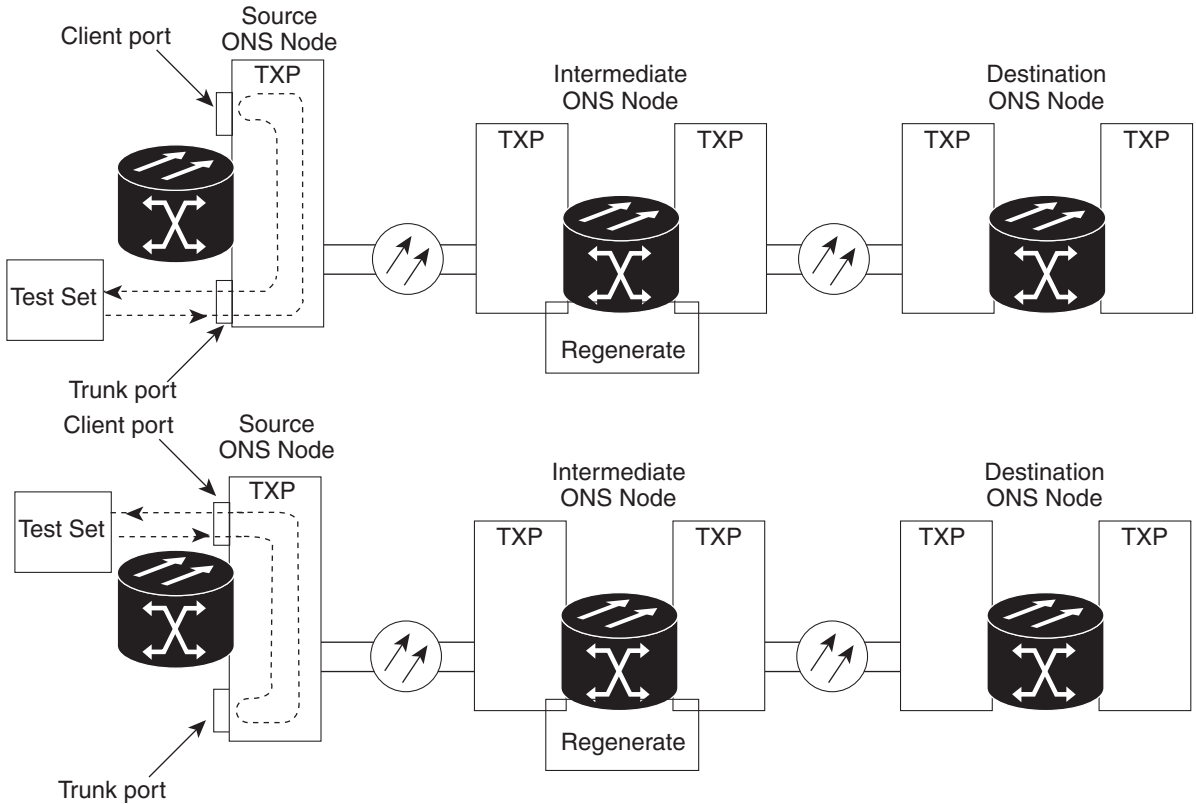
Figure 1-4 Terminal Loopback on a Source-Node MXP or TXP Port

The terminal loopback test is performed on the node source MXP or TXP muxponder or transponder port. For the circuit in this example, it is the source TXP trunk port or a client port in the source node. Completing a successful terminal loopback to a node source port verifies that the circuit is through the source port. [Figure 1-4](#) shows an example of a terminal loopback on a source TXP port and a client TXP port.

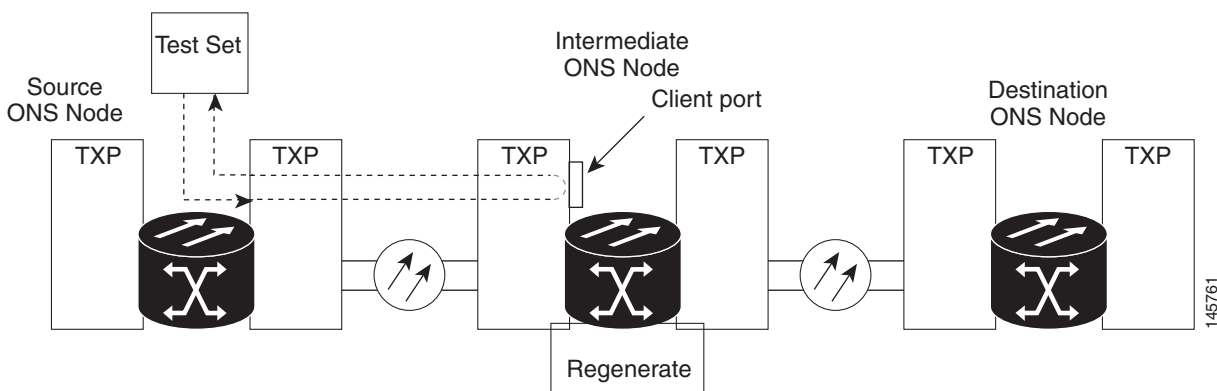
Figure 1-6 Terminal Loopback on an Intermediate-Node MXP or TXP Port

In the next troubleshooting test, you perform a terminal loopback on the intermediate-node port to isolate whether the intermediate client or trunk port is causing circuit trouble. In the example situation in [Figure 1-6](#), the terminal loopback is performed on an intermediate MXP or TXP port in the circuit. If you successfully complete a terminal loopback on the node, this node is excluded from possible sources of circuit trouble.

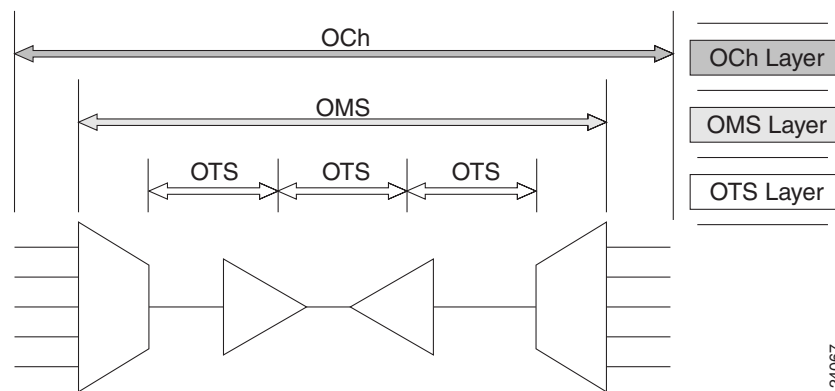
Figure 1-9 Optical Transport Network Layers

Like traditional SONET networks, ITU-T G.709 optical networks have a layered design (Figure 1-9). This structure enables localized monitoring that helps you isolate and troubleshoot network problems.

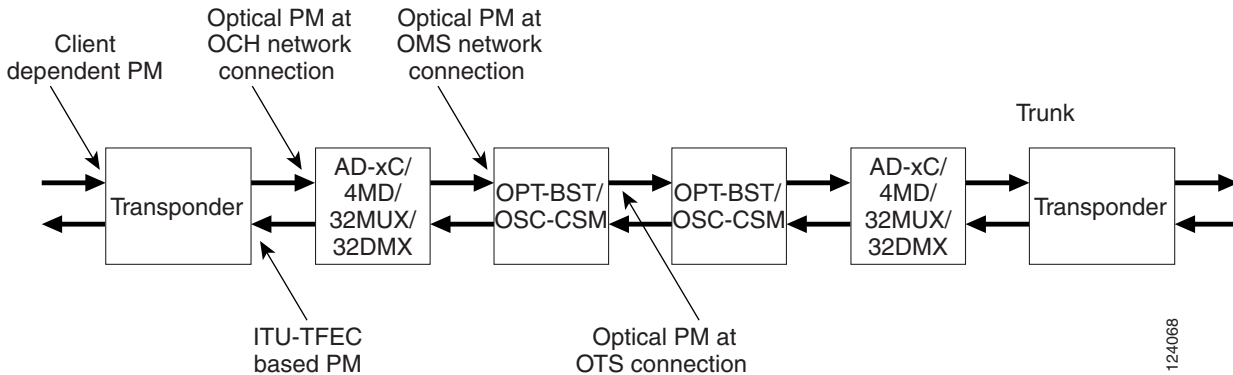
Figure 1-10 Performance Monitoring Points on ONS DWDM

Different PM count parameters are associated with different read points in a network. [Figure 1-10](#) illustrates the PM read points that are useful in identifying DWDM circuit points of failure. The “Performance Monitoring” chapter in the *Cisco ONS 15454 DWDM Reference Manual* lists all PM parameters and provides block diagrams of signal entry points, exit points, and interconnections between the individual circuit cards. Consult these specifications to determine which PM parameters are associated with the system points you want to monitor or provision with CTC or TL1. The monitoring points might vary according to your configuration.

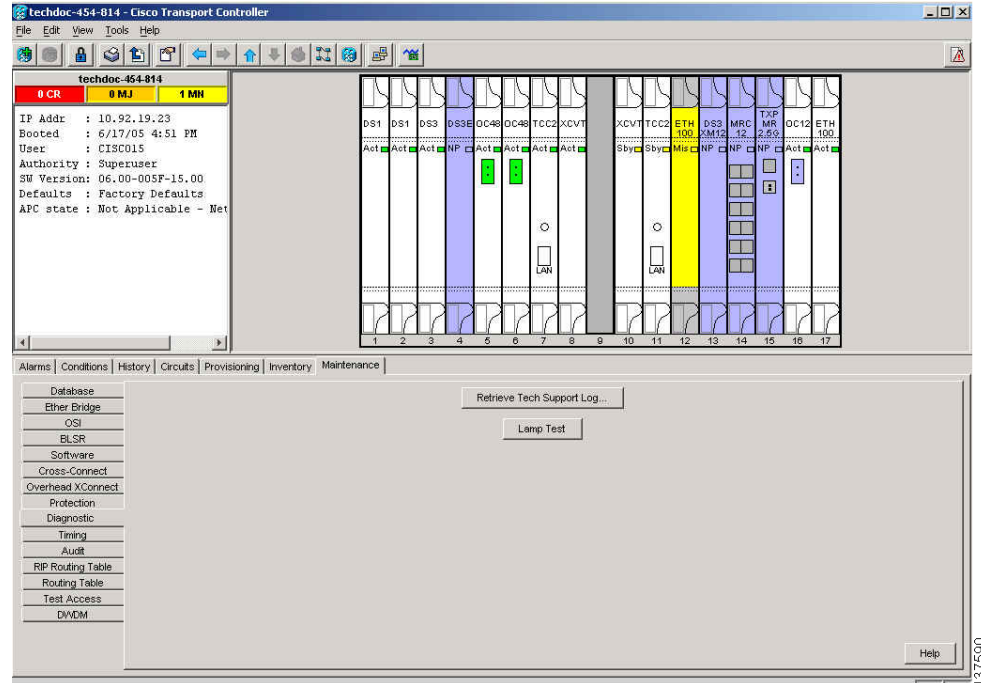
Figure 1-15 ONS 15454 Node View Diagnostic Window

-
- Step 1** In node view (single-shelf mode) or shelf view (multishelf mode), click the **Maintenance > Diagnostic** tabs ([Figure 1-15](#)).

Step 2 Click **Lamp Test**.

-
- Step 1** In node view (single-shelf mode) or shelf view (multishelf mode), click the **Maintenance > Diagnostic** tabs ([Figure 1-15](#)).
- Step 2** Click **Retrieve Tech Support Log**.
- Step 3** In the Saving Diagnostic File dialog box, navigate to the directory (local or network) where you want to save the file.
- Step 4** Enter a name in the File Name field.
- You do not have to give the archive file a particular extension. It is a compressed file (gzip) that can be unzipped and read by Cisco Technical Support.
- Step 5** Click **Save**.
- The Get Diagnostics status window shows a progress bar indicating the percentage of the file being saved, then shows “Get Diagnostics Complete.”
- Step 6** Click **OK**.
-

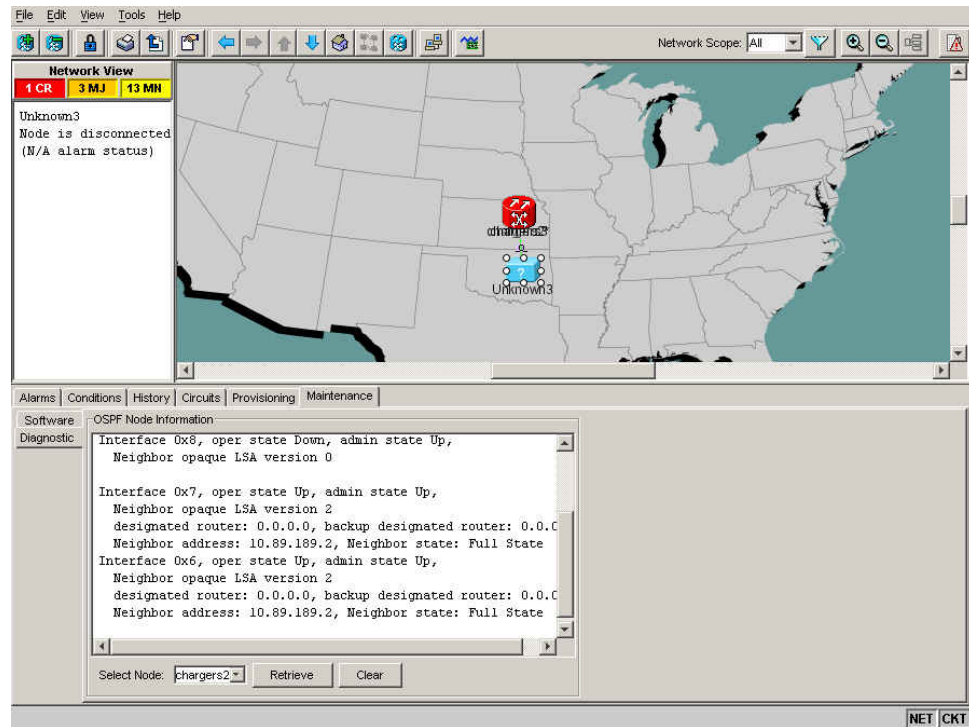
Figure 1-16 DCN Tools OSPF Dump

CTC contains a data communications network (DCN) tool that assists with network troubleshooting for Open Shortest Path First (OSPF) networks. This tool, located in network view, is shown in [Figure 1-16](#). It executes an internal dump command to retrieve information about all nodes accessible from the entry point.

The dump, which provides the same information as a dump executed by special networking commands, is available at the network view in the Maintenance > Diagnostic tab. You can select the access point node in the Select Node drop-down list. To create the dump, click Retrieve. (To clear the dump, click Clear.)

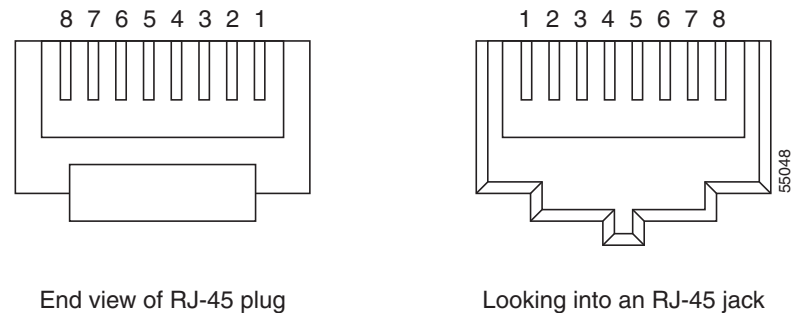
Figure 1-18 RJ-45 Pin Numbers

You can crimp your own LAN cables for use with the ONS 15454. Use a cross-over cable when connecting an ONS 15454 to a hub, LAN modem, or switch, and use a LAN cable when connecting an ONS 15454 to a router or workstation. Use CAT-5 cable RJ-45 T-568B, Color Code (100 Mbps), and a crimping tool. [Figure 1-18](#) shows the wiring of an RJ-45 connector. [Figure 1-19](#) shows a LAN cable layout, and [Table 1-5](#) shows the cable pinouts. [Figure 1-20](#) shows a cross-over cable layout, and [Table 1-6](#) shows the cross-over pinouts.

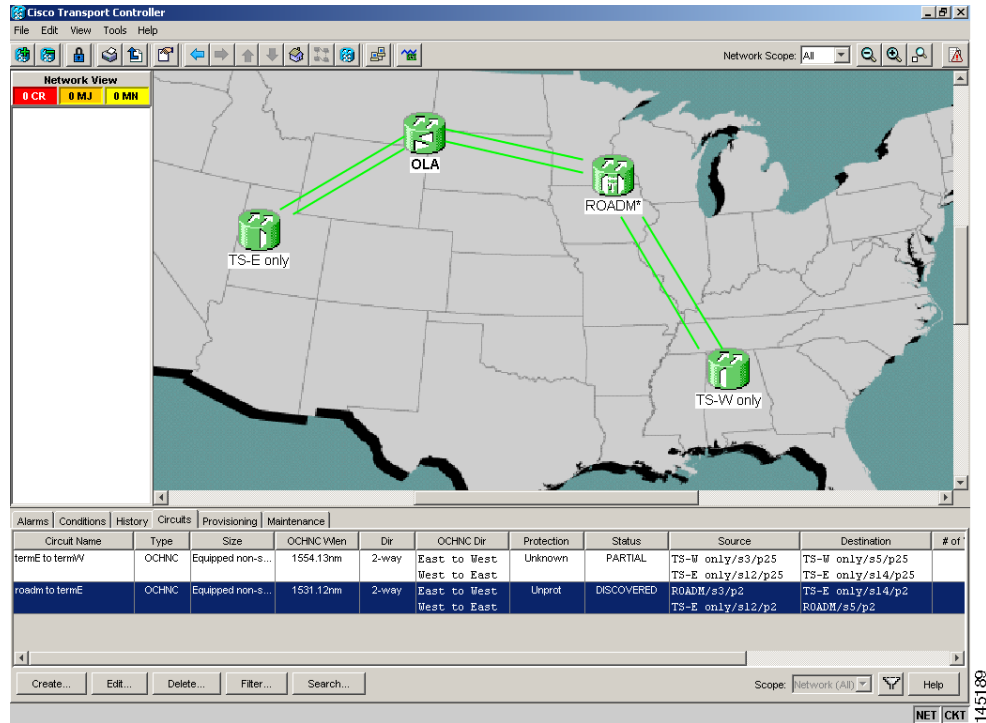
Figure 1-21 Linear Network, With No Fiber Cut

Different symptoms and scenarios can occur, depending on the network ALS settings. Consider the linear network (four nodes) in [Figure 1-21](#) as a reference. The scenarios are presented after the figure.

The symptoms of the possible span loss scenarios (except for span loss decrease) are described in the following paragraphs. Refer to the linear network in [Figure 1-21 on page 1-61](#) during the discussion of the scenarios.

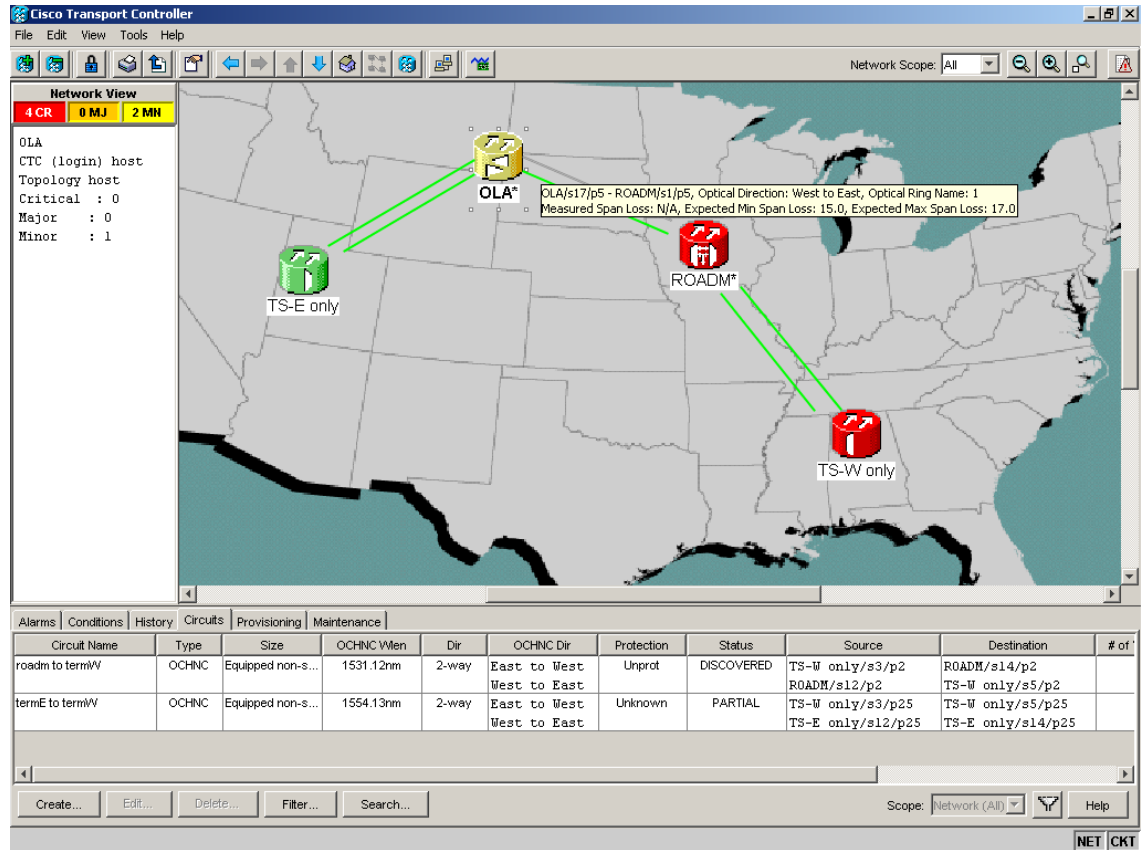
Figure 1-25 Network View Fault Condition for Fiber Cut with ALS Mode Disabled

The LOS (OTS or AOTS) alarm is raised by the ROADM-RX node that was receiving the signal coming from the broken fiber. The final fault condition of the network is shown in Figure 1-25.

In network view (Figure 1-25), only the actual affected fiber becomes gray, whereas the traffic (and OSC signal as well) on the good fiber is active and fault identification is immediate.

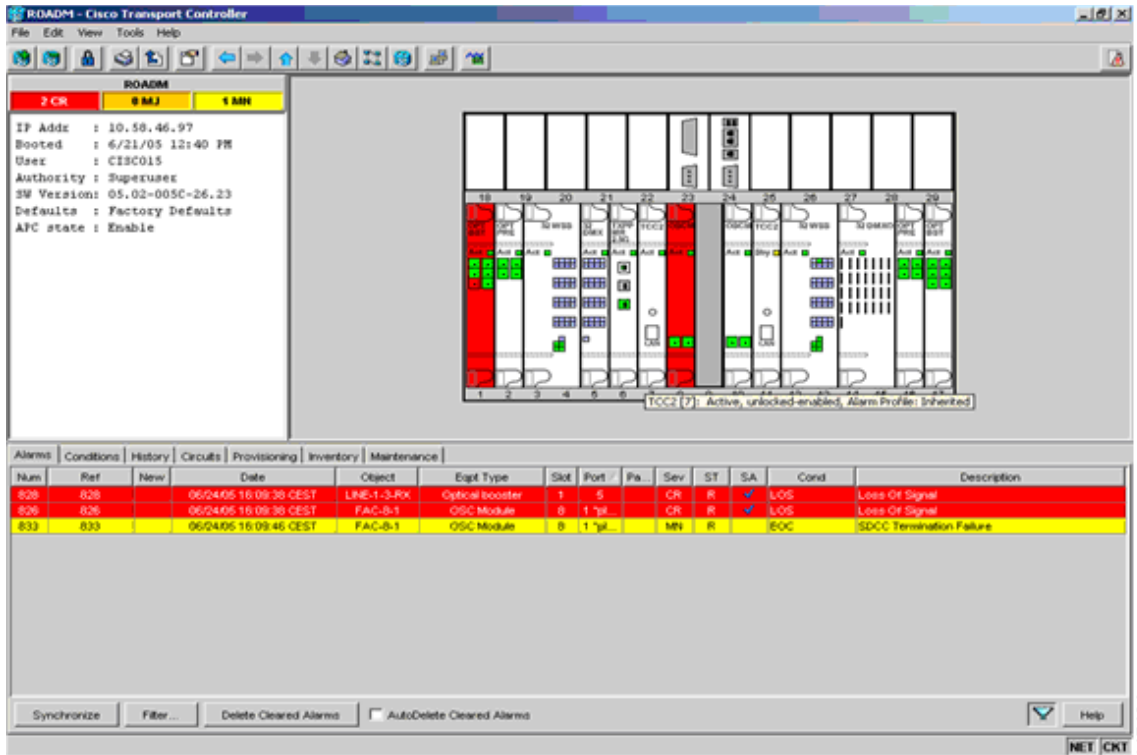
Figure 1-26 ONS 15454 SDH ROADM Node View with Fault Condition for ALS MODE Disabled

In node view (single-shelf mode) or shelf view (multishelf mode) (Figure 1-26 and Figure 1-27), the alarm panel of the receiving node (ROADM in this example) reports the LOS (OTS), while the transmitting node (OLA) reports only an EOC alarm.

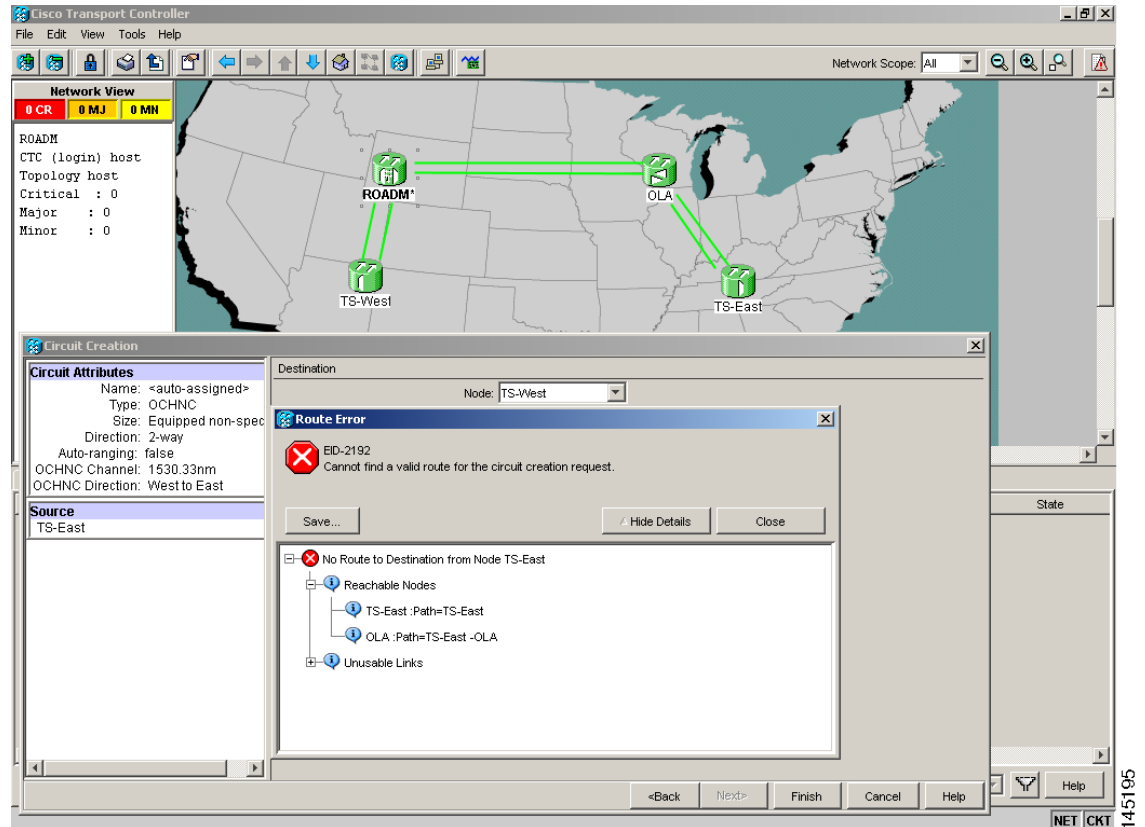
Figure 1-30 Partial Circuit

- If the WPP wizard cannot complete the circuit creation procedure, CTC displays the error message shown in [Figure 1-30](#). In the message, click **Details** to see the partial connections that WPP can set up. Start troubleshooting the problem in the first node that is unreachable along the path.

To troubleshoot and eventually fix issues related to the faulty OCHNC circuit creation shown in [Figure 1-30 on page 1-81](#), the following procedure must be performed.

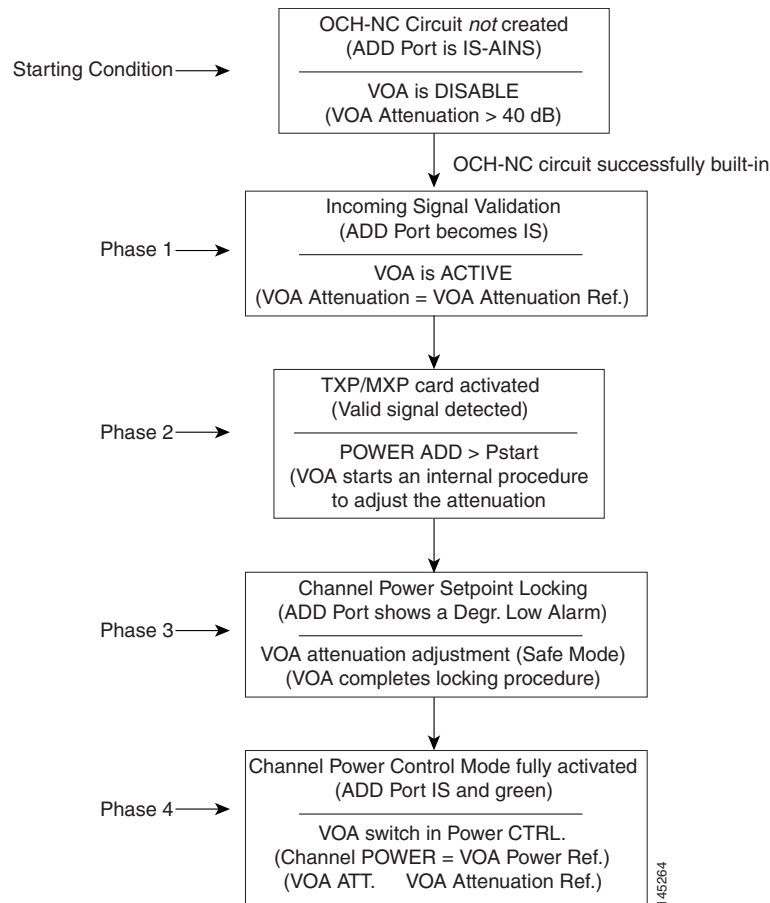
Figure 1-32 VOA Startup Procedure

The final VOA condition is achieved through a startup procedure divided into the four sequential phases shown in [Figure 1-32](#).

Until the VOA has completed all the phases shown in [Figure 1-32](#), the power control mode is not fully activated.

When the power is lower than expected, the start-up procedure can stop at Phase 1, Phase 2, or Phase 3 (see [Figure 1-32](#)). The point at which the start-up procedure stops depends on the amount of power missing.

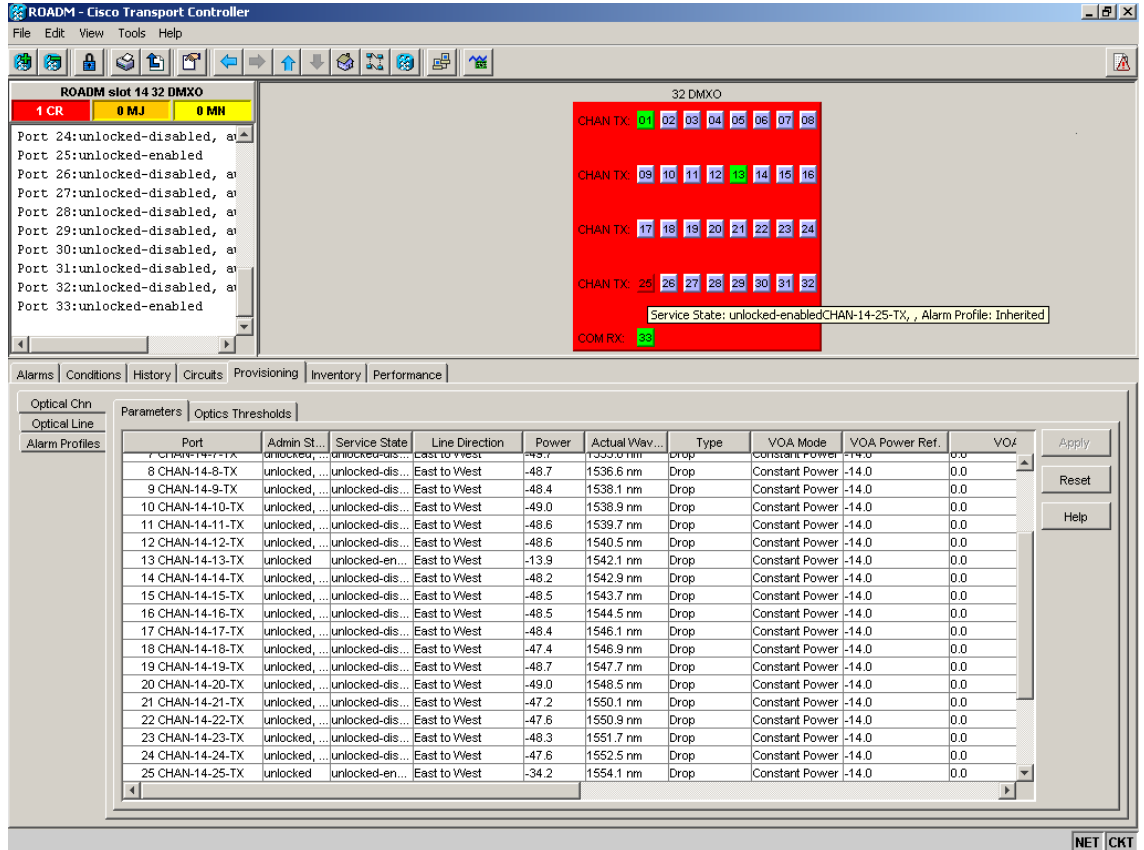
Figure 1-37 Optical Drop Power Less than 6 dB Lower than Expected

A dirty connection or excessive loss of the incoming span are among the possible reasons that can lead to a fault condition. They are the most common and affect all wavelengths, whereas an excessive amplifier gain tilt or a wavelength misconfiguration on the far-end TXP or MXP card can lead to condition where only a single wavelength fails, such as the one (Channel 25) shown in Figure 1-37.

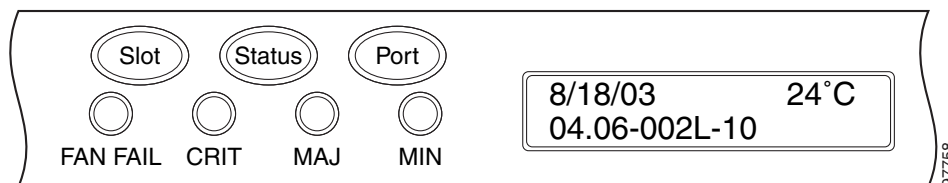
Figure 2-1 Shelf LCD Panel

- Step 1** View the temperature displayed on the ONS system LCD front panel. For example, the ONS 15454 front panel is illustrated in [Figure 2-1](#).

-
- Step 1** Check for any outstanding alarms that were raised against the active and standby TCC2/TCC2P and resolve them.
- Step 2** If the alarm does not clear, determine whether the LCD display on the fan tray ([Figure 2-1 on page 2-63](#)) is blank or if the text is garbled. If so, proceed to [Step 8](#). If not, continue with [Step 3](#).
- Step 3** At the earliest maintenance window, reset the standby TCC2/TCC2P:

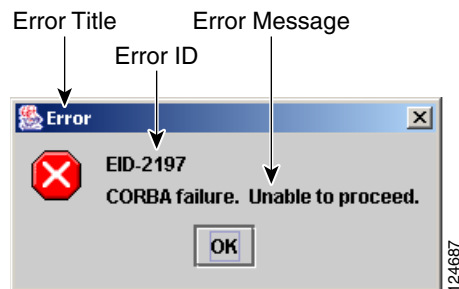
Figure 4-1 Error Dialog Box

This chapter lists the error messages for the Cisco ONS 15454 Multi-Service Transport Platform (MSTP). The error dialog box in [Figure 4-1](#) consists of three parts: the error title, error ID, and error message.
