Alarm Troubleshooting

This chapter gives a description, severity, and troubleshooting procedure for each commonly encountered Cisco DWDM alarm and condition. Tables 2-1 through 2-5 provide lists of DWDM alarms organized by severity. Table 2-6 on page 2-7 provides a list of alarms organized alphabetically. Table 2-7 gives definitions of all DWDM alarm logical objects, which are the basis of the alarm profile list in Table 2-8 on page 2-13. For a comprehensive list of all conditions and instructions for using TL1 commands, refer to the *Cisco SONET TL1 Command Guide*.

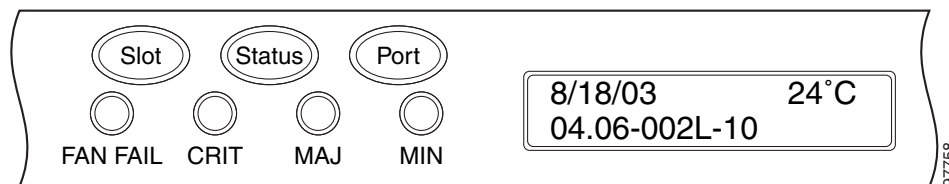
Figure 2-1 Shelf LCD Panel

- Step 1** View the temperature displayed on the ONS system LCD front panel. For example, the ONS 15454 front panel is illustrated in [Figure 2-1](#).

-
- Step 1** Check for any outstanding alarms that were raised against the active and standby TCC2/TCC2P and resolve them.
- Step 2** If the alarm does not clear, determine whether the LCD display on the fan tray ([Figure 2-1 on page 2-67](#)) is blank or if the text is garbled. If so, proceed to [Step 8](#). If not, continue with [Step 3](#).
- Step 3** At the earliest maintenance window, reset the standby TCC2/TCC2P:
