CHAPTER 1

General Troubleshooting

This chapter provides procedures for troubleshooting the most common problems encountered when operating a Cisco ONS 15454 DWDM shelf in ANSI or ETSI platforms. To troubleshoot specific alarms, see [Chapter 2, “Alarm Troubleshooting.”](#) If you cannot find what you are looking for, contact Cisco Technical Support (1-800-553-2447).

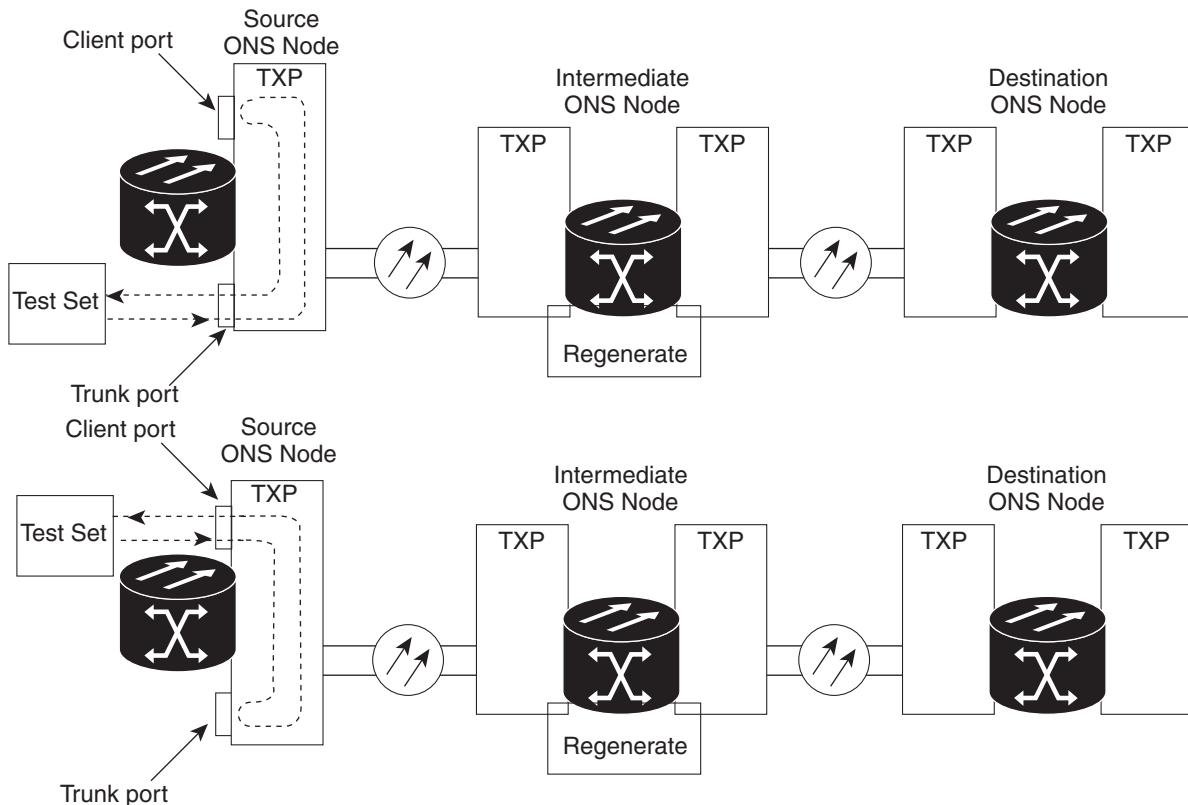
The terminal loopback test is performed on the node source MXP, TXP, XP, or ADM-10G port. For the circuit in this example, it is the source TXP trunk port or a client port in the source node. Completing a successful terminal loopback to a node source port verifies that the circuit is through the source port. [Figure 1-4](#) shows an example of a terminal loopback on a source TXP port and a client TXP port.

Figure 1-4 Terminal Loopback on a Source-Node MXP or TXP Port

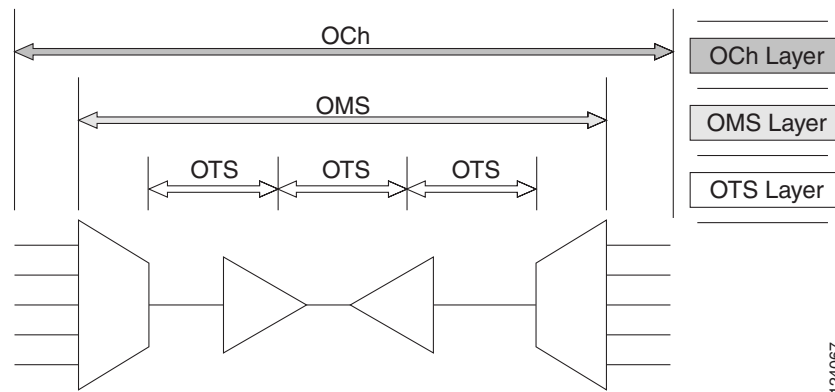
Like traditional SONET networks, ITU-T G.709 optical networks have a layered design (Figure 1-9). This structure enables localized monitoring that helps you isolate and troubleshoot network problems.

Figure 1-9 Optical Transport Network Layers
