## **Cisco ONS 15454 Troubleshooting Guide**

Product and Documentation Release 9.0  
September 2010

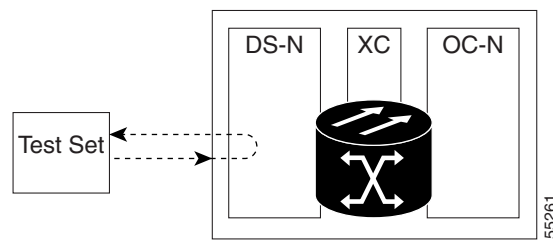
**Figure 1-1 Facility Loopback Path on a Near-End DS-N Card**

A facility loopback tests the line interface unit (LIU) of a card, the electrical interface assembly (EIA), and related cabling. After applying a facility loopback on a port, use a test set to run traffic over the loopback. A successful facility loopback isolates the LIU, the EIA, or the cabling plant as the potential cause of a network problem. [Figure 1-1](#) shows a facility loopback on a DS-N electrical card.

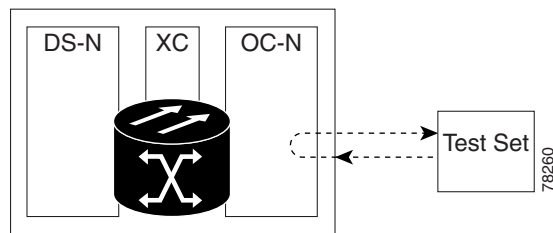
**Figure 1-2 Facility Loopback Path on a Near-End OC-N Card**

To test an OC-N card LIU, connect an optical test set to the OC-N port and perform a facility loopback. Alternately, use a loopback or hairpin circuit on a card that is farther along the circuit path. [Figure 1-2](#) shows a facility loopback on an OC-N card.

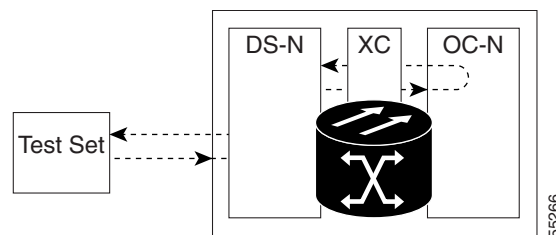
**Figure 1-4** Terminal Loopback Path on an OC-N Card

A terminal loopback tests a circuit path as it passes through the cross-connect card and loops back from the card with the loopback. [Figure 1-4](#) shows a terminal loopback on an OC-N card. The test-set traffic comes into the electrical port and travels through the cross-connect card to the optical card. The terminal loopback on the optical card turns the signal around before it reaches the LIU and sends it back through the cross-connect card to the electrical card. This test verifies that the cross-connect card and terminal circuit paths are valid, but does not test the LIU on the optical card.

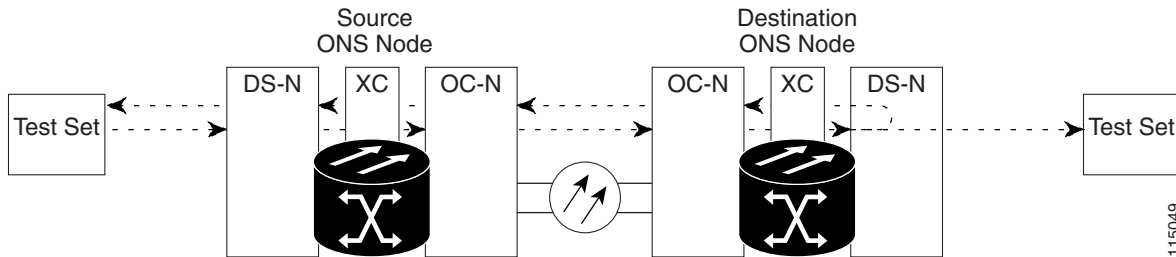
**Figure 1-7 Terminal Loopback on a DS-N Card with a Bridged Signal**

Bridged DS-N and OC-N terminal loopback examples are shown in [Figure 1-7](#) and [Figure 1-8](#).

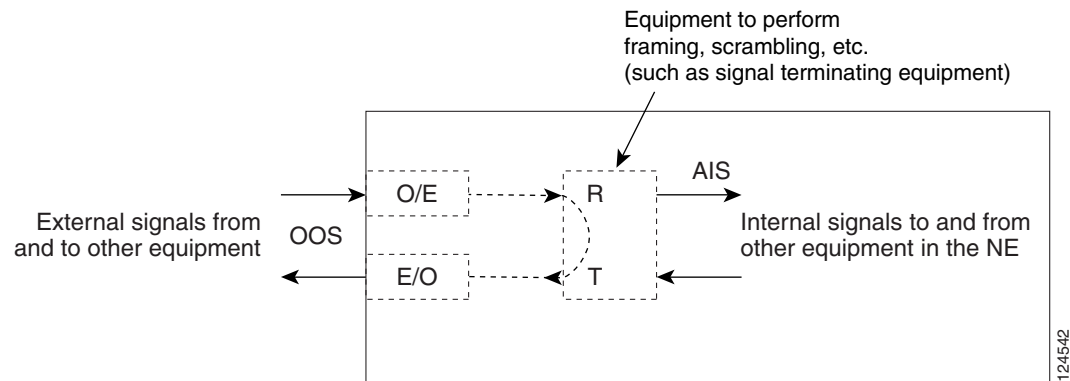
**Figure 1-10 Network Element with SONET Cross-Connect Loopback Function**

The XC loopback breaks down the existing path and creates a new cross-connect—a hairpin—while the source of the original path is set to inject a line-side AIS-P. The loopback signal path and AIS injection are shown in Figure 1-10.

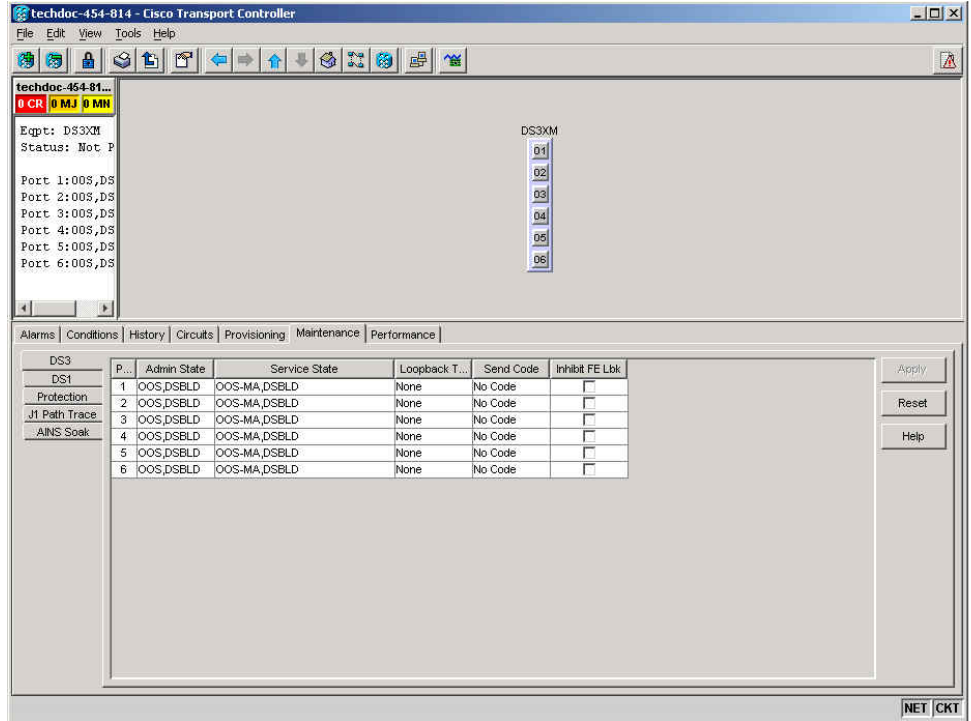
Figure 1-19 Accessing FEAC Functions on the DS3XM-6 Card

The DS3XM-6 card and DS3XM-12 cards support FEAC functions that are not available on basic DS-3 cards. Click the DS3XM-6 or DS3XM-12 **Maintenance > DS1** tabs at the card view to reveal the two additional function columns. [Figure 1-19](#) shows the DS3 subtab and the additional Send Code and Inhibit FE Lbk function columns.

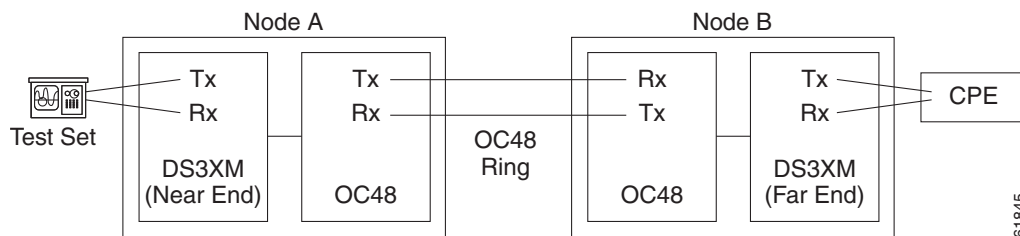
Figure 1-20 Diagram of FEAC Circuit

The “far end” in FEAC refers to the equipment connected to the DS3XM card and not to the far end of a circuit. In Figure 1-20, if a DS3XM-6 (near-end) port is configured to send a line loop code, the code will be sent to the connected test set, not the DS3XM-6 (far-end) port.

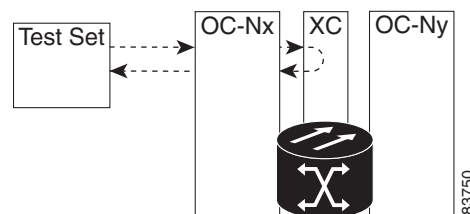
The XC loopback test occurs on the cross-connect card in a network circuit. Completing a successful XC loopback from an OC-N card through the cross-connect card eliminates the cross-connect card as the source of trouble for a faulty circuit. [Figure 1-24](#) shows an example of an XC loopback path on a source OC-N port.

**Figure 1-24** XC Loopback on a Source OC-N Port

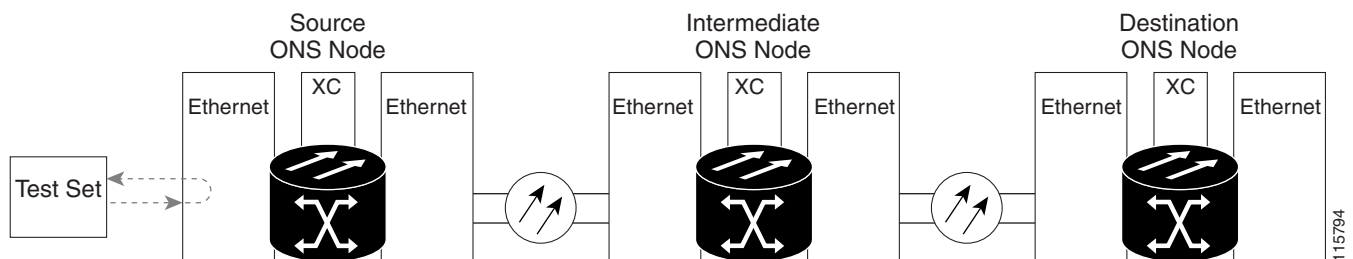
The facility loopback test is performed on the node source port in the network circuit. In the testing situation used in this example, the source G-Series port in the source node. Completing a successful facility loopback on this port isolates the G-Series port as a possible failure point. [Figure 1-21](#) shows an example of a facility loopback on a circuit source Ethernet port.

**Figure 1-30** Facility Loopback on a Circuit Source Ethernet Port

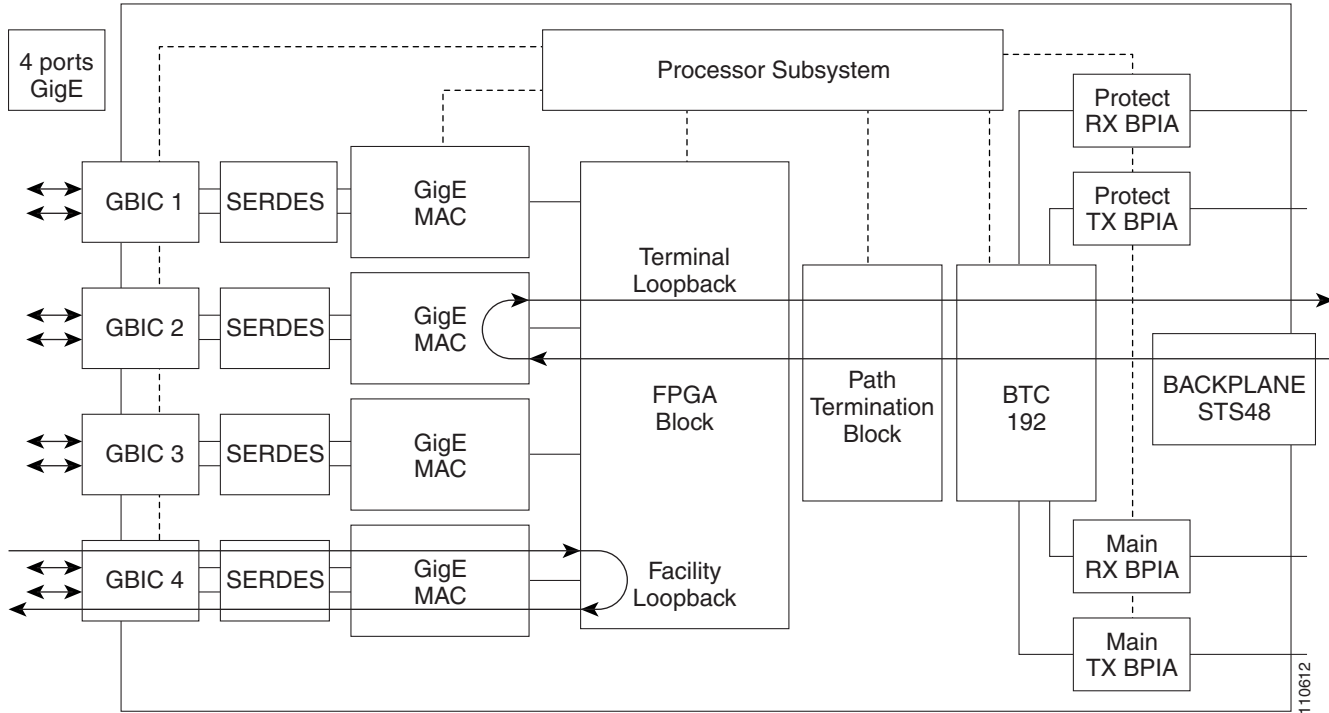
The terminal loopback test is performed on the node source Ethernet port. For the circuit in this example, it is the source G-Series port in the source node. You first create a bidirectional circuit that starts on the node destination G-Series port and loops back on the node source G-Series port. You then proceed with the terminal loopback test. Completing a successful terminal loopback to a node source port verifies that the circuit is good to the source port. [Figure 1-31](#) shows terminal loopback on a G-Series port.

Figure 1-31 Terminal Loopback on a G-Series Port

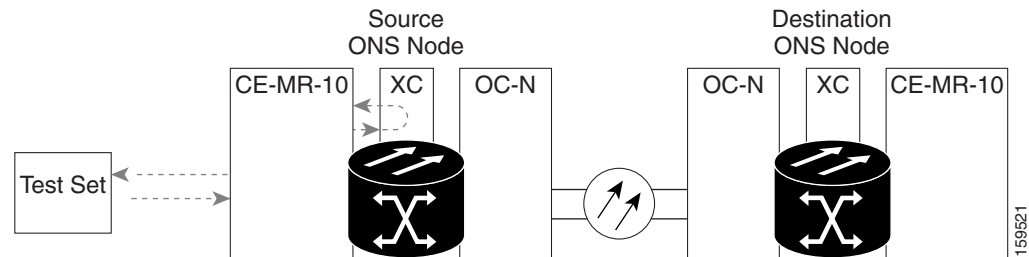
The hairpin test is performed on the cross-connect card in the network circuit. A hairpin circuit uses the same port for both source and destination. Completing a successful hairpin through the port isolates the possibility that the cross-connect card is the cause of the faulty circuit. [Figure 1-32](#) shows an example of a hairpin loopback on a source-node port.

**Figure 1-32** Hairpin on a Source-Node Ethernet Port

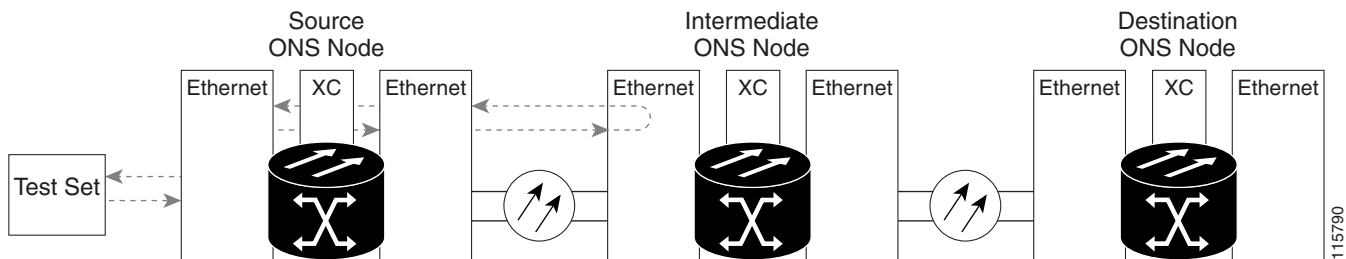
Performing the facility loopback test on an intermediate port isolates whether this node is causing circuit failure. It is shown in [Figure 1-33](#).

**Figure 1-33 Facility Loopback on an Intermediate-Node Ethernet Port**

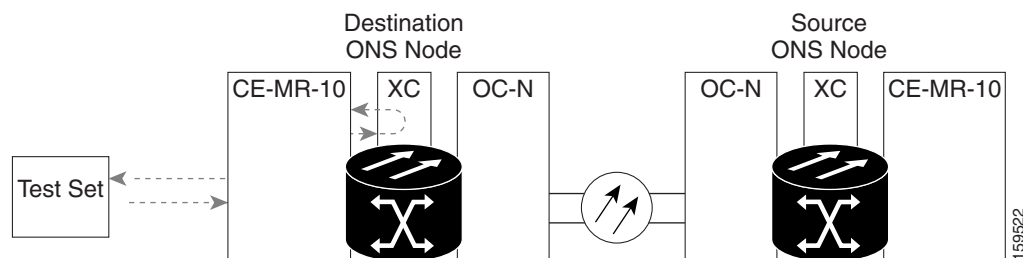
The hairpin test is performed on the cross-connect card in the network circuit. A hairpin circuit uses the same port as source as well as destination. Completing a successful hairpin through the card isolates the possibility that the cross-connect card is the cause of the faulty circuit. [Figure 1-37](#) shows an example of a hairpin loopback on a destination-node port.

**Figure 1-37** Hairpin on a Destination-Node Ethernet Port

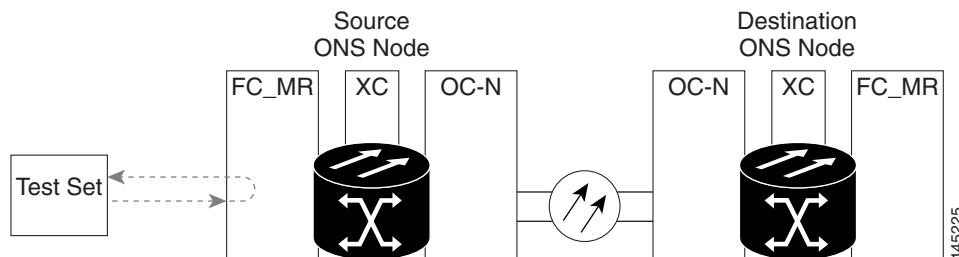
[Figure 1-38](#) shows an example of a facility loopback on a circuit source FC\_MR port.

**Figure 1-38 Facility Loopback on a Circuit Source FC\_MR Port**

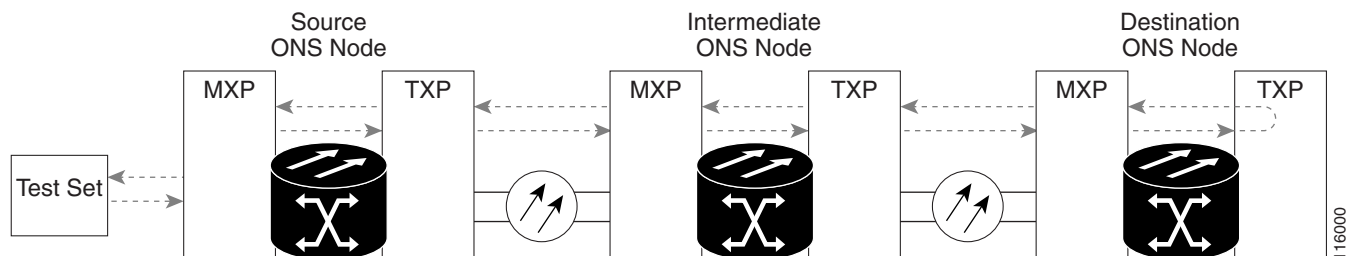
The terminal loopback at the destination-node port is the final local hardware error elimination in the circuit troubleshooting process. If this test is completed successfully, you have verified that the circuit is good up to the destination port. The example in [Figure 1-43](#) shows a terminal loopback on an intermediate-node destination FC\_MR port.

**Figure 1-43** Terminal Loopback on a Destination-Node FC\_MR Port

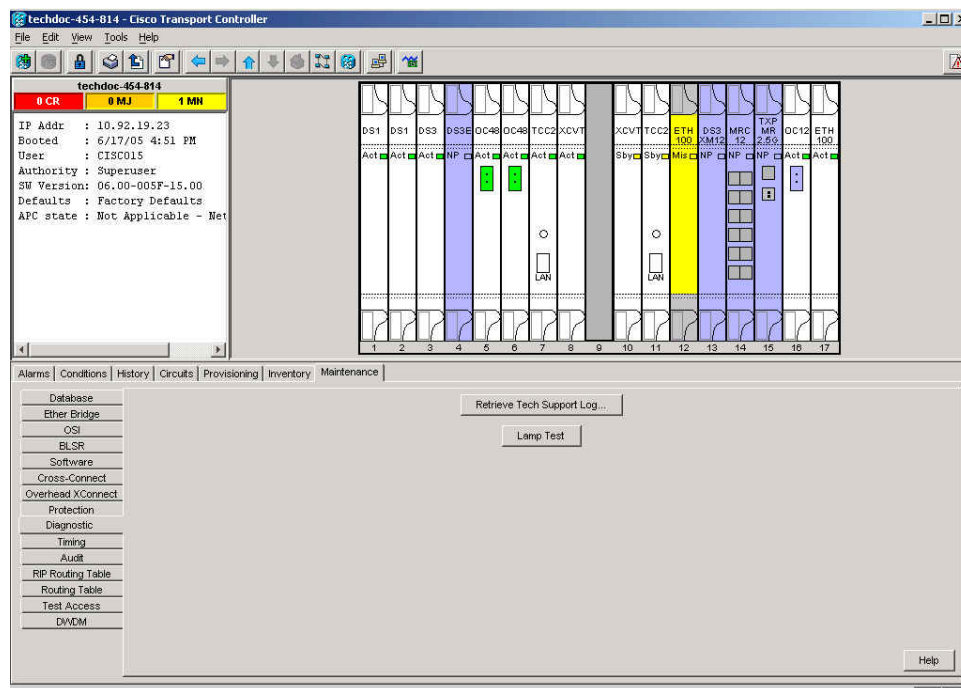
**Step 1** In node view, click the **Maintenance > Diagnostic** tabs (Figure 1-44).

**Figure 1-44** CTC Node View Diagnostic Window

**Step 1** In the node view, click the **Maintenance > Diagnostic** tabs (Figure 1-44).

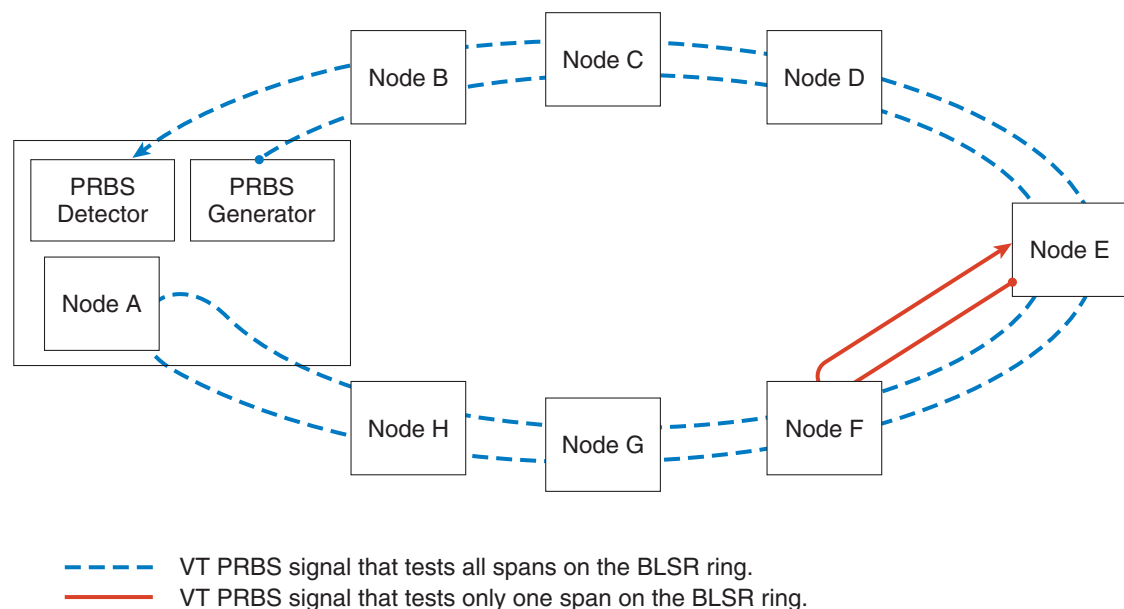
- Step 2** Resend test traffic on the loopback circuit with a known-good card.
- Step 3** If the test set indicates a good circuit, the problem was probably the defective card. Return the defective card to Cisco through the RMA process. Contact Cisco Technical Support at 1 800 553-2447.

The diagnostic circuit can be configured for an end-to-end or multiple-node path layout, traversing the transmit and receive standby paths as shown in [Figure 1-45](#).

NOTE: The end without the arrow is where the PRBS pattern is generated. The end with the arrow is the end where the PRBS pattern is detected.

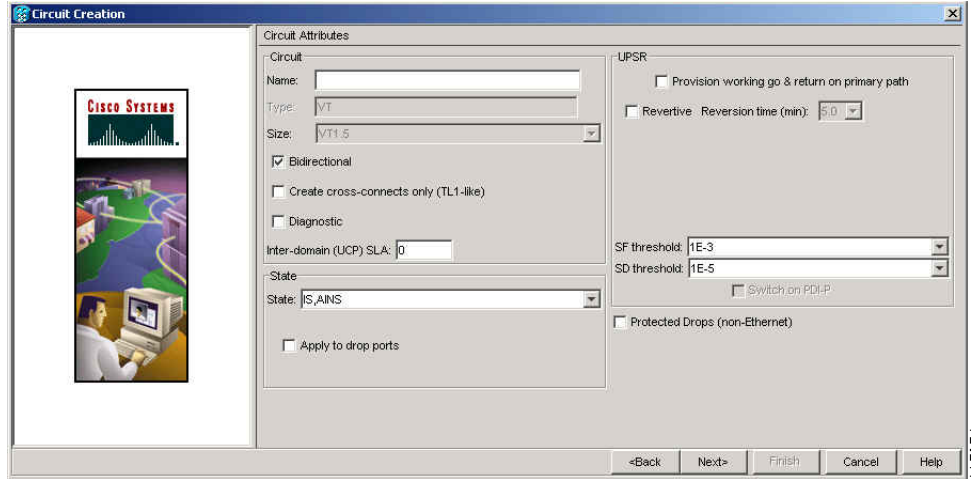
- Step 6** Click **Next**.
- Step 7** Define the circuit attributes in the Circuit Creation Dialog Box ([Figure 1-46](#)) using the following parameters:

Figure 1-46 Network View Circuit Creation Dialog Box

- Name—Assign a name to the circuit. The name can be alphanumeric and up to 48 characters, (including spaces). Circuit names should be 44 characters or less if you want the ability to create monitor circuits. If you leave the field blank, CTC assigns a default name to the circuit.
- Size—VT1.5 is the default. You cannot change it.
- Bidirectional—This is the default value. Leave it checked for this circuit.
- State—This option is not available when you check the Diagnostic option.
- Diagnostic—Check this box to create a diagnostic circuit.
- Apply to drop ports—Leave this box unchecked.
- Create cross-connects only (TL1-like)—Not applicable to diagnostic circuits.
- Inter-domain (UCP) SLA—Not applicable to diagnostic circuits.
- Protected Drops—Not applicable to diagnostic circuits.

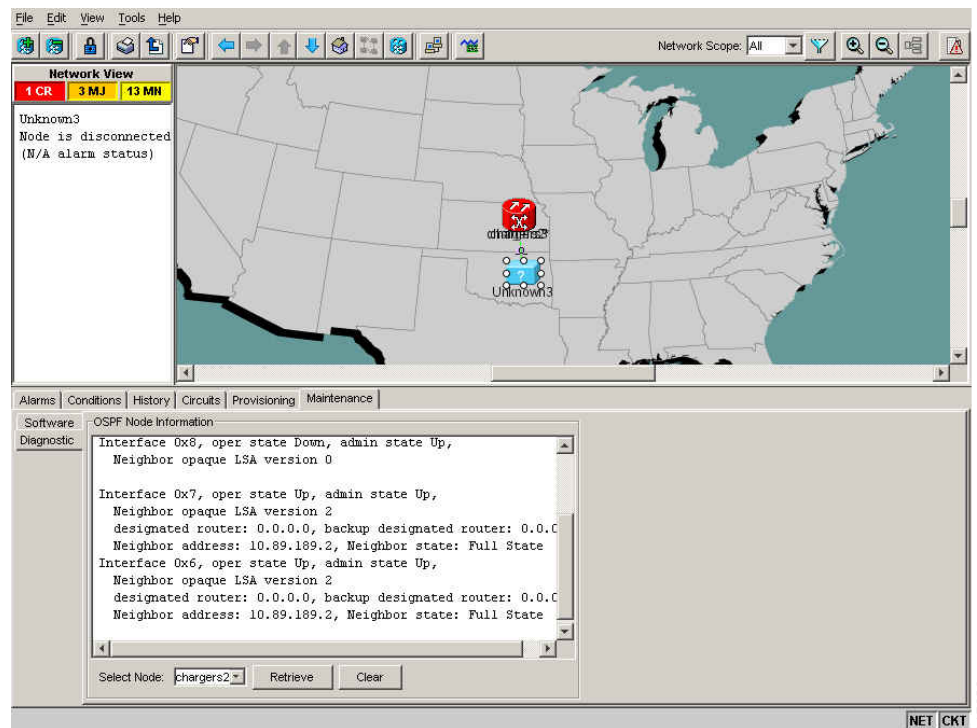
CTC contains a data communications network (DCN) tool that assists with network troubleshooting for Open Shortest Path First (OSPF) networks. This tool, located in network view, is shown in Figure 1-47. It executes an internal dump command to retrieve information about all nodes accessible from the entry point.

**Figure 1-47** DCN Tools OSPF Dump

The dump, which provides the same information as a dump executed by special networking commands, is available at the network view in the Maintenance > Diagnostic tabs. You can select the access point node in the Select Node drop-down list. To create the dump, click Retrieve. (To clear the dump, click Clear.)

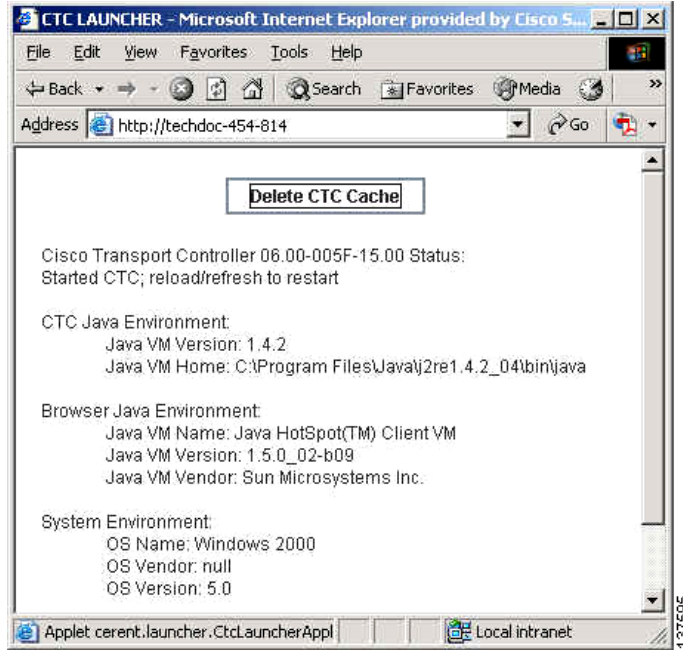
- 
- Step 1** Enter an ONS 15454 IP address into the browser URL field. The initial browser window shows a **Delete CTC Cache** button.
  - Step 2** Close all open CTC sessions and browser windows. The PC operating system does not allow you to delete files that are in use.
  - Step 3** Click **Delete CTC Cache** on the initial browser window to clear the CTC cache. [Figure 1-48](#) shows the Delete CTC Cache window.

Figure 1-48 Deleting the CTC Cache

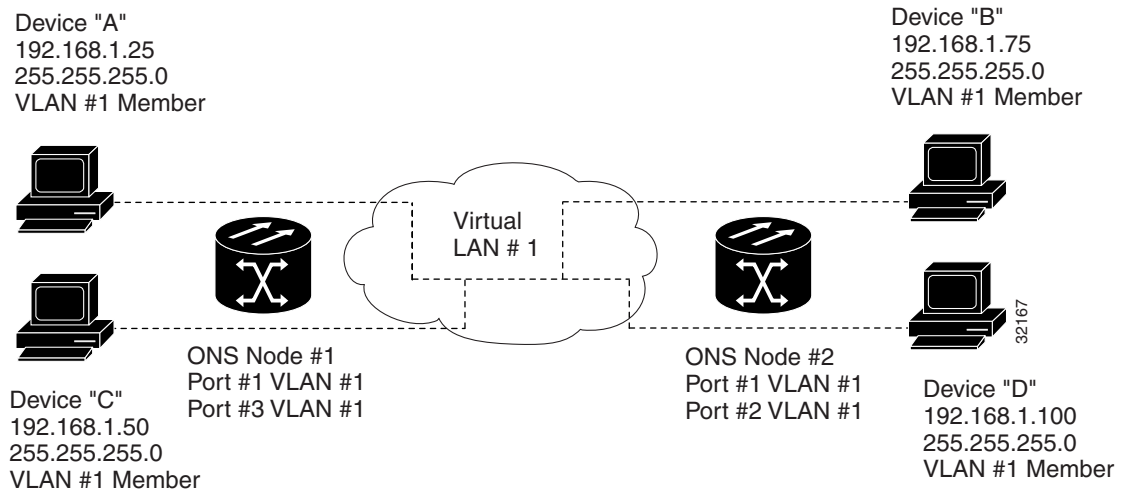
**Recommended Action** You can fix most connectivity problems in an Ethernet network by following a few guidelines. See [Figure 1-49](#) when using the steps in the “Verify Ethernet Connections” procedure on page 1-132.

**Figure 1-49 Ethernet Connectivity Reference**

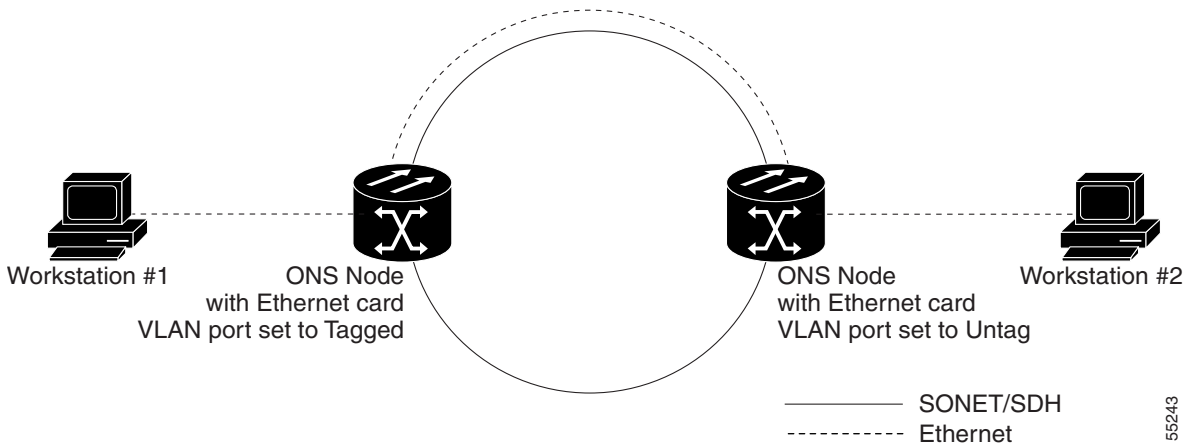
**Symptom** Networks that have a VLAN with one ONS 15454 Ethernet card port set to Tagged and one ONS 15454 Ethernet card set to Untag might have difficulty implementing Address Resolution Protocol (ARP) for a network device attached to the Untag port ([Figure 1-50](#)). They might also see a higher than

**Recommended Action** The solution is to set both ports in the VLAN to Tagged to stop the stripping of the 4 bytes from the data packet and prevent the NIC card in the network access device from recognizing the packet as a runt and dropping it. Network devices with IEEE 802.1Q-compliant NIC cards accept the tagged packets. Network devices with non IEEE 802.1Q compliant NIC cards still drop these tagged packets. The solution might require upgrading network devices with non-IEEE 802.1Q compliant NIC cards to IEEE 802.1Q compliant NIC cards. You can also set both ports in the VLAN to Untag, but you will lose IEEE 802.1Q compliance.

Figure 1-50 VLAN with Ethernet Ports at Tagged and Untag

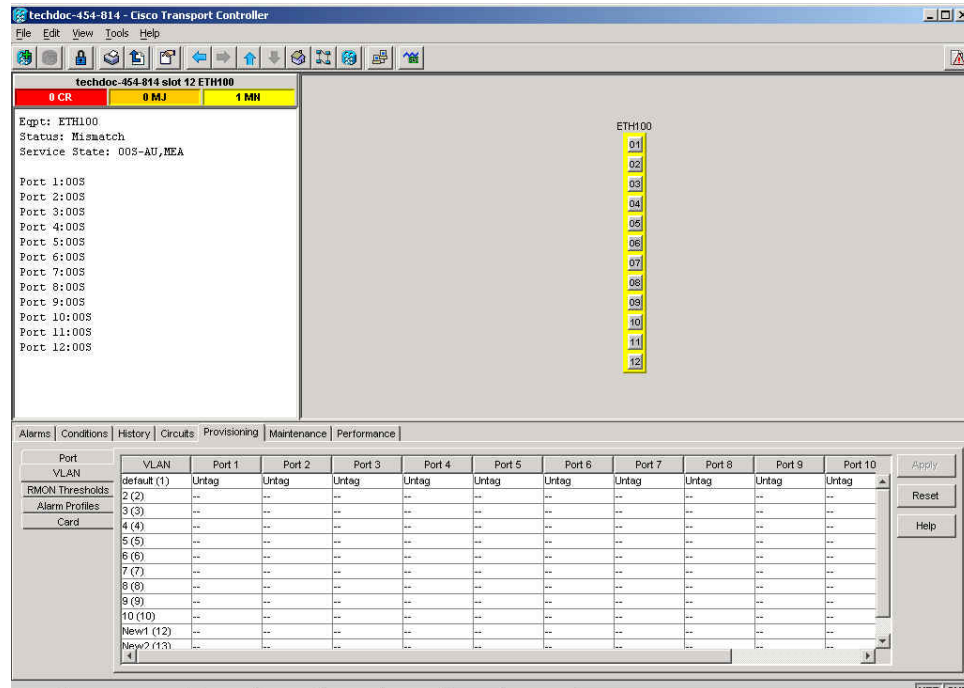
- 
- Step 1** Open the CTC card view for the Ethernet card involved in the problem VLAN.
  - Step 2** Click the **Provisioning > Ether VLAN** tabs (Figure 1-51).

Figure 1-51 Configuring VLAN Membership for Individual Ethernet Ports

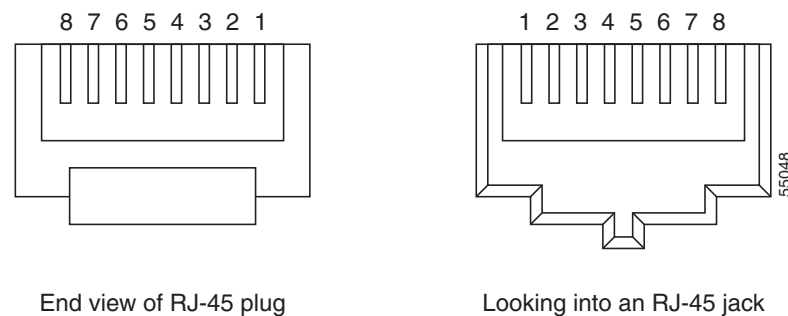
You can crimp your own LAN cables for use with the ONS 15454. Use a cross-over cable when connecting an ONS 15454 to a hub, LAN modem, or switch, and use a LAN cable when connecting an ONS 15454 to a router or workstation. Use Category-5 cable RJ-45 T-568B, Color Code (100 Mbps), and a crimping tool. [Figure 1-52](#) shows the wiring of an RJ-45 connector. [Figure 1-53](#) shows a LAN cable layout, and [Table 1-6](#) shows the cable pinouts. [Figure 1-54](#) shows a cross-over cable layout, and [Table 1-7](#) shows the cross-over pinouts.

**Figure 1-52 RJ-45 Pin Numbers**

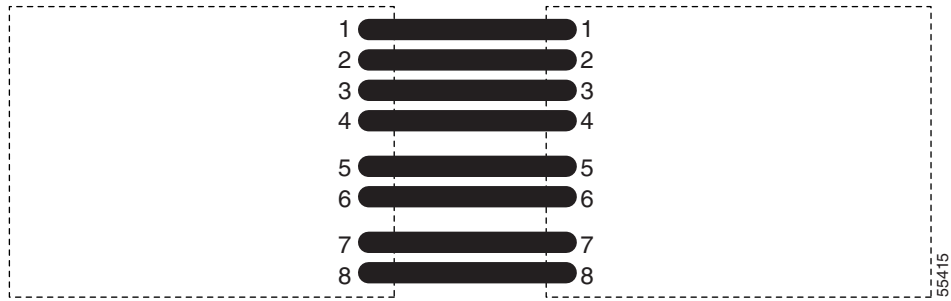
**Figure 1-53 LAN Cable Layout**

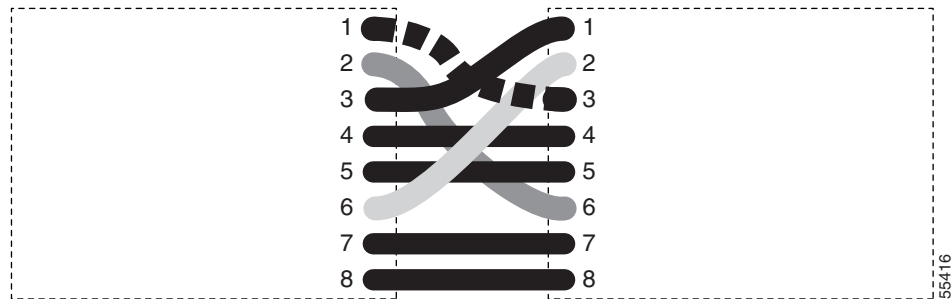
**Figure 1-54 Cross-Over Cable Layout**

Pin	Color	Pair	Name	Pin
1	white/orange	2	Transmit Data +	3
2	orange	2	Transmit Data –	6
3	white/green	3	Receive Data +	1
4	blue	1	—	4
5	white/blue	1	—	5
6	green	3	Receive Data –	2

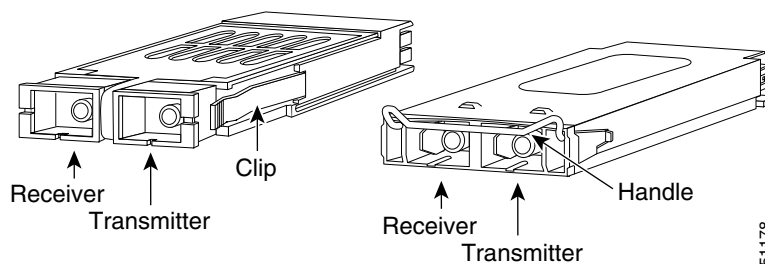
**Figure 1-55** GBICs

GBICs are available in two different models. One GBIC model has two clips (one on each side of the GBIC) that secure the GBIC in the slot on the E1000-2-G, G-Series, or G1K-4 card. The other model has a locking handle. Both models are shown in [Figure 1-55](#).

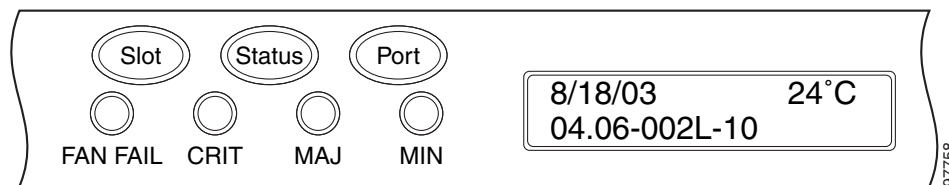
**Figure 2-1 Shelf LCD Panel**

- Step 1** View the temperature displayed on the ONS 15454 LCD front panel (Figure 2-1).

- Step 2** If the temperature of the shelf exceeds 194 degrees F (90 degrees C), the alarm should clear if you solve the ONS 15454 temperature problem. Complete the [“Clear the HITEMP Alarm” procedure on page 2-128](#).
- Step 3** If the temperature of the shelf is under 194 degrees F (90 degrees C), the HITEMP alarm is not the cause of the AUTOLSROFF alarm. Complete the [“Physically Replace a Traffic Card” procedure on page 2-281](#) for the OC-192 card.
- Step 4** If card replacement does not clear the alarm, call Cisco TAC 1 800 553-2447 to discuss the case and if necessary open a returned materials authorization (RMA) on the original OC-192 card.

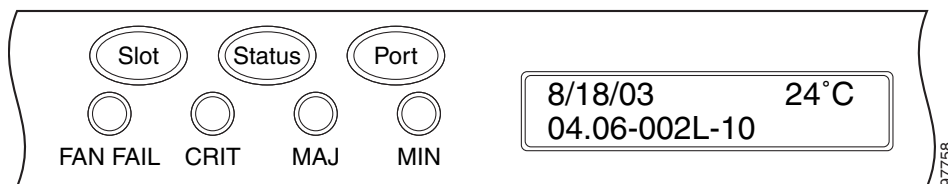
**Figure 2-2 Shelf LCD Panel**

- Step 1** View the temperature displayed on the ONS 15454 LCD front panel ([Figure 2-2](#)).

- Step 2** Verify that the environmental temperature of the room is not abnormally high.
- Step 3** If the room temperature is not abnormal, physically ensure that nothing prevents the fan-tray assembly from passing air through the ONS 15454 shelf.
- Step 4** If airflow is not blocked, physically ensure that blank faceplates fill the ONS 15454 shelf empty slots. Blank faceplates help airflow.
- Step 5** If faceplates fill the empty slots, determine whether the air filter needs replacement. Refer to the [“Inspect, Clean, and Replace the Reusable Air Filter” procedure on page 2-286](#).
- Step 6** If the fan does not run or the alarm persists, complete the [“Replace the Fan-Tray Assembly” procedure on page 2-288](#).

- 
- Step 1** Check for any outstanding alarms that were raised against the active and standby TCC2/TCC2P and resolve them.
- Step 2** If the alarm does not clear, determine whether the LCD display on the fan tray ([Figure 2-2 on page 2-128](#)) is blank or if the text is garbled. If so, proceed to [Step 8](#). If not, continue with [Step 3](#).
- Step 3** At the earliest maintenance window, reset the standby TCC2/TCC2P:
