CHAPTER 1

General Troubleshooting

This chapter provides procedures for troubleshooting the most common problems encountered when operating a Cisco ONS 15454 DWDM shelf in ANSI or ETSI platforms. To troubleshoot specific alarms, see [Chapter 2, “Alarm Troubleshooting.”](#) If you cannot find what you are looking for, contact Cisco Technical Support (1-800-553-2447).

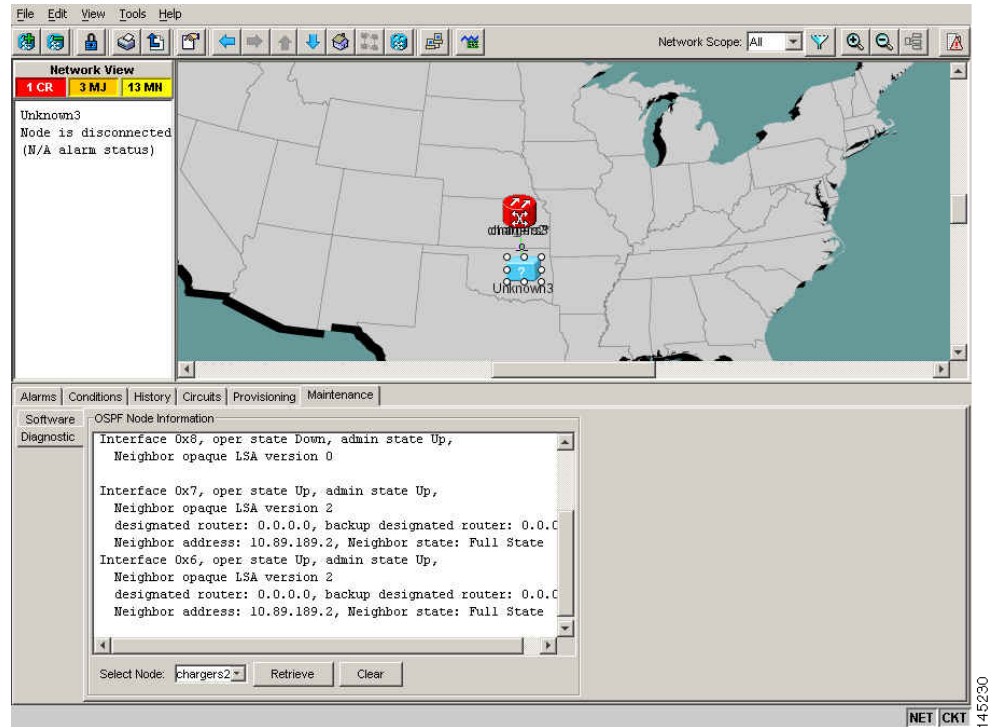
Figure 1-16 DCN Tools OSPF Dump

CTC contains a data communications network (DCN) tool that assists with network troubleshooting for Open Shortest Path First (OSPF) networks. This tool, located in network view, is shown in Figure 1-16. It executes an internal dump command to retrieve information about all nodes accessible from the entry point.

The dump, which provides the same information as a dump executed by special networking commands, is available at the network view in the Maintenance > Diagnostic tab. You can select the access point node in the Select Node drop-down list. To create the dump, click Retrieve. (To clear the dump, click Clear.)
