## **Troubleshooting Guide for Cisco NCS 1010, IOS XR Release 7.10.x**

**First Published:** 2023-08-18

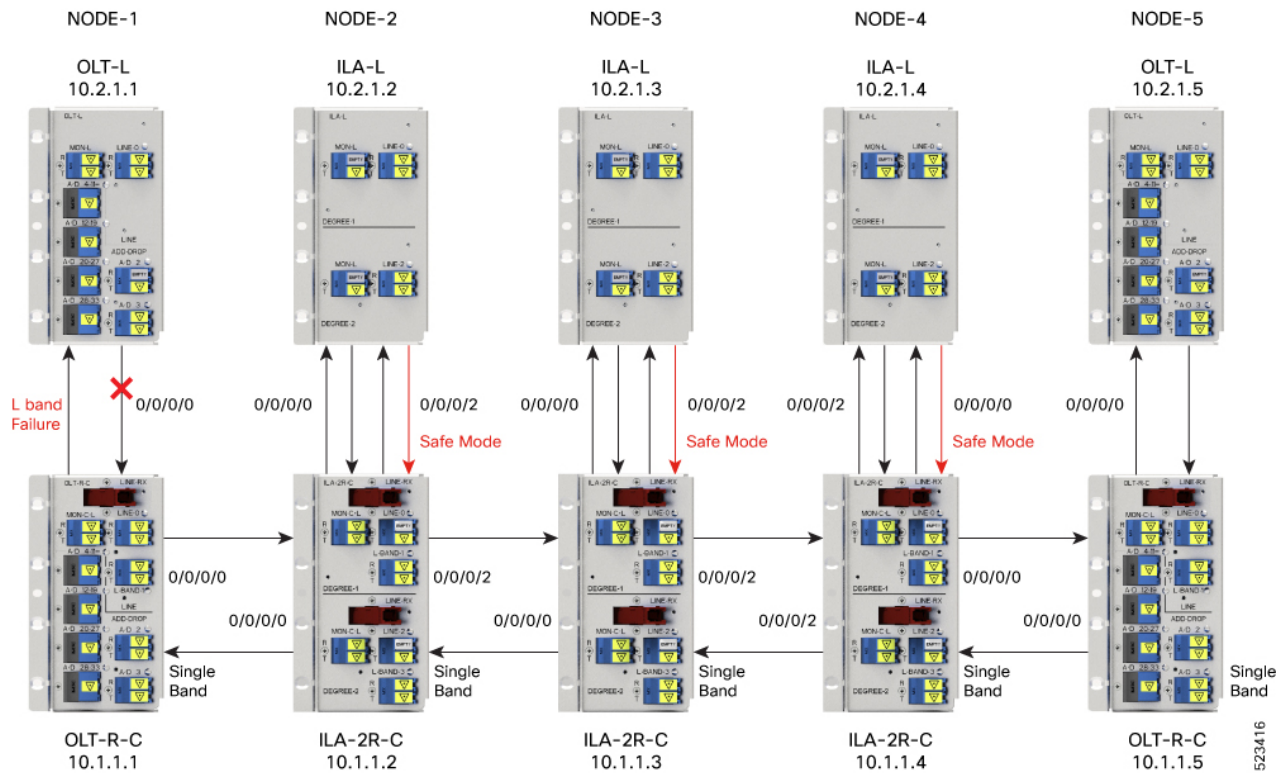
Figure 1: Example of L-band Failure

In this section, we will troubleshoot L band failure due to connectivity failure between OLT-C and OLT-L nodes. To troubleshoot L-band failure on a C+L band network, start by running the following commands on the manager nodes:

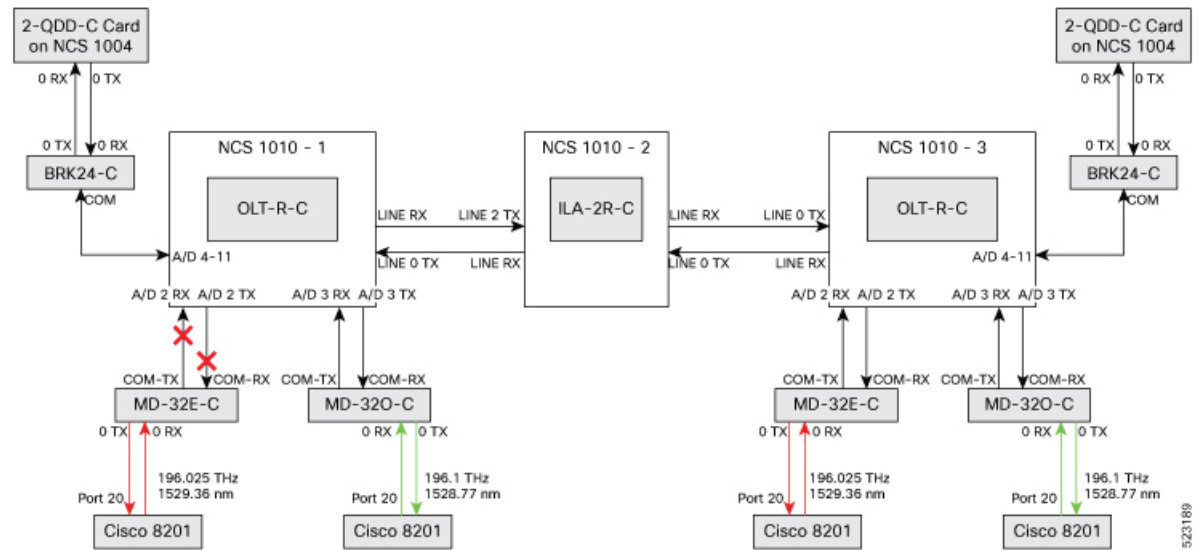
Figure 5: Fiber Cut at the AD Port OTS Controller and OMS Controller

The following figure displays client-side failure due to fiber cut:
