## **General Troubleshooting**

This chapter provides procedures for troubleshooting the most common problems encountered when operating the NCS 1020 chassis.

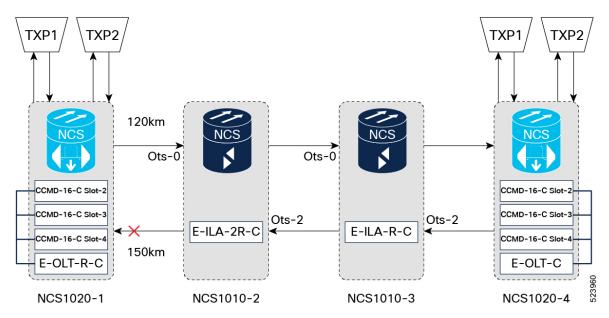
Figure 2: Fiber Cut at the Line OTS Controller

The following figure shows loss of fiber connection continuity at the Line port:
