Release Notes for the Catalyst 4900M Series Switch and the Catalyst 4948E Ethernet Switch, Cisco IOS Release 12.2(54)SGx and 12.2(53)SGx

12.2(53)SG11—August 18, 2014

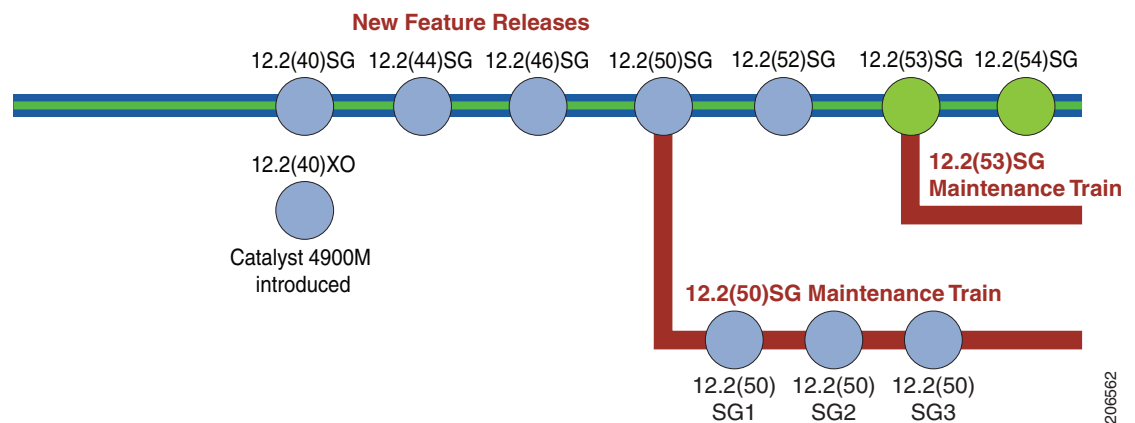
Figure 2 Software Release Strategy for the Catalyst 4900M Series Switch

Figure 2 displays the two active, 12.2(31)SGA and 12.2(50)SG, and newly introduced 12.2(53)SG extended maintenance trains.

Support for the Catalyst 4900M platform was introduced in 12.2(40)XO. Moving forward, the Cisco Catalyst 4900M platform has two maintenance trains. The Cisco IOS Release 12.2(53)SG is the latest maintenance train and includes the most recent features including support for OSPF for routed Access
