# Release Notes for the Catalyst 4500 Series Switch, Cisco IOS Release 12.2(46)SG1

**Current Release**  
12.2(46)SG1—Sept 15, 2008

These release notes describe the features, modifications, and caveats for the Cisco IOS software on the Catalyst 4500 series switch. The most current software release is Cisco IOS Release 12.2(46)SG1.

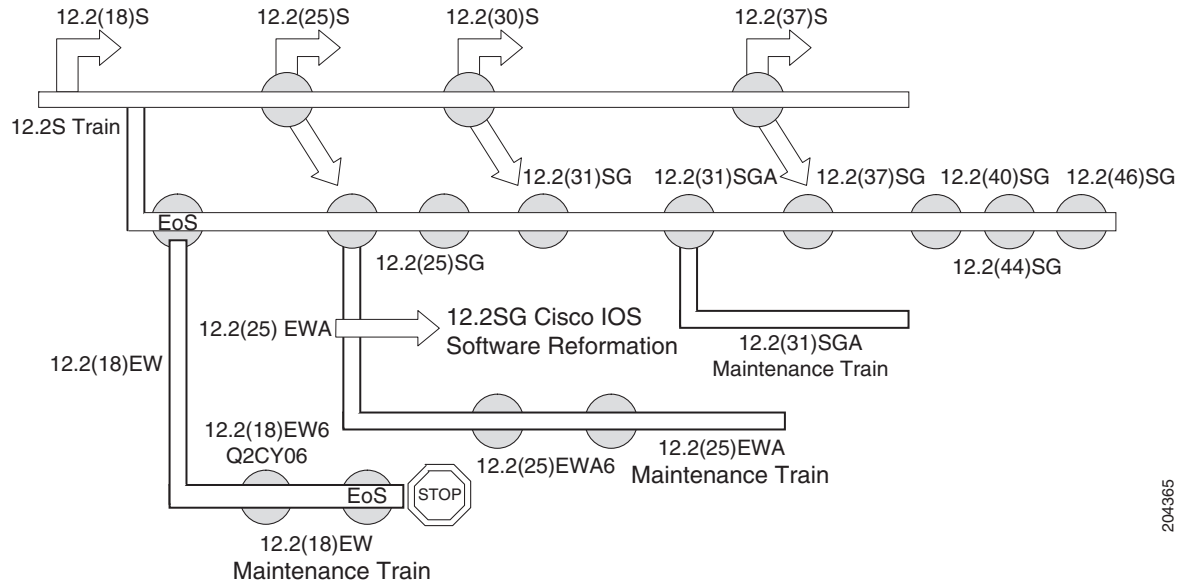
**Figure 1 Software Release Strategy for the Catalyst 4500 Series Switch**

[Figure 1](#) displays the Cisco IOS Software Release 12.2(46)SG plan relative to the 12.2S release train and identifies the recommended migration path. Note that 12.2(44)SG will not be the base release for a new maintenance train. Currently, the Cisco Catalyst 4500 platform has two active maintenance trains: 12.2(25)EWA and 12.2(31)SGA.

Catalyst 4500 Series has two maintenance trains. The Cisco IOS Release 12.2(25)EW train is the most stable train but only has features found in the Cisco IOS Release 12.2(25)EW. The Cisco IOS Release 12.2(31)SG train has more recent features including support for the WS-X4013+10GE supervisor engine. Currently, the Cisco IOS Release 12.2(31)SGA7 is the recommended release for customers desiring a release with a maintenance train.
