Release Notes for the Catalyst 4900M Series Switch, Cisco IOS Release 12.2(53)SG

12.2(53)SG2—March 23, 2010

These release notes describe the features, modifications, and caveats for Cisco IOS software on the Catalyst 4900M switch.

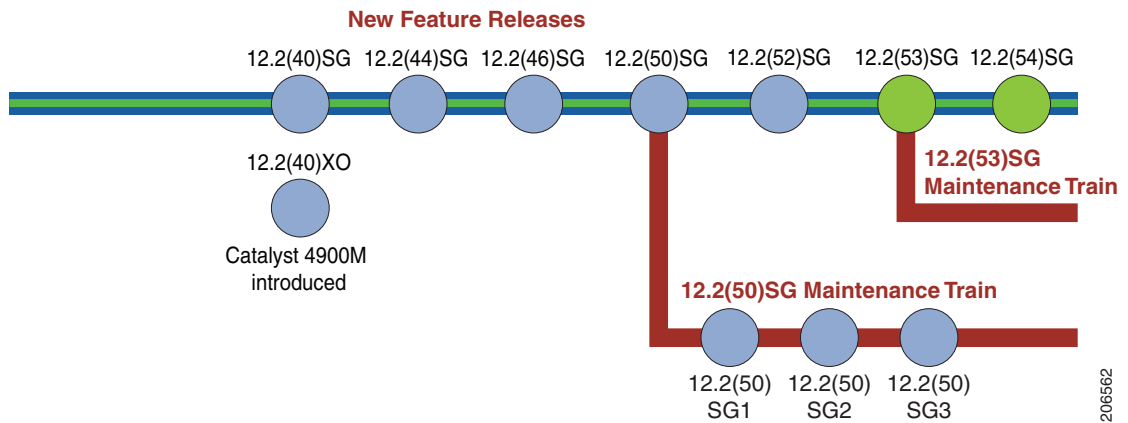
Figure 1 Software Release Strategy for the Catalyst 4900M Series Switch

Figure 1 displays the two active, 12.2(31)SGA and 12.2(50)SG, and newly introduced 12.2(53)SG extended maintenance trains.

Support for the Catalyst 4900M platform was introduced in 12.2(40)XO. Moving forward, the Cisco Catalyst 4900M platform has two maintenance trains. The Cisco IOS Release 12.2(53)SG is the latest maintenance train and includes the most recent features including support for OSPF for routed Access
