Release Notes for the Catalyst 4900M Series Switch and the Catalyst 4948E Ethernet Switch, Cisco IOS Release 15.1(1)SG

Current Release
IOS 15.1(1)SG2—November 1, 2012

These release notes describe the features, modifications, and caveats for Cisco IOS Release 15.1(1)SG on the Catalyst 4900M switch and the Catalyst 4948E Ethernet Switch.

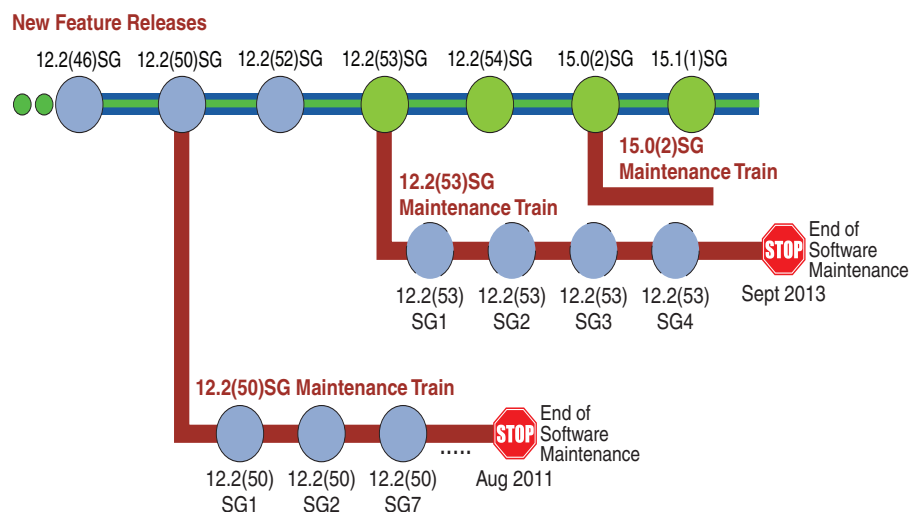
Figure 1 Software Release Strategy for the Catalyst 4900M Series Switch

The Catalyst 4900M Series Switch have has two maintenance trains: 12.2(53)SGx and 15.0(2)SGx. The Catalyst 4948E has one maintenance train: 15.0(2)SGx. Cisco IOS Release 15.0(2)SGx is the latest maintenance train. [Figure 1](#) displays the two active trains, 12.2(53)SG and 15.0(2)SG.
