Release Notes for Catalyst 4500 Series Switch Cisco IOS Release 12.1E

12.1(26)E3—August 22, 2005

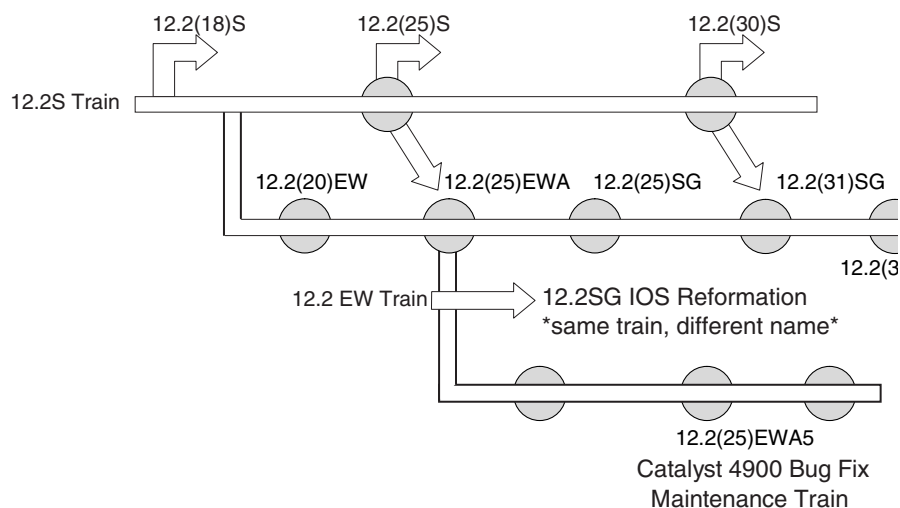
Figure 1 Software Release Strategy

Figure 1 shows the Catalyst 4500 series switch Cisco IOS release strategy.
