# Release Notes for the Catalyst 4900 Series Switch, Cisco IOS Release 12.2(54)SGx and 12.2(53)SGx

12.2(53)SG11—August 18,, 2014

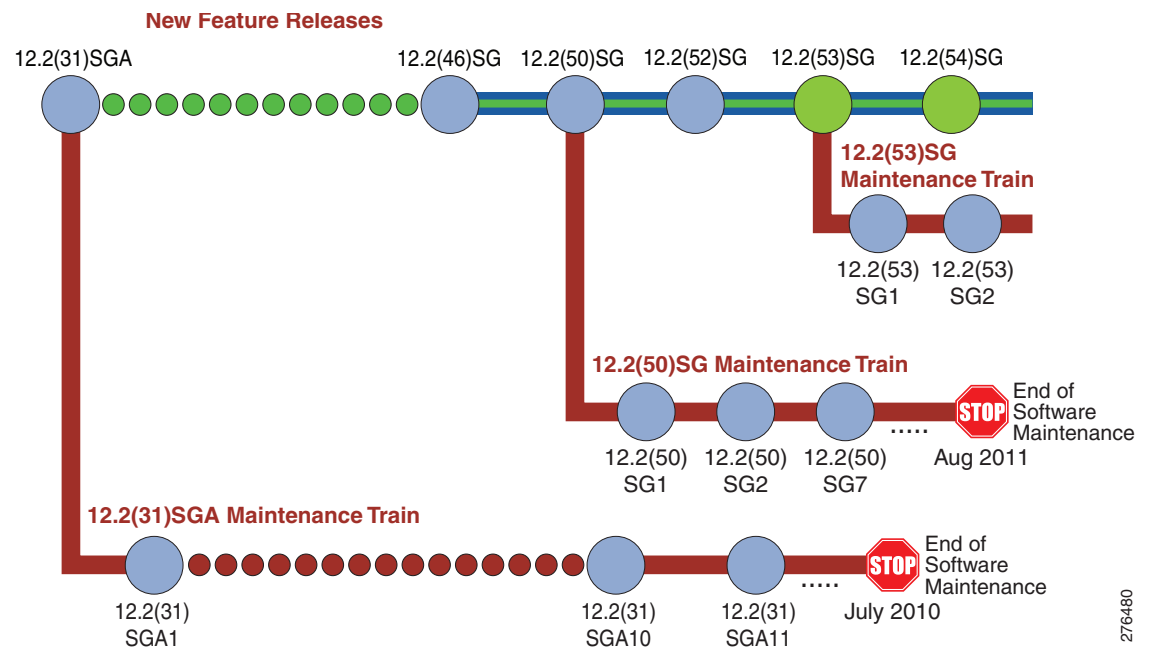
**Figure 1** Software Release Strategy for the Catalyst 4900 Series Switch

Figure 1 displays the two active, 12.2(31)SGA and 12.2(50)SG, and newly introduced 12.2(53)SG extended maintenance trains.

Catalyst 4900 Series has three maintenance trains. The Cisco IOS Release 12.2(31)SGA train is the longest living train. Currently, the Cisco IOS Release 12.2(31)SGA10 is the recommended release for customers who require a release with a maintenance train. The Cisco IOS Release 12.2(53)SG is the latest maintenance train.
