Release Notes for Cisco Wireless LAN Controllers and Lightweight Access Points for Release 7.3.112.0

OL-26898-03

These release notes describe what is new in this release, instructions to upgrade to this release, and open and resolved caveats for this release.

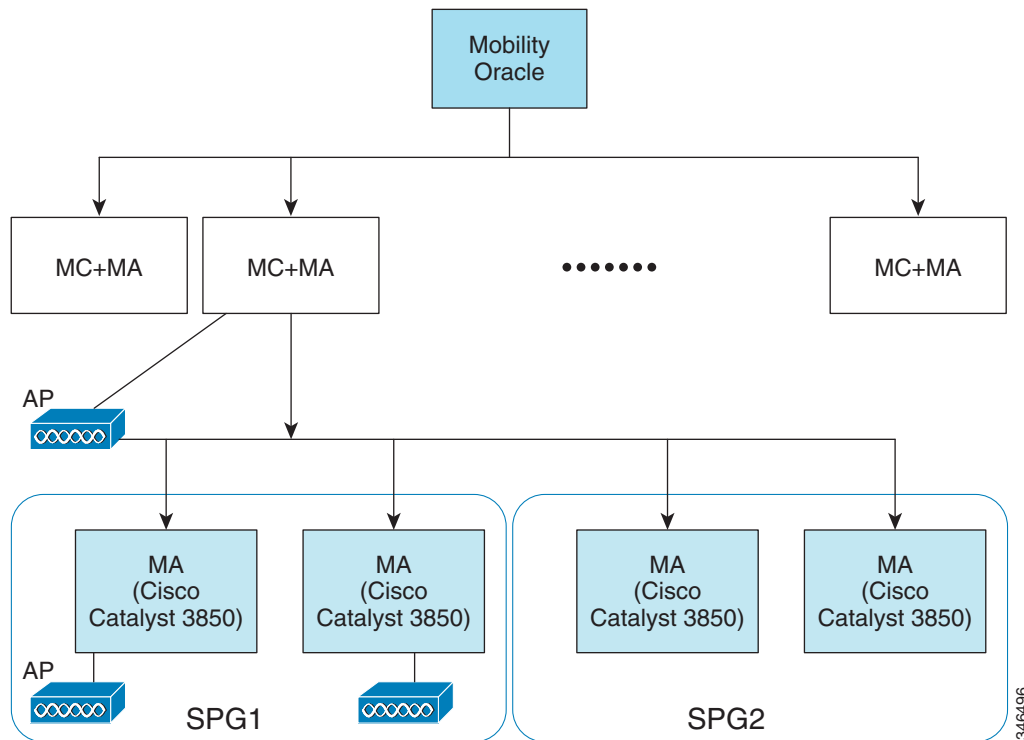
Figure 1 Architecture of Hierarchical Mobility

A group of 3850 catalyst switch MAs can form a switch peer group (SPG). The internal MA of 5500, WISM2, and 5760 controllers form an independent SPG. The MC, MA, and MO can be in a single 5500, WISM2, or 5760 controller. Each MC forms a subdomain that can have multiple SPGs. Cisco 5500 Series Wireless LAN Controller, Cisco WiSM2, or the Cisco 5760 Wireless LAN Controller are MA/MC, by default. However, Cisco Catalyst 3850 switch can function both as MA/MC or MA only. The keepalives between MC and MO are not DTLS encrypted. [Figure 1](#) shows the architecture of hierarchical mobility (also known as New Mobility). For more information, see [Compatibility Matrix with Mobility Network Elements](#). By default, hierarchical mobility is disabled. For seamless mobility, the controller should either use hierarchical mobility or old mobility (flat mobility). Interoperability between the two types of mobility is not supported. High availability for Mobility Oracle is not supported in this release.

Hierarchical Mobility is supported only on Cisco 5500 Series Wireless LAN Controllers and Cisco WiSM2.
