在HA中更换Catalyst 9000的Supervisor模块或堆叠成员

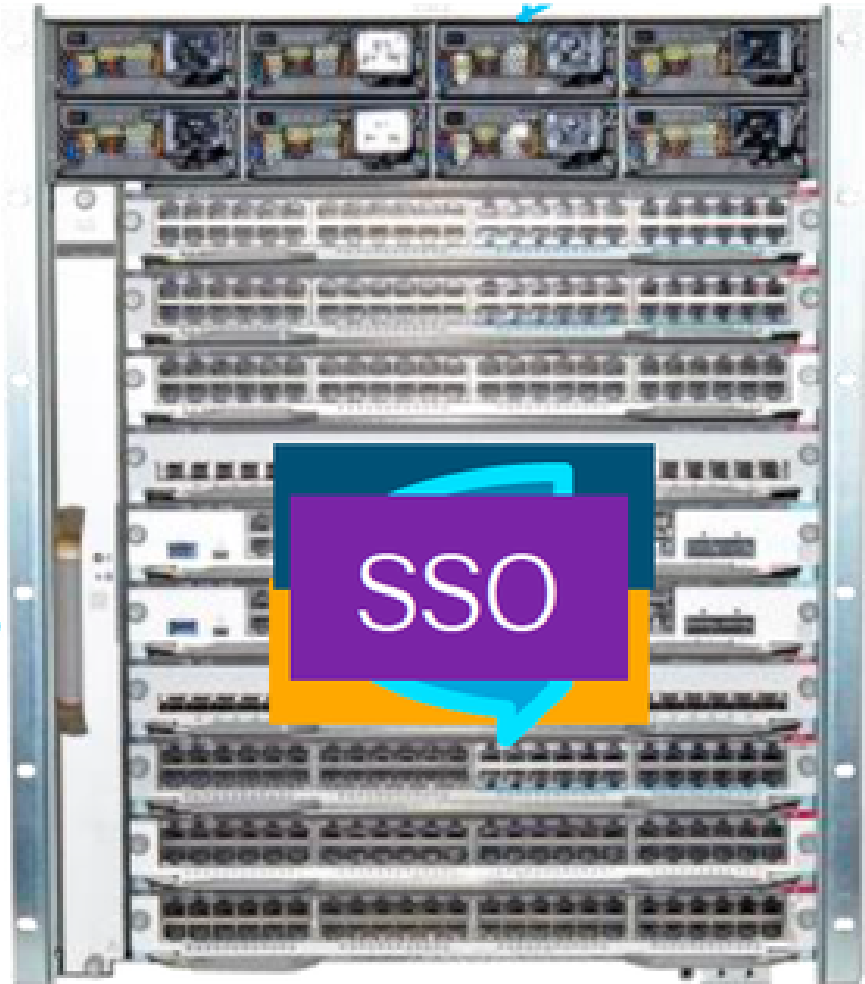
Catalyst 9400

在本示例中，您将更换C9404机箱的Active管理引擎。（本示例中的交换机在“安装”引导模式下用于插槽3。）

Active SUP
Standby SUP

如果需要替换主用Supervisor(如本示例中的我们)，请执行到备用管理引擎的故障转移，并等待它接管主用角色。如果要替换备用管理引擎，请跳过此步骤。

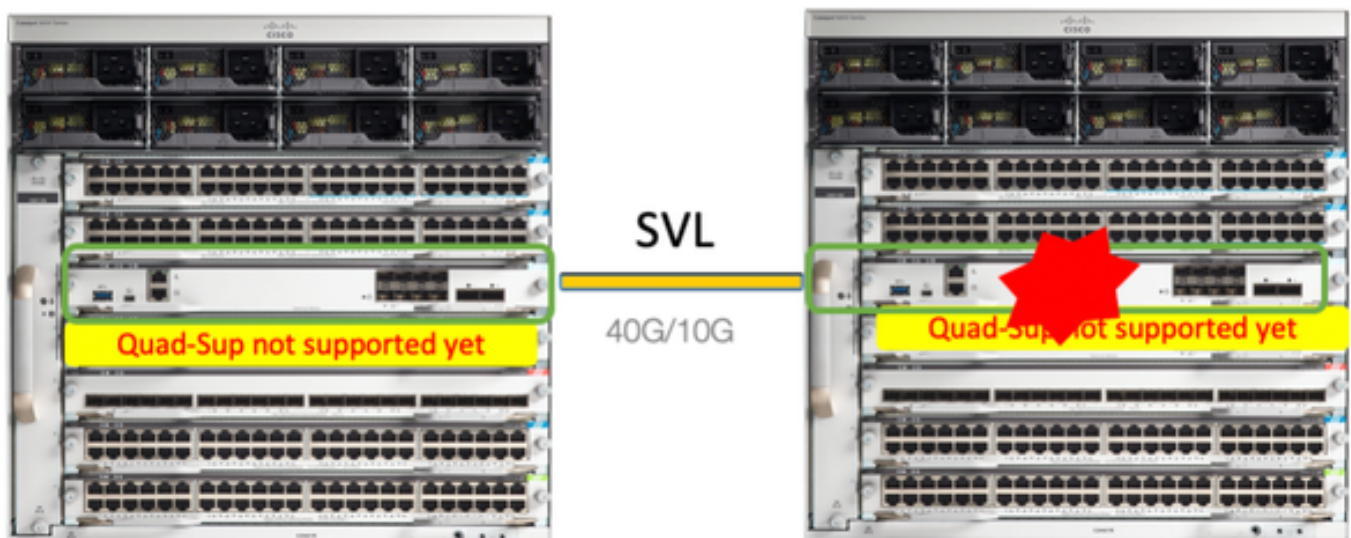
此示例适用于C9400 Stackwise虚拟设置（每个机箱一个管理引擎），其中机箱-1的管理引擎（活动交换机）已损坏，需要更换。SVL在“安装”引导模式下运行。

```
-----  
1          1          TenGigabitEthernet1/5/0/1 <<< switch 1 needs to be replaced here  
2          1          TenGigabitEthernet2/5/0/1
```

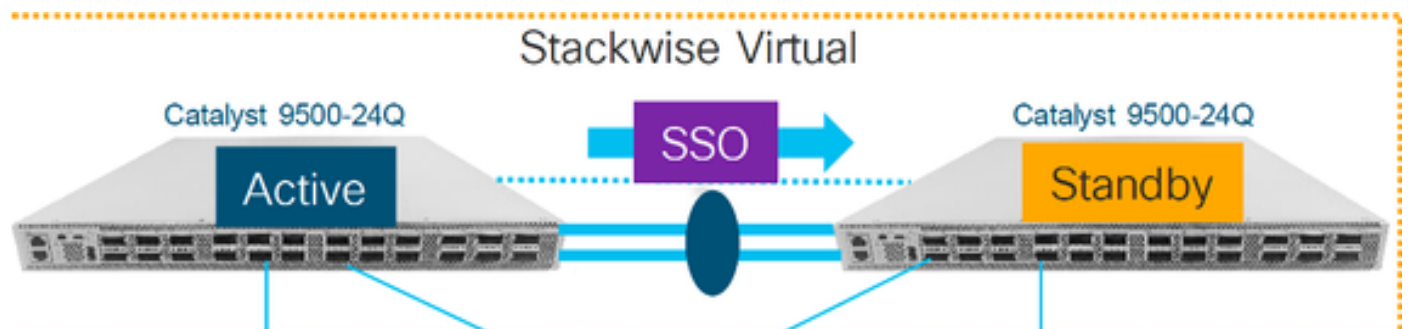
在本例中，您考虑将C9500 Stackwise虚拟设置中的Switch-1（活动交换机）作为需要更换的故障交换机。SVL在INSTALL引导模式下运行。

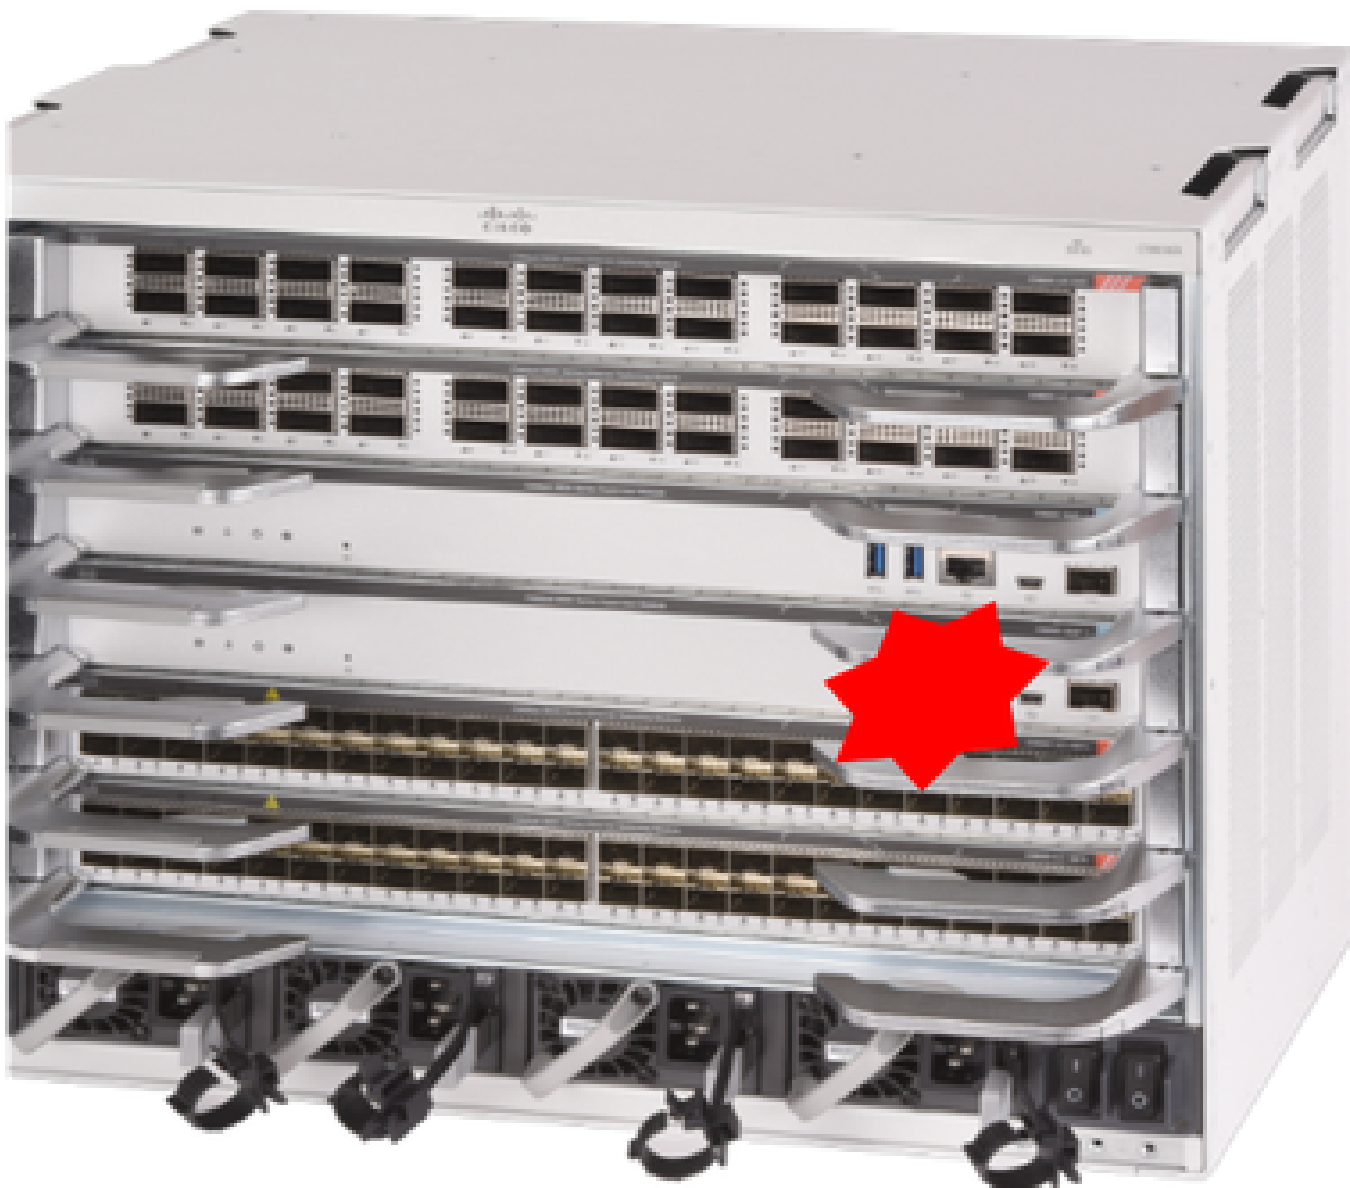
在本示例中，您正在考虑更换C9606机箱插槽3上的主用管理引擎。（交换机在“安装”引导模式下运行。）

如果需要替换主用Supervisor(如本例中的我们的)，请执行到备用Supervisor的故障切换，并等待它接管主用角色。（如果要更换备用Supervisor，请跳过此步骤）。

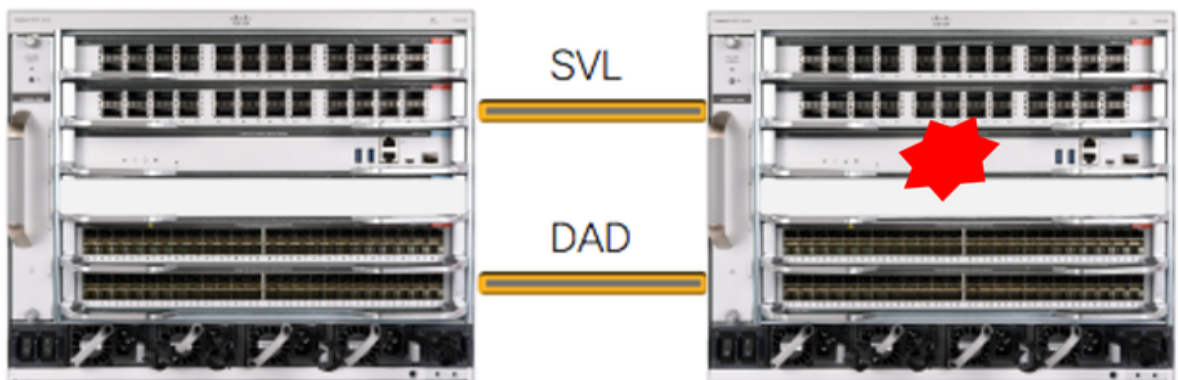
在本例中，您考虑的是C9600 Stackwise虚拟设置（每个机箱一个管理引擎），其中chassis-1的管理引擎（活动交换机）已损坏，需要更换。SVL在“安装”引导模式下运行。

```
<< supervisor of SW1 needs to be replaced
```

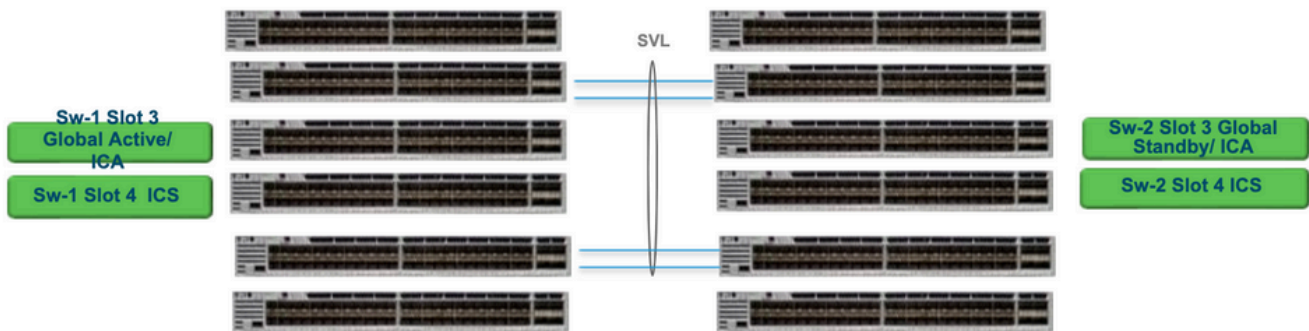
在本示例中，您考虑采用C9600 Quad Sup Stackwise-Virtual设置（每个机箱有两个管理引擎），管理引擎出现故障并需要更换。SVL在“安装”引导模式下运行。

- 如果要更换的Supervisor是Global Active Supervisor (图中所示为Sw-1插槽3) , 请执行故障切换, 以便全局备用 (上一图中的Sw-2插槽3) 接替Active。等待新的全局备用并完成SSO。(在本例中, Sw-1插槽4将成为新的全局备用插槽)。
- 如果要更换的Supervisor是Global Standby Supervisor (图中所示的Sw-2插槽3) , 请拔出Supervisor。等待新的全局备用并完成SSO。(在本例中, Sw-2插槽4将成为新的全局备用插槽)
- 如果要更换的Supervisor是ICS Supervisor (图中所示的Sw-1插槽4或Sw-2插槽4) , 请拔出Supervisor。
