在HA中更換Catalyst 9000的Supervisor模組或堆疊成員

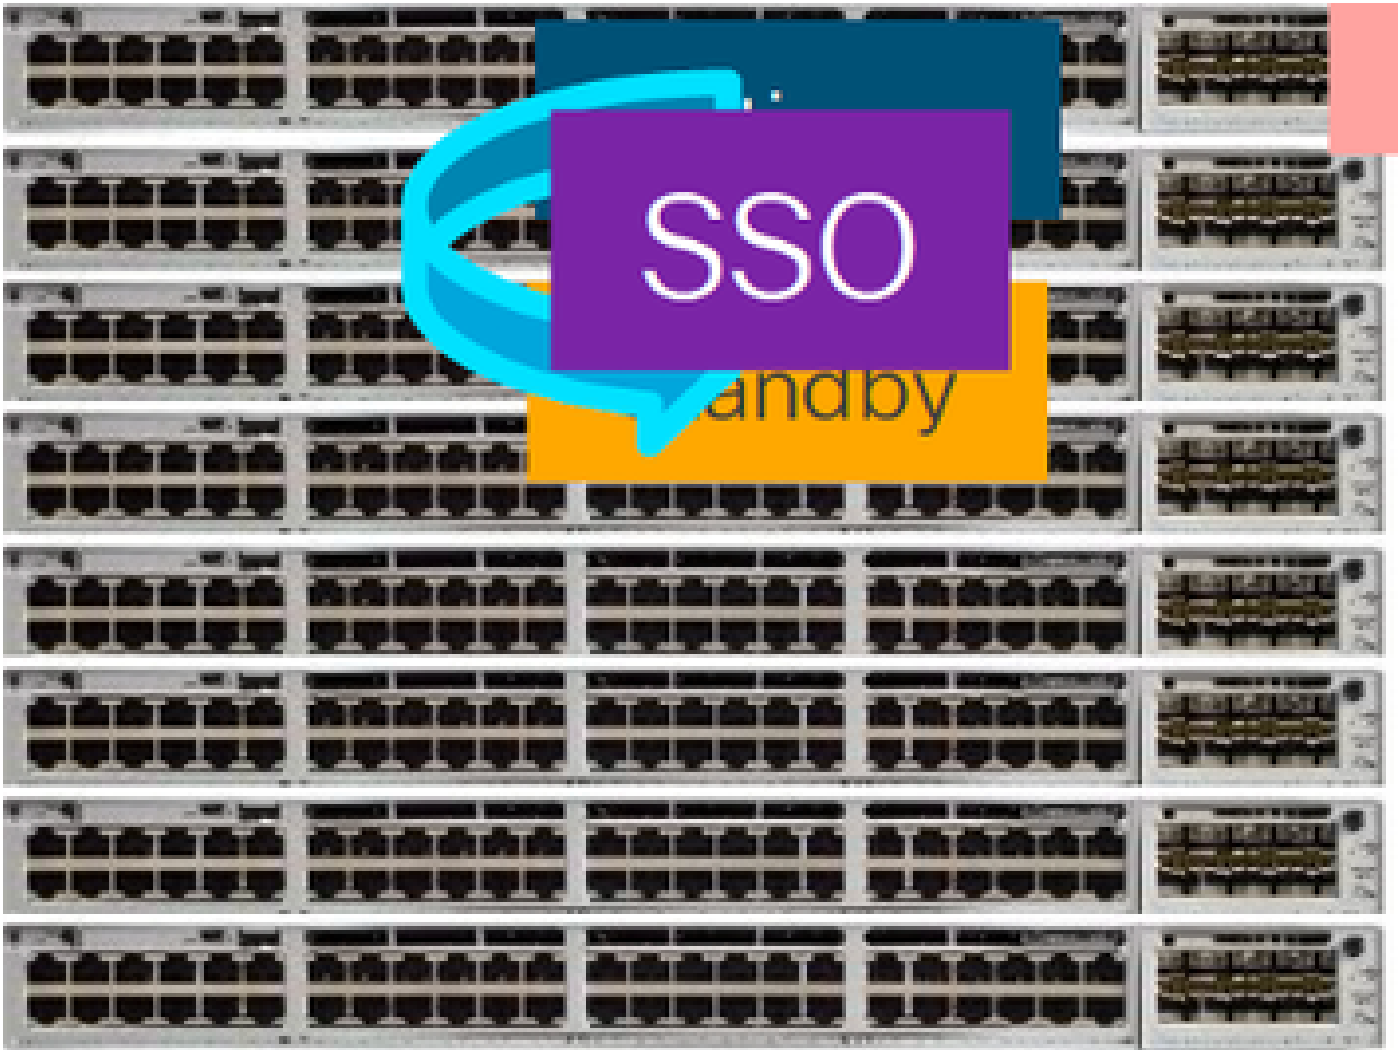
附註：同一過程可用於替換C9200堆疊成員。

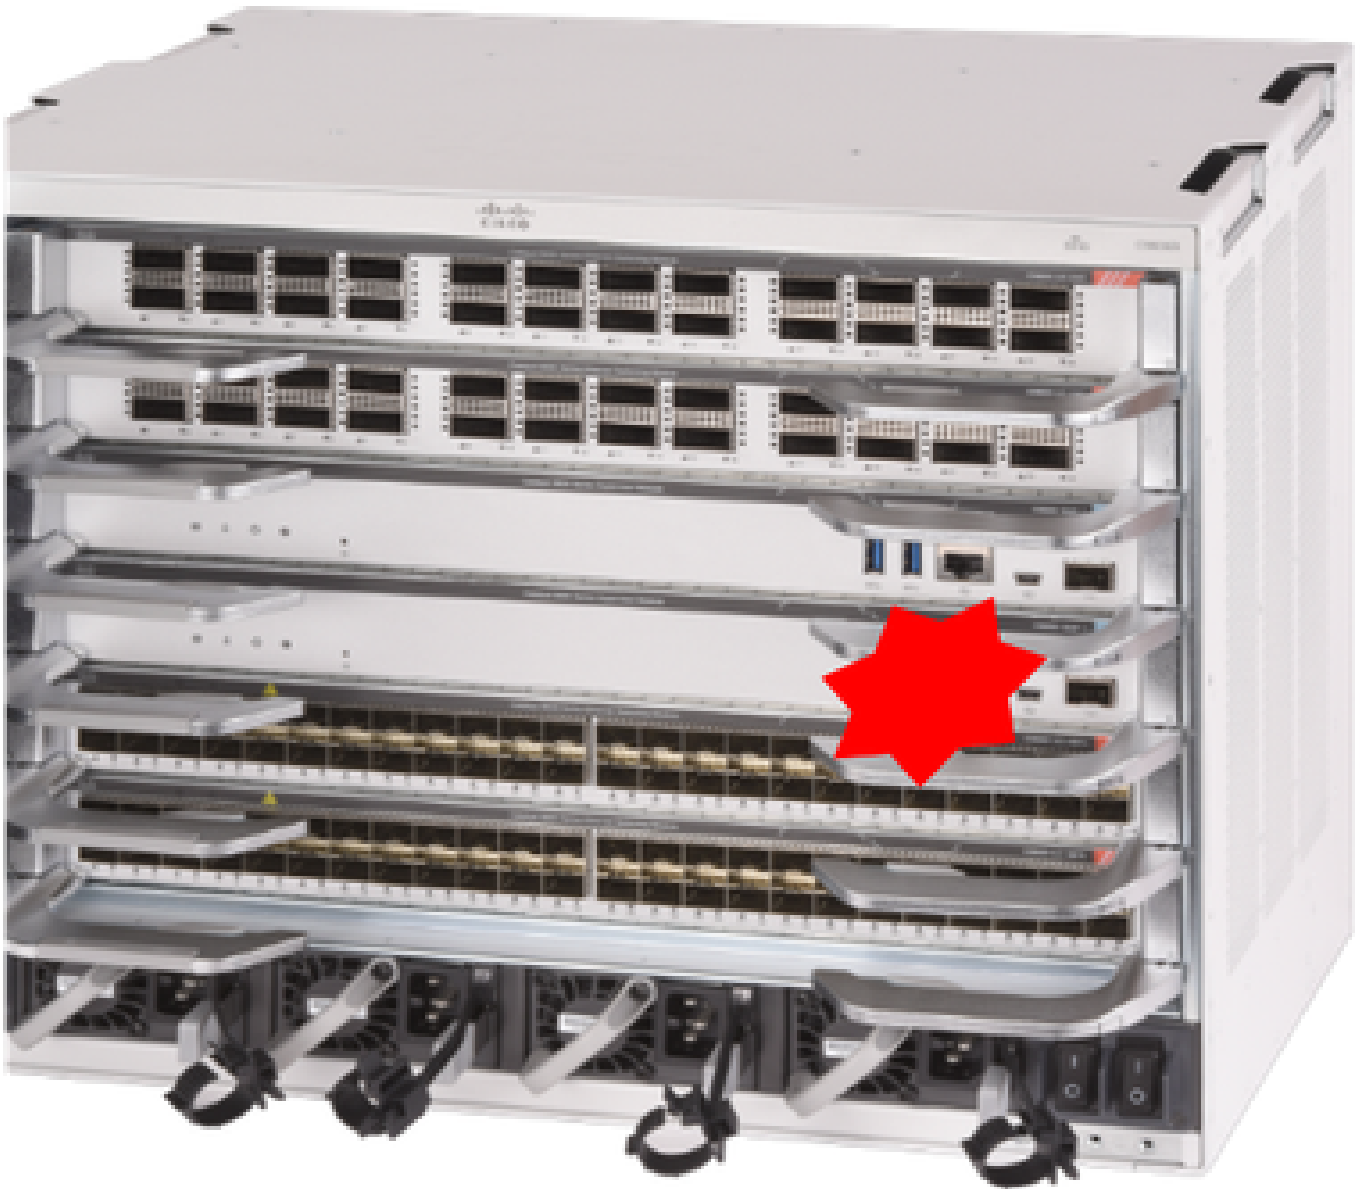
在本示例中，您正在考慮更換C9606機箱插槽3上的活動管理引擎。（交換機正在以「安裝」引導模式運行。）
